GLOVERTOWN FLOOD STUDY

FIELD REPORT

CANADA-NEWFOUNDLAND FLOOD
DAMAGE REDUCTION PROGRAM

SHAWMONT NEWFOUNDLAND LIMITED
P.O. Box 9600
St. John's, Newfoundland
A1A 3C1

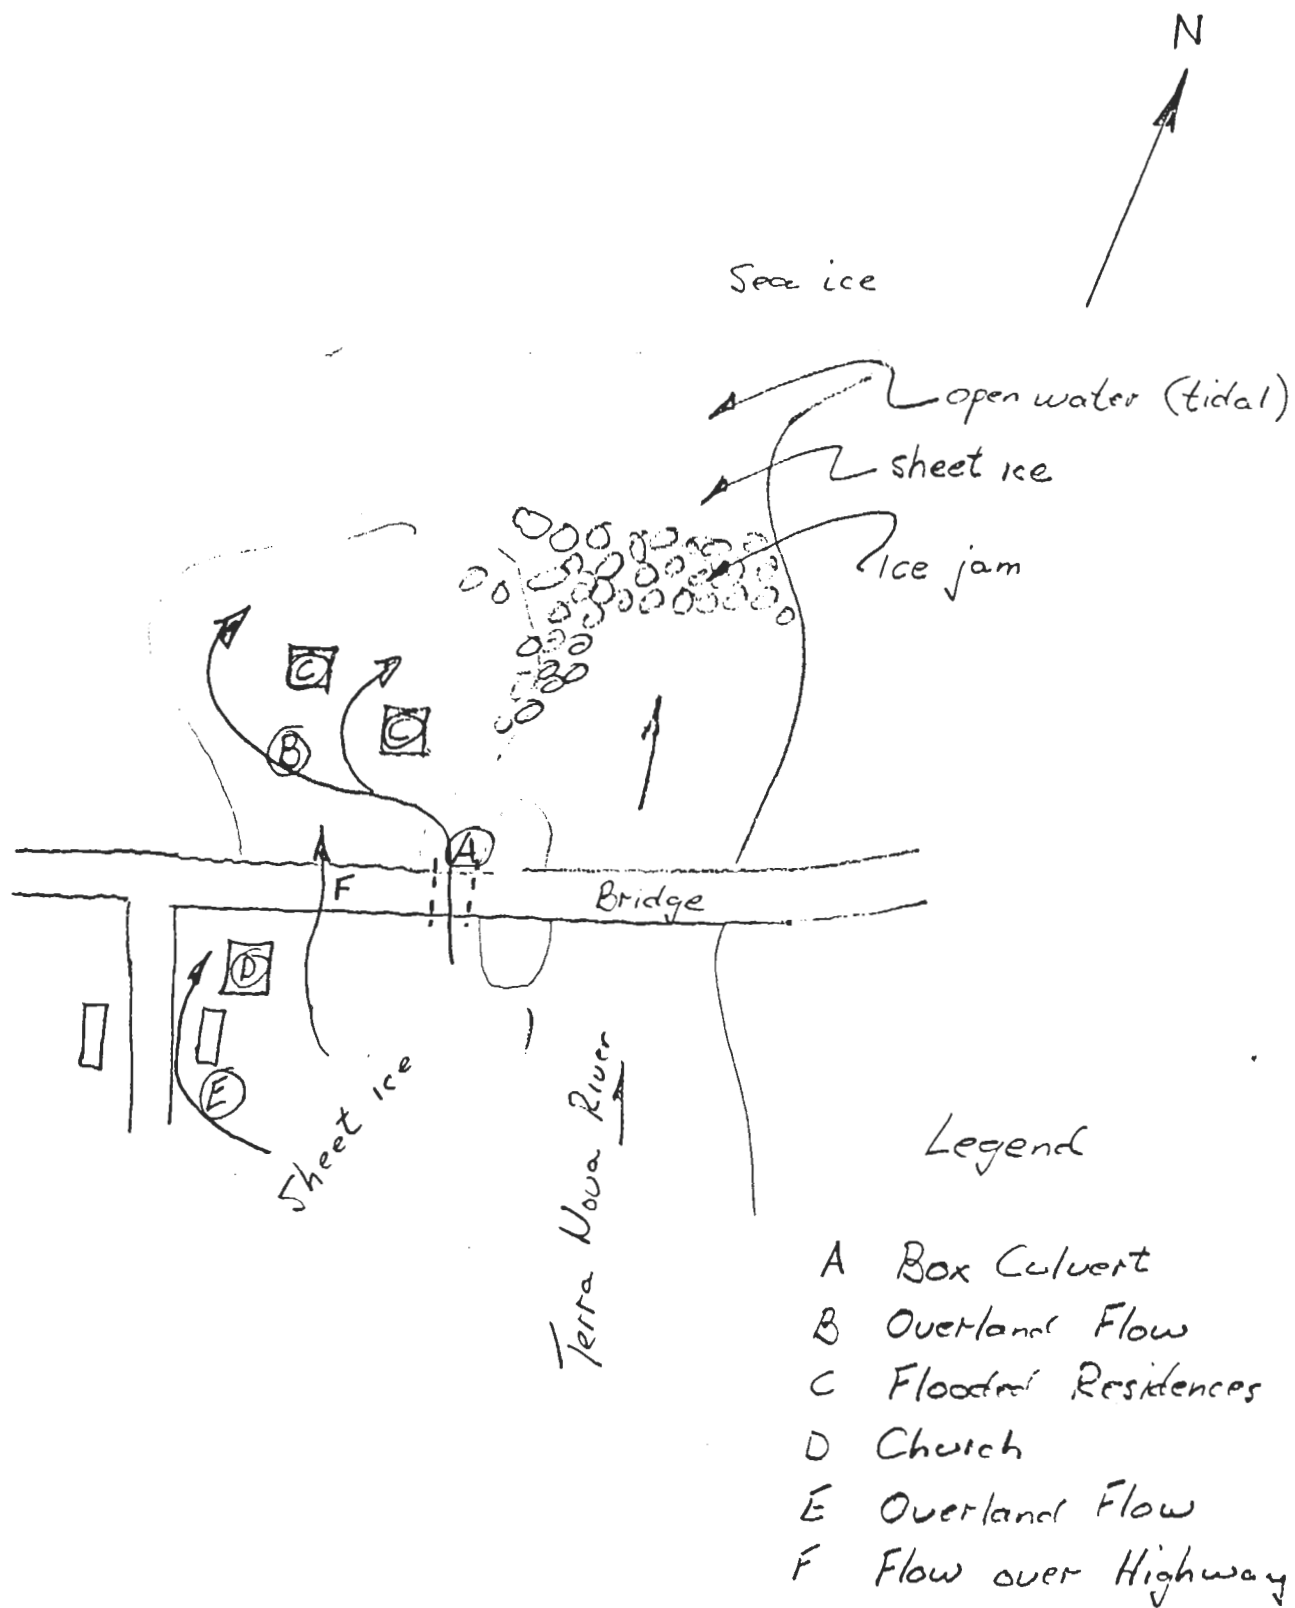
Fig 1. Site Plan at Glovertown

Heavy rainfall which occurred on the weekend prior to the flooding, resulted in the rising of water levels in the Terra Nova River. It is estimated that approximately 1.5 km of ice broke loose. This ice jammed at the outlet of the river where the depth of the channel is reduced and where the presence of sea ice further restricted flow. The production of frazil ice and additional floes of surface ice were contributing to increase the density of the jam. The situation at that time was as shown in Figure 1.

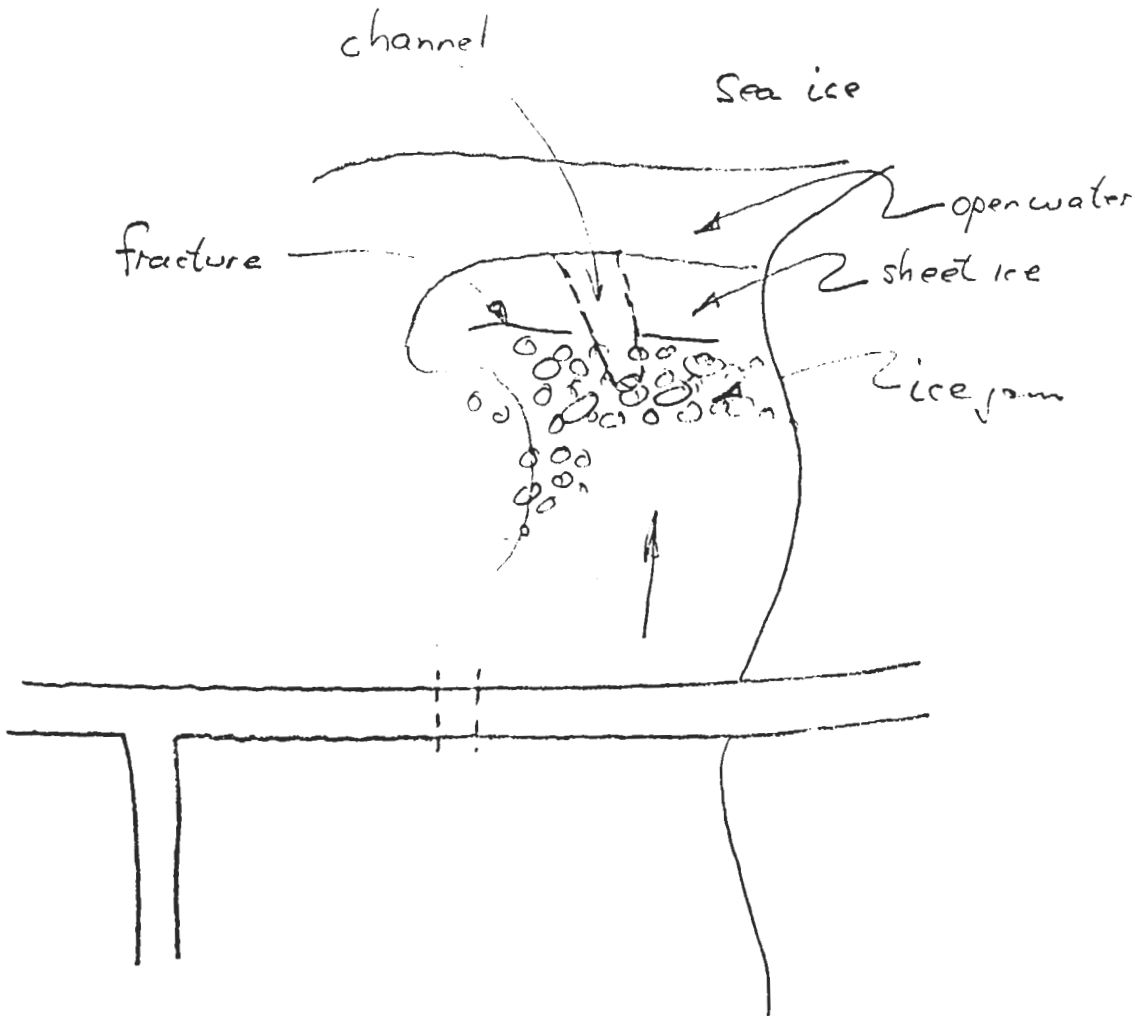
Fig 2. Ice Jam Prior to Break

Blasting again commenced at 1:30 p.m. Boosters had arrived by this time and the charges were significantly more effective. By 3:30 p.m. all but a few blasting caps had been used up. Blasting operations ceased and Mr. M. Goebel flew over the jam to observe the progress. A significant channel had been created but more important, a small fracture about four inches wide and running at right angles to the flow

direction was observed in what was previously competent sheet ice (see Figure 2).

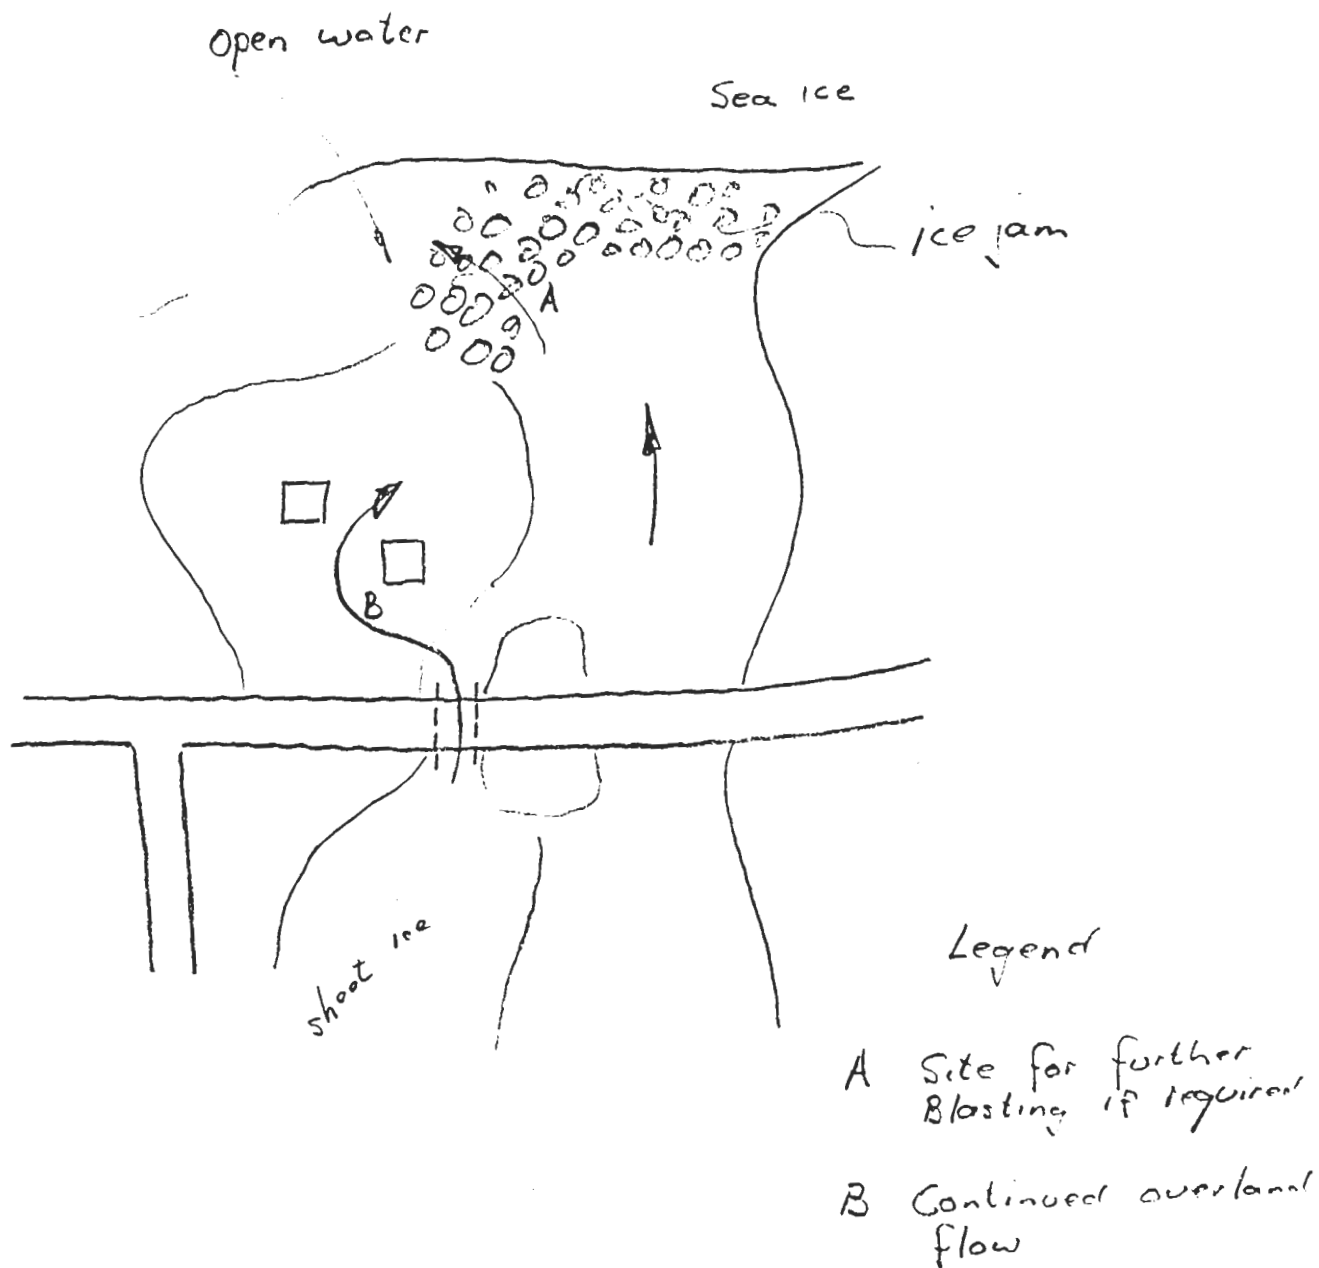
Fig 3 Site Plan after breaking the ice jam

The Honourable Hal Andrews arrived by helicopter and was briefed about the situation at that time. A fly-over of the area confirmed that an additional ice sheet had broken loose upstream and was piled up against the jam. Water flowing through the box culvert was still flooding the area around the two houses. A site was identified where further blasting could be effective if necessary.

By about 11:00 a.m. it was evident that the water levels were no longer rising. The R.C.M.P. were advised to monitor the water levels closely as there was a possibility that if more ice broke loose from upstream it could cause more flooding. However, the cold temperature and lack of precipitation was contributing to a decrease in flow in the river and water levels were expected to gradually go down.
