Hydrotechnical Study of the Placentia Area Flood Plain

FIELD REPORT

Volume 2 of 2

SMR-05-84

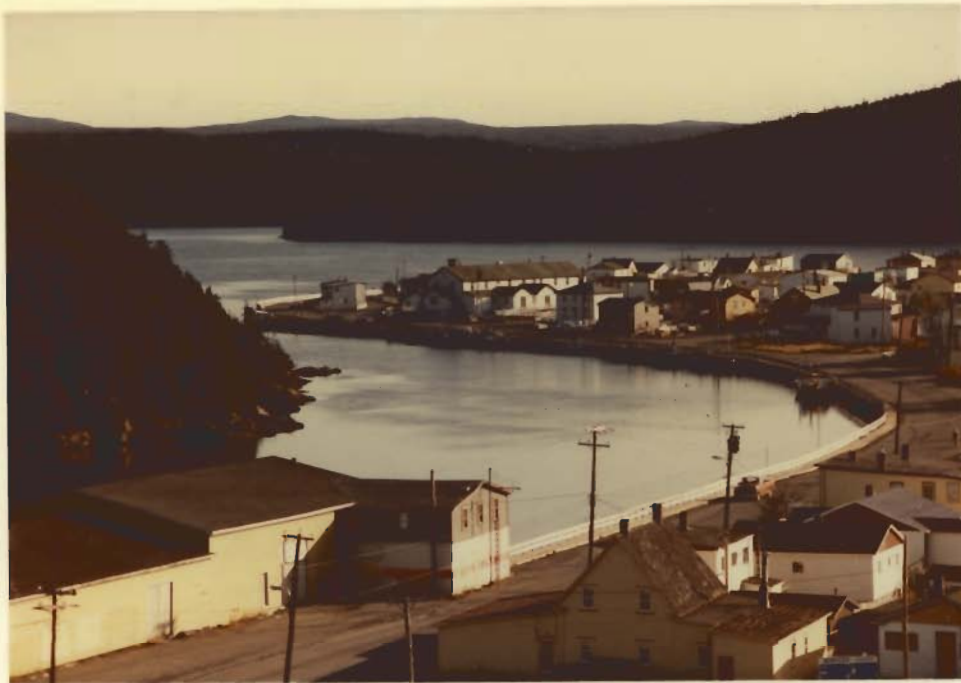
Photo No. 1

The Narrows with Swan Arm in background.

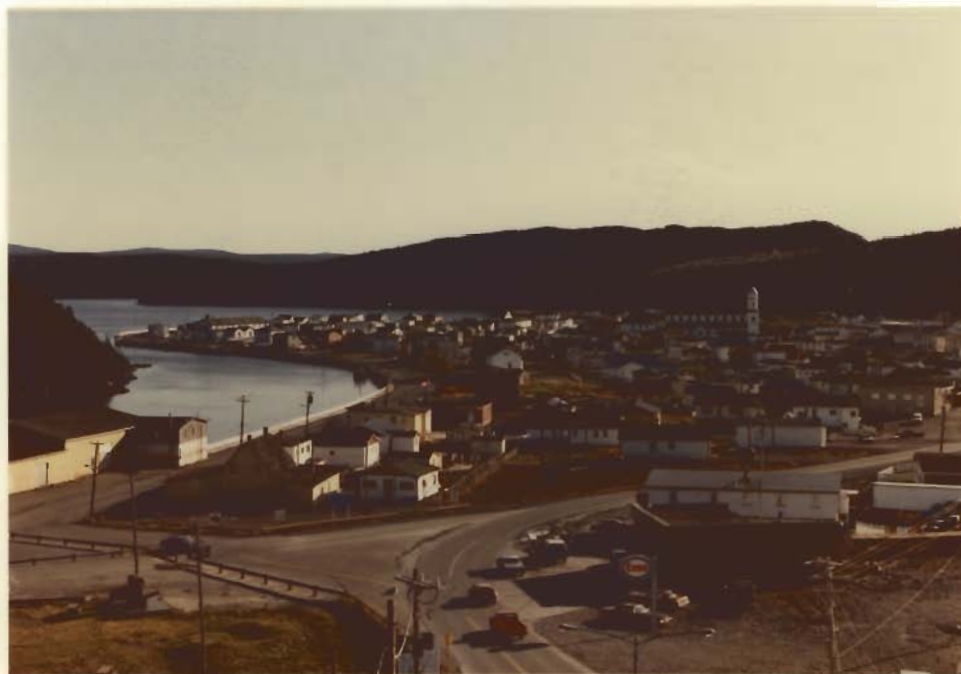
Photo No. 2

Eastern side of Placentia looking south from lift bridge.

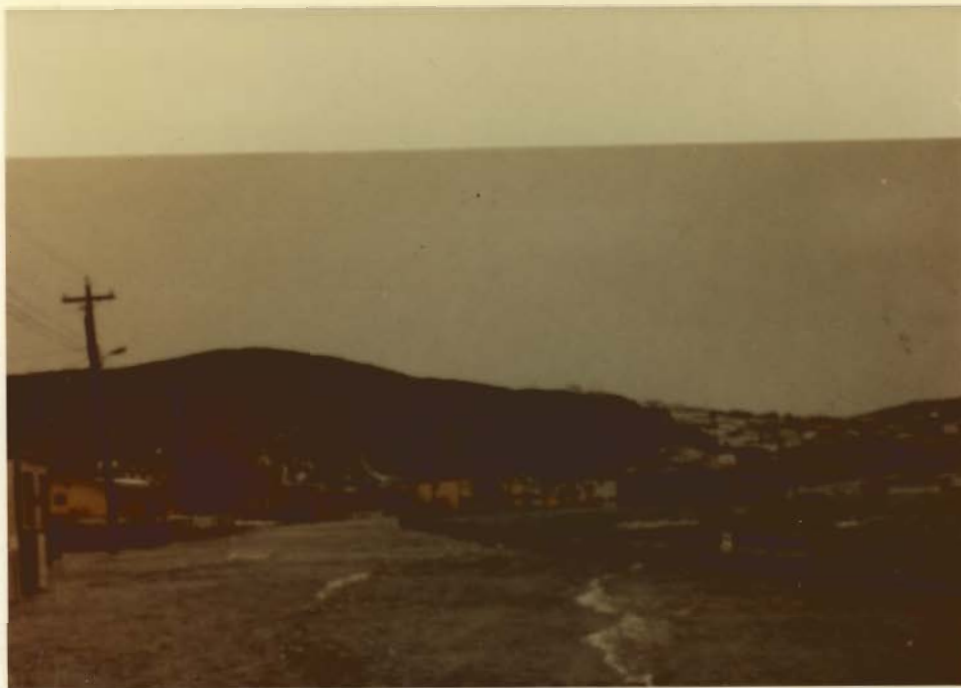
Photo No. 3

Under certain climatic conditions the water level in Swan Arm and Southeast Arm is raised and the Town is flooded from the south and east. Flooding usually begins along Riverside Drive and O'Rielly Street (See Drawing 2 and Photos 1 and 2). The northern and western movement of flood waters continues depending on actual levels of water in Swan Arm and the force of wind aggravating overtopping of the breastwork along the Narrows (See Photos 3 and 4).

Riverside Drive adjacent to the Narrows looking north.

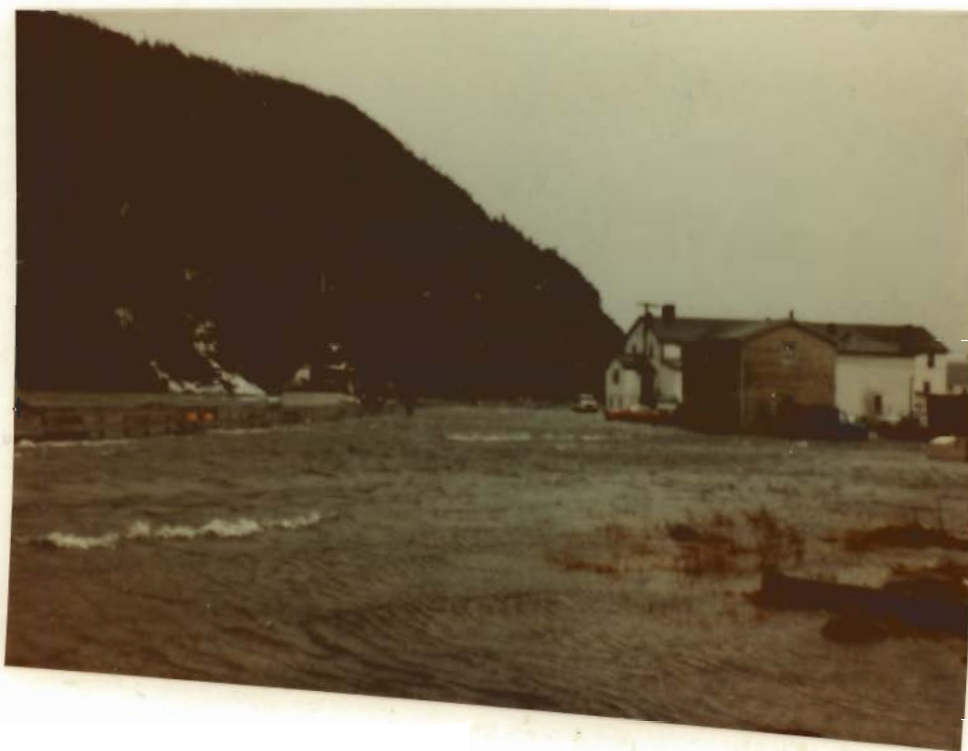
Photo No. 4

Riverside Drive adjacent to the Narrows looking south.

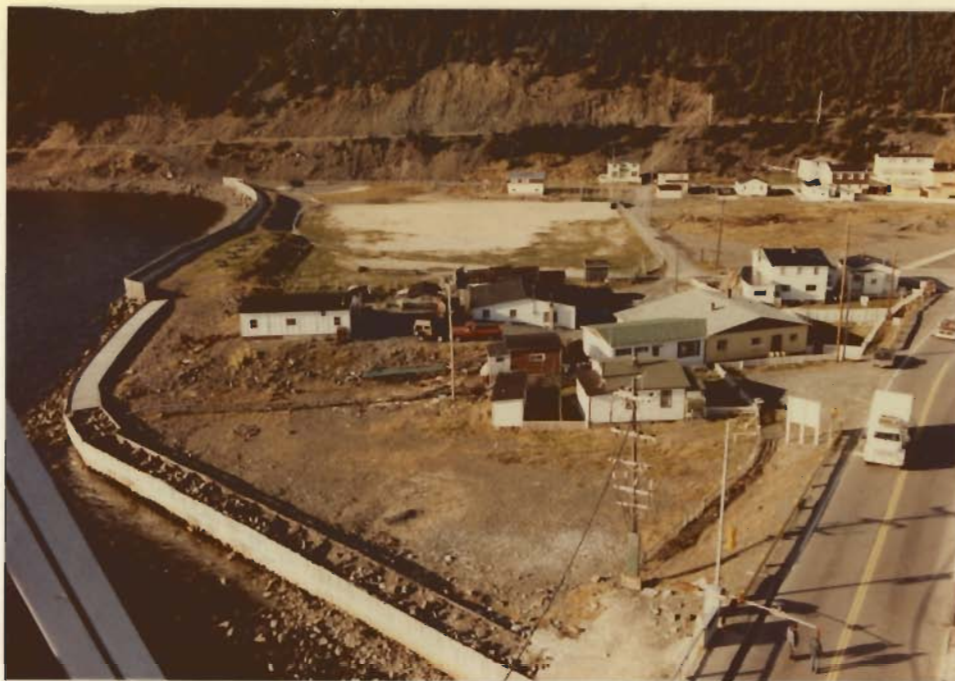
Photo No. 5

Seawall adjacent to Battery on west side of Jersey side.

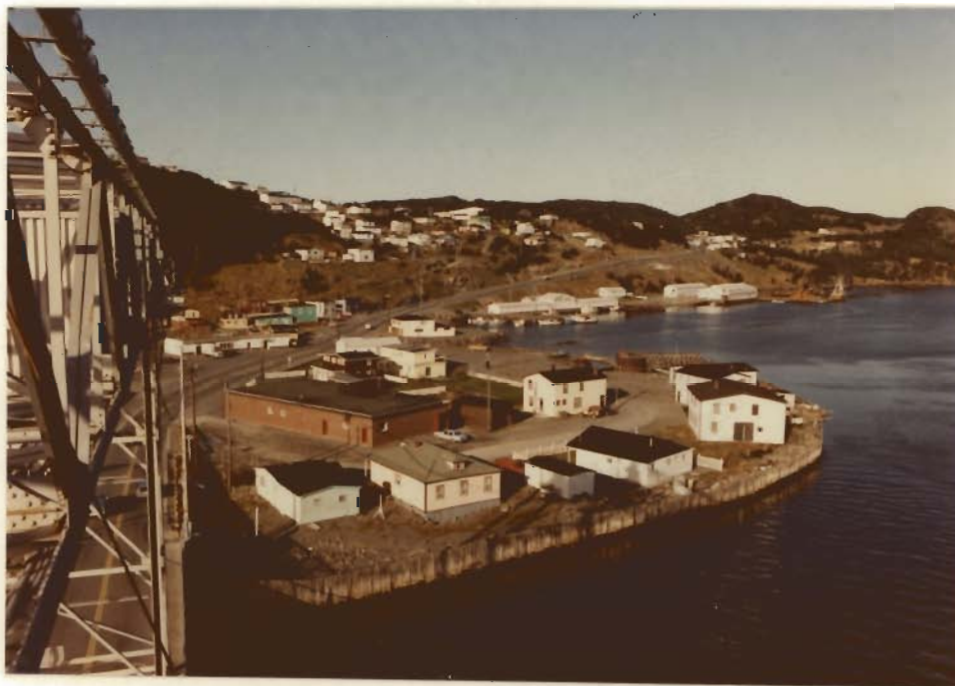
Photo No. 6

Breastwork on southeast side of Jersey side.

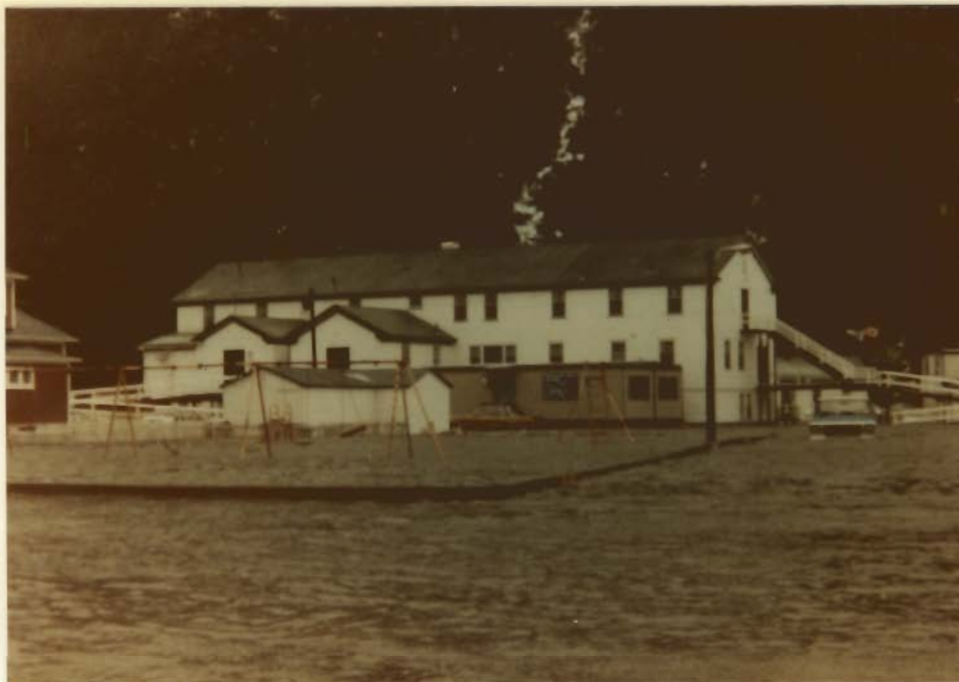
Photo No. 7

On this date an unusually high tide was driven by generally southeasterly winds. The breastwork along the east side of Placentia could not contain the high water and waves in Swan Arm and was overtopped. Photos 7 to 9 are indicative of the flood conditions in this area. For comparison purposes Photo 10 was taken during a flood in 1960. See Drawing 3 for the key to photo locations.

Placentia Cottage Hospital.

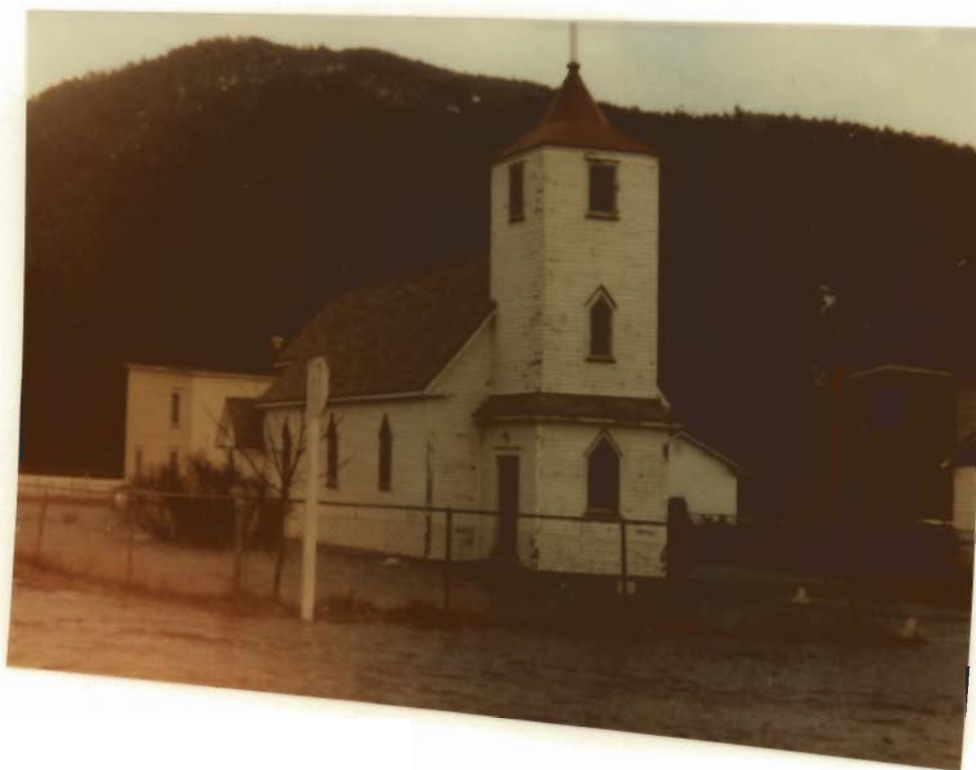
Photo No. 8

Anglican Church and Cemetery.

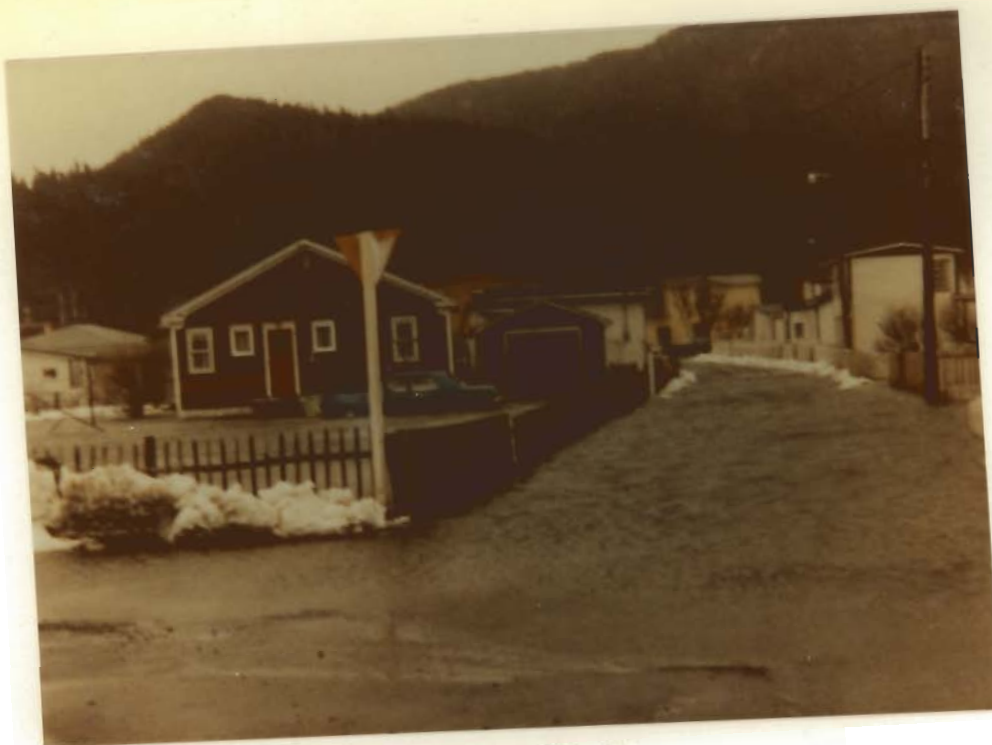
Photo No. 9

Flynn Street looking east.

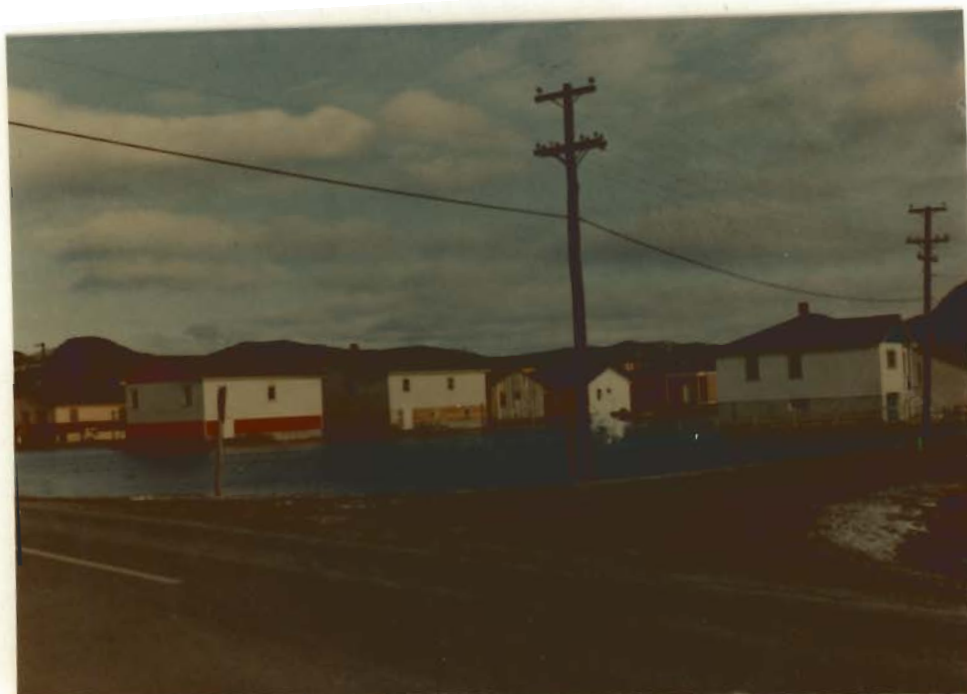
Photo No. 10

Blenhelm Street looking east. Circa 1960.

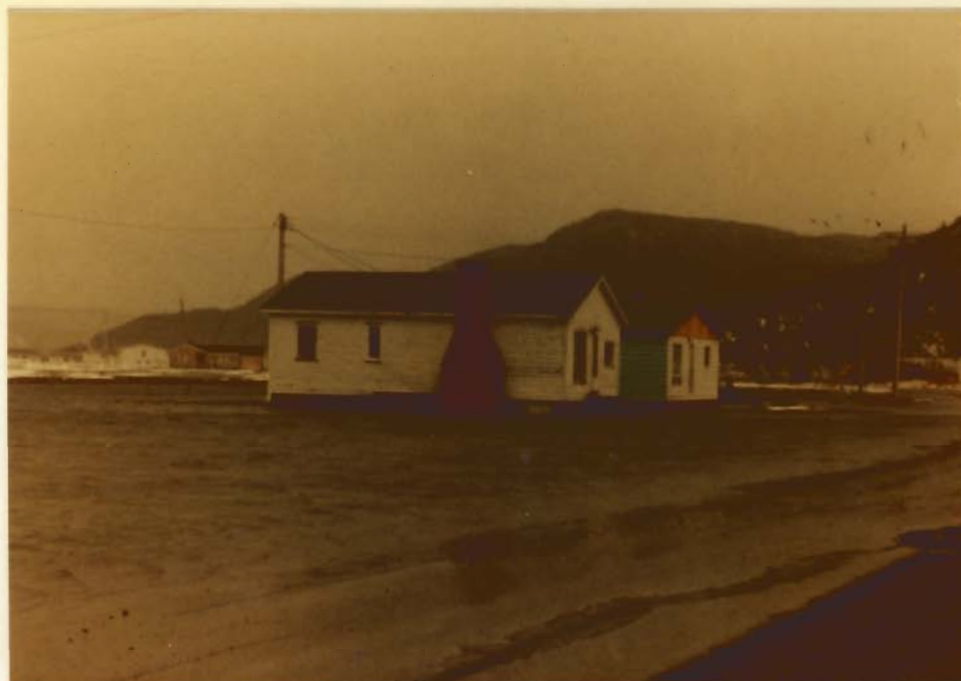
Photo No. 11

Blockhouse Road near Aylward's Mall.

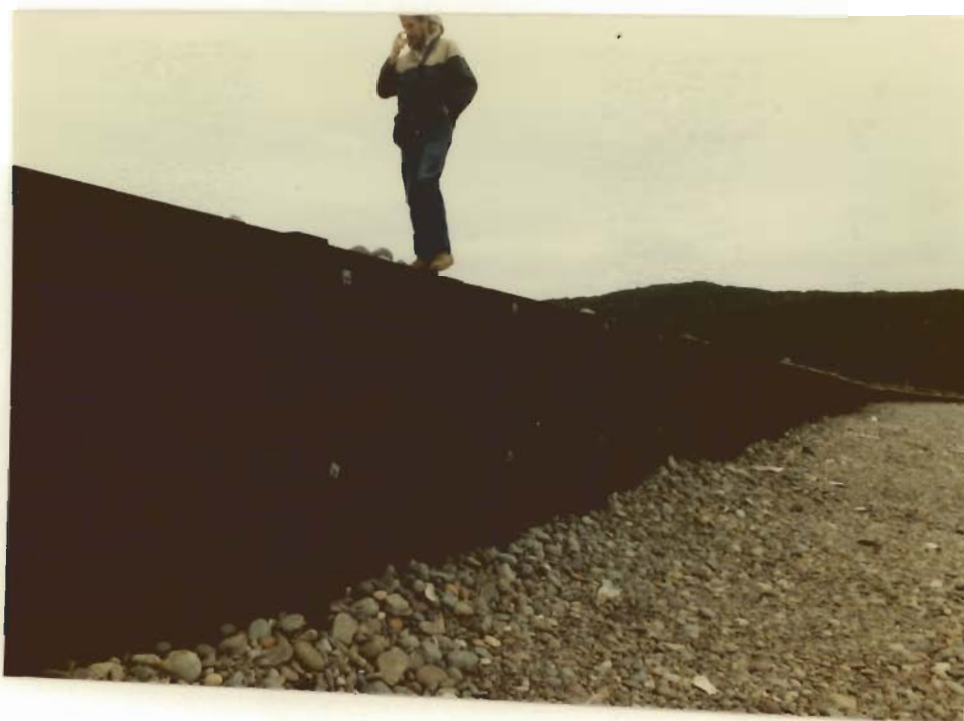
Photo No. 12

Seawall along beach on west side of Placentia.

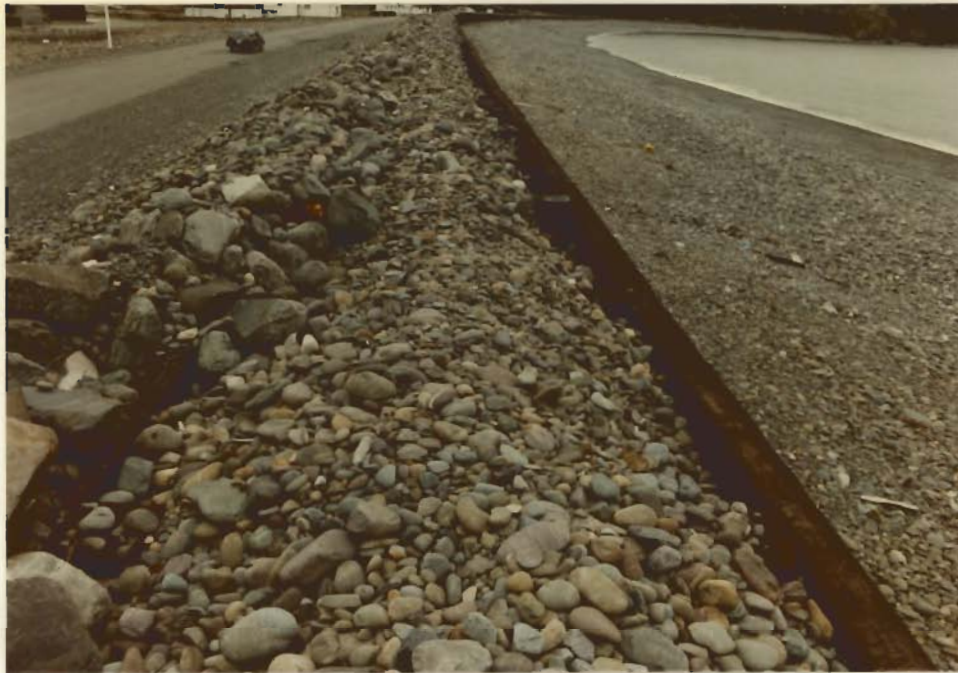
Photo No. 13

Seawall with ballast adjacent to Beach Road, on west side of Placentia.

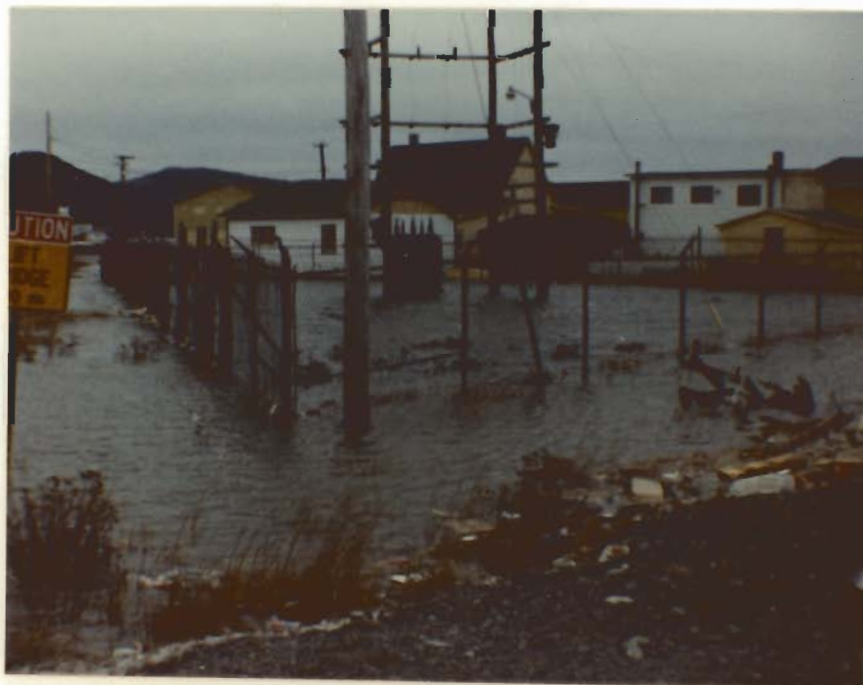
Photo No. 14

Newfoundland Light & Power substation south of lift bridge.

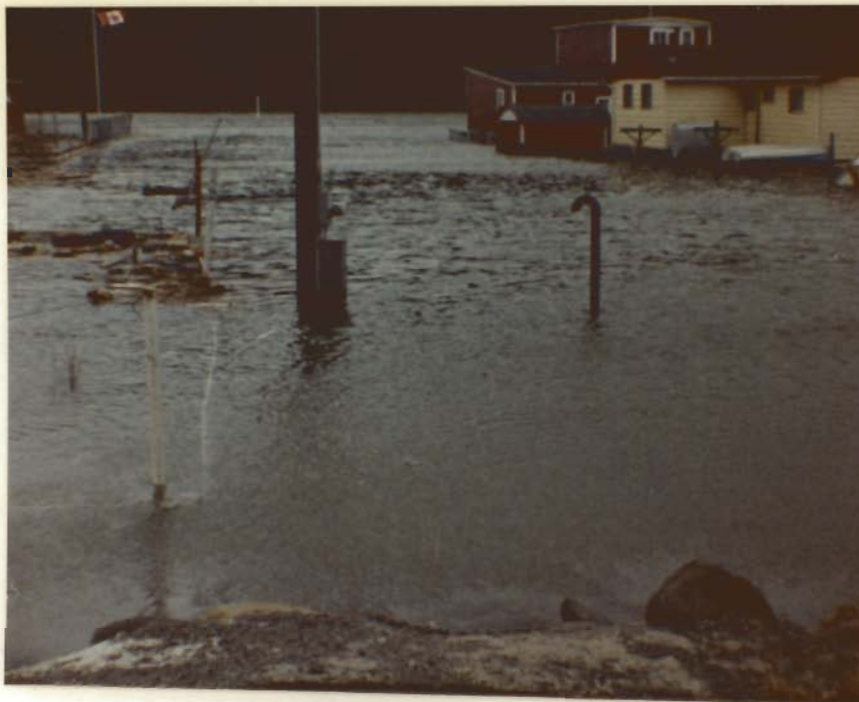
Photo No. 15

Backyards between Roache Street and Blenheim Street
behind Manning's Pharmacy.

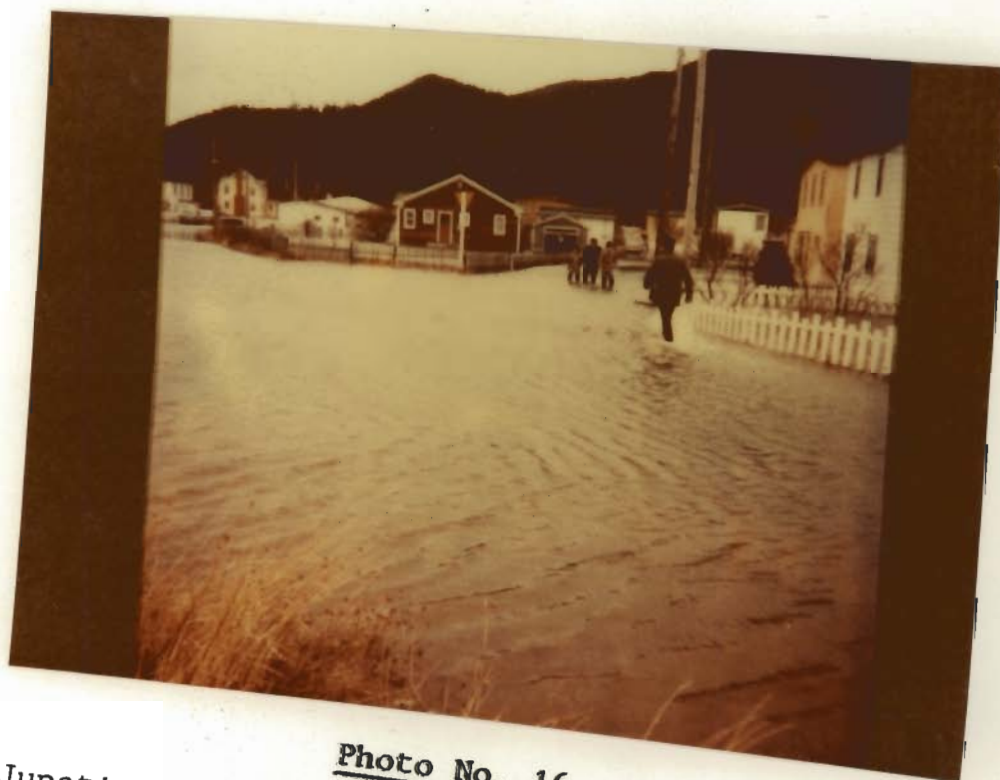
Photo No. 16

Junction of Flynn Street and Banker's Road looking
east.

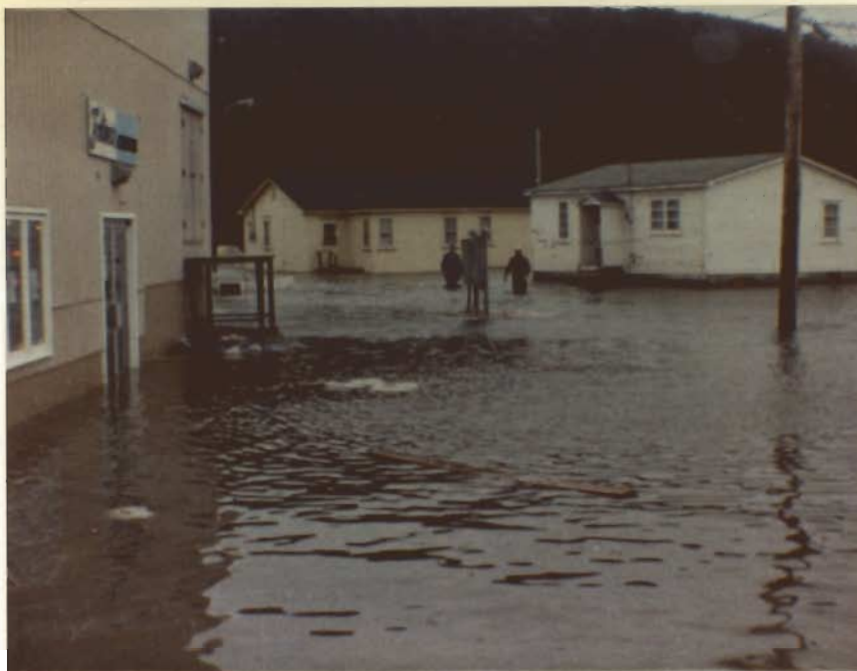
Photo No. 17

Blenhelm Street adjacent to Manning's Pharmacy.

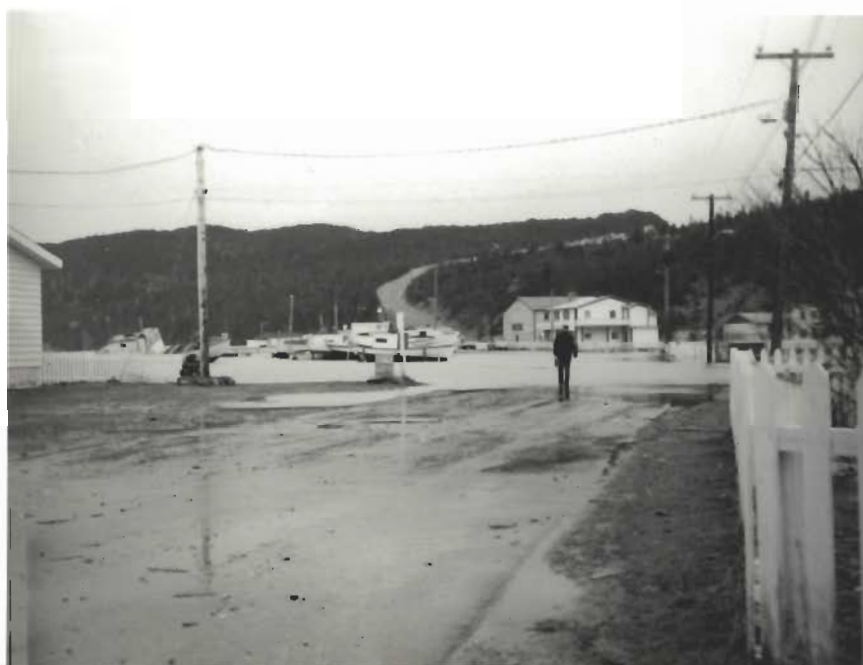
Photo No. 18

Swan's Road at intersection of Jubilee Road and Riverside Drive South looking toward Dixon Hill. Water level shown has receded from the maximum attained.

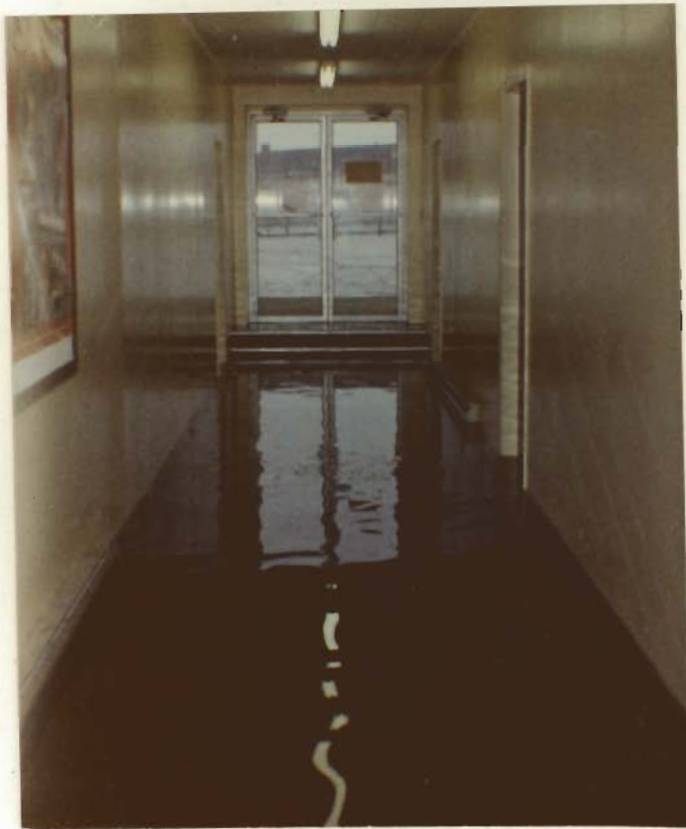
Photo No. 19

Lower floor of Manning's Pharmacy. Notice water level outside door which is below the maximum attained.

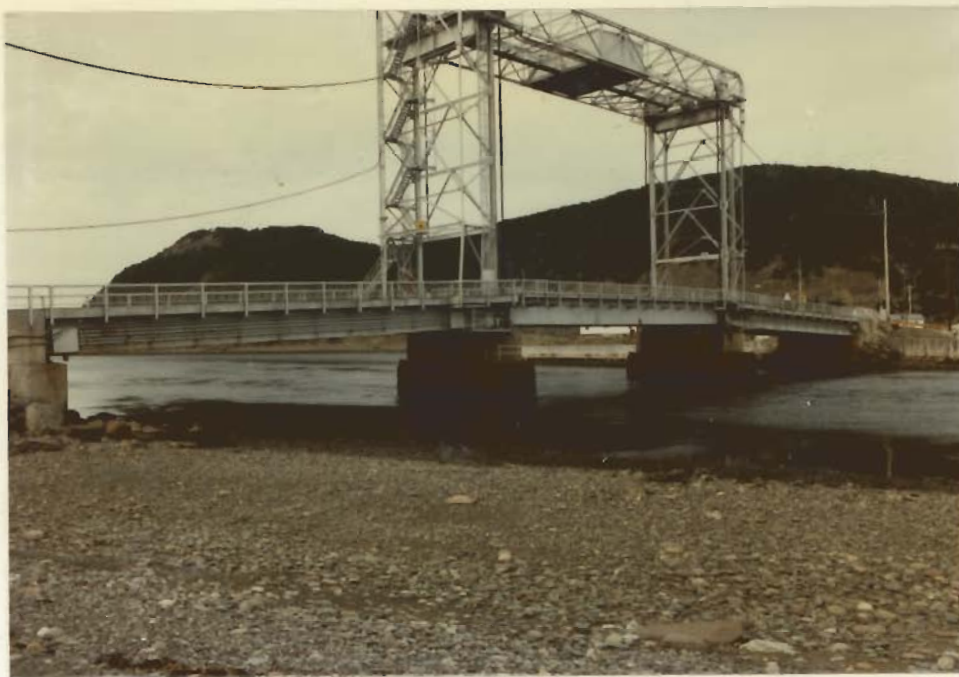
Photo No. 20

Spanning the Gut is a steel lift bridge built in 1960. The bridge structure is shown in Photo 20 and is detailed in Figure 3. The two main bridge piers are constructed of steel sheet piles filled with concrete. The abutments are reinforced concrete blocks founded on steel piling.

Sir Ambrose Shea lift bridge looking Northwest.

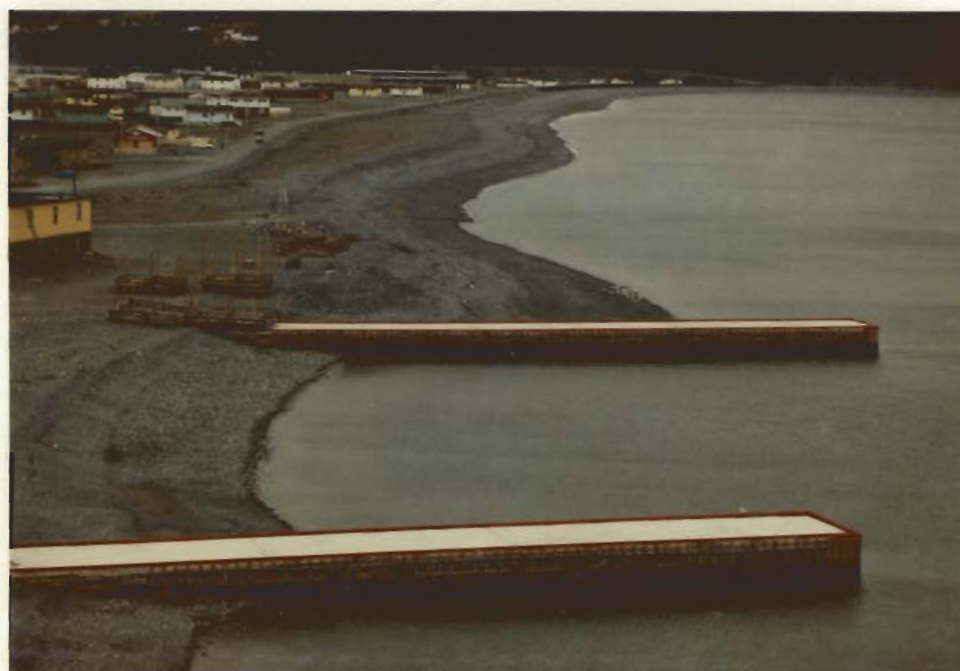
Photo No. 21

On the northern end of the beach to the west of Placentia, two timber crib groins were constructed in 1983 (Photo 21). The installation of these groins was recommended by Woodward Clyde Consultants in their 1982 report on the "Hydraulic and Physical Character of Placentia in Relation to the Fishing Industry". The purpose of the groins was to trap the sediment moving northwards along the beach towards the Gut and thereby reduce the amount of silt and sand being carried through the Gut and eventually into the Narrows and Northeast Arm. The effectiveness of these groins has not been established but it can be seen that transported material has been deposited on the south side of each structure.

Groins on beach along west side of Placentia.
Notice the accumulation of material on south side
of groins.

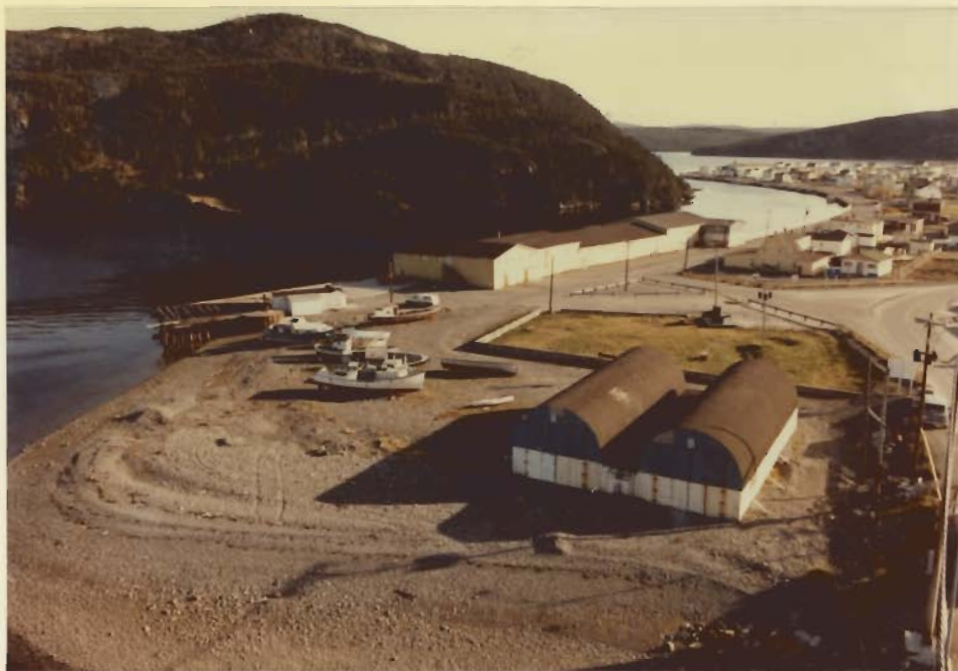
Photo No. 22

North end of Narrows and beach to southeast of lift bridge.

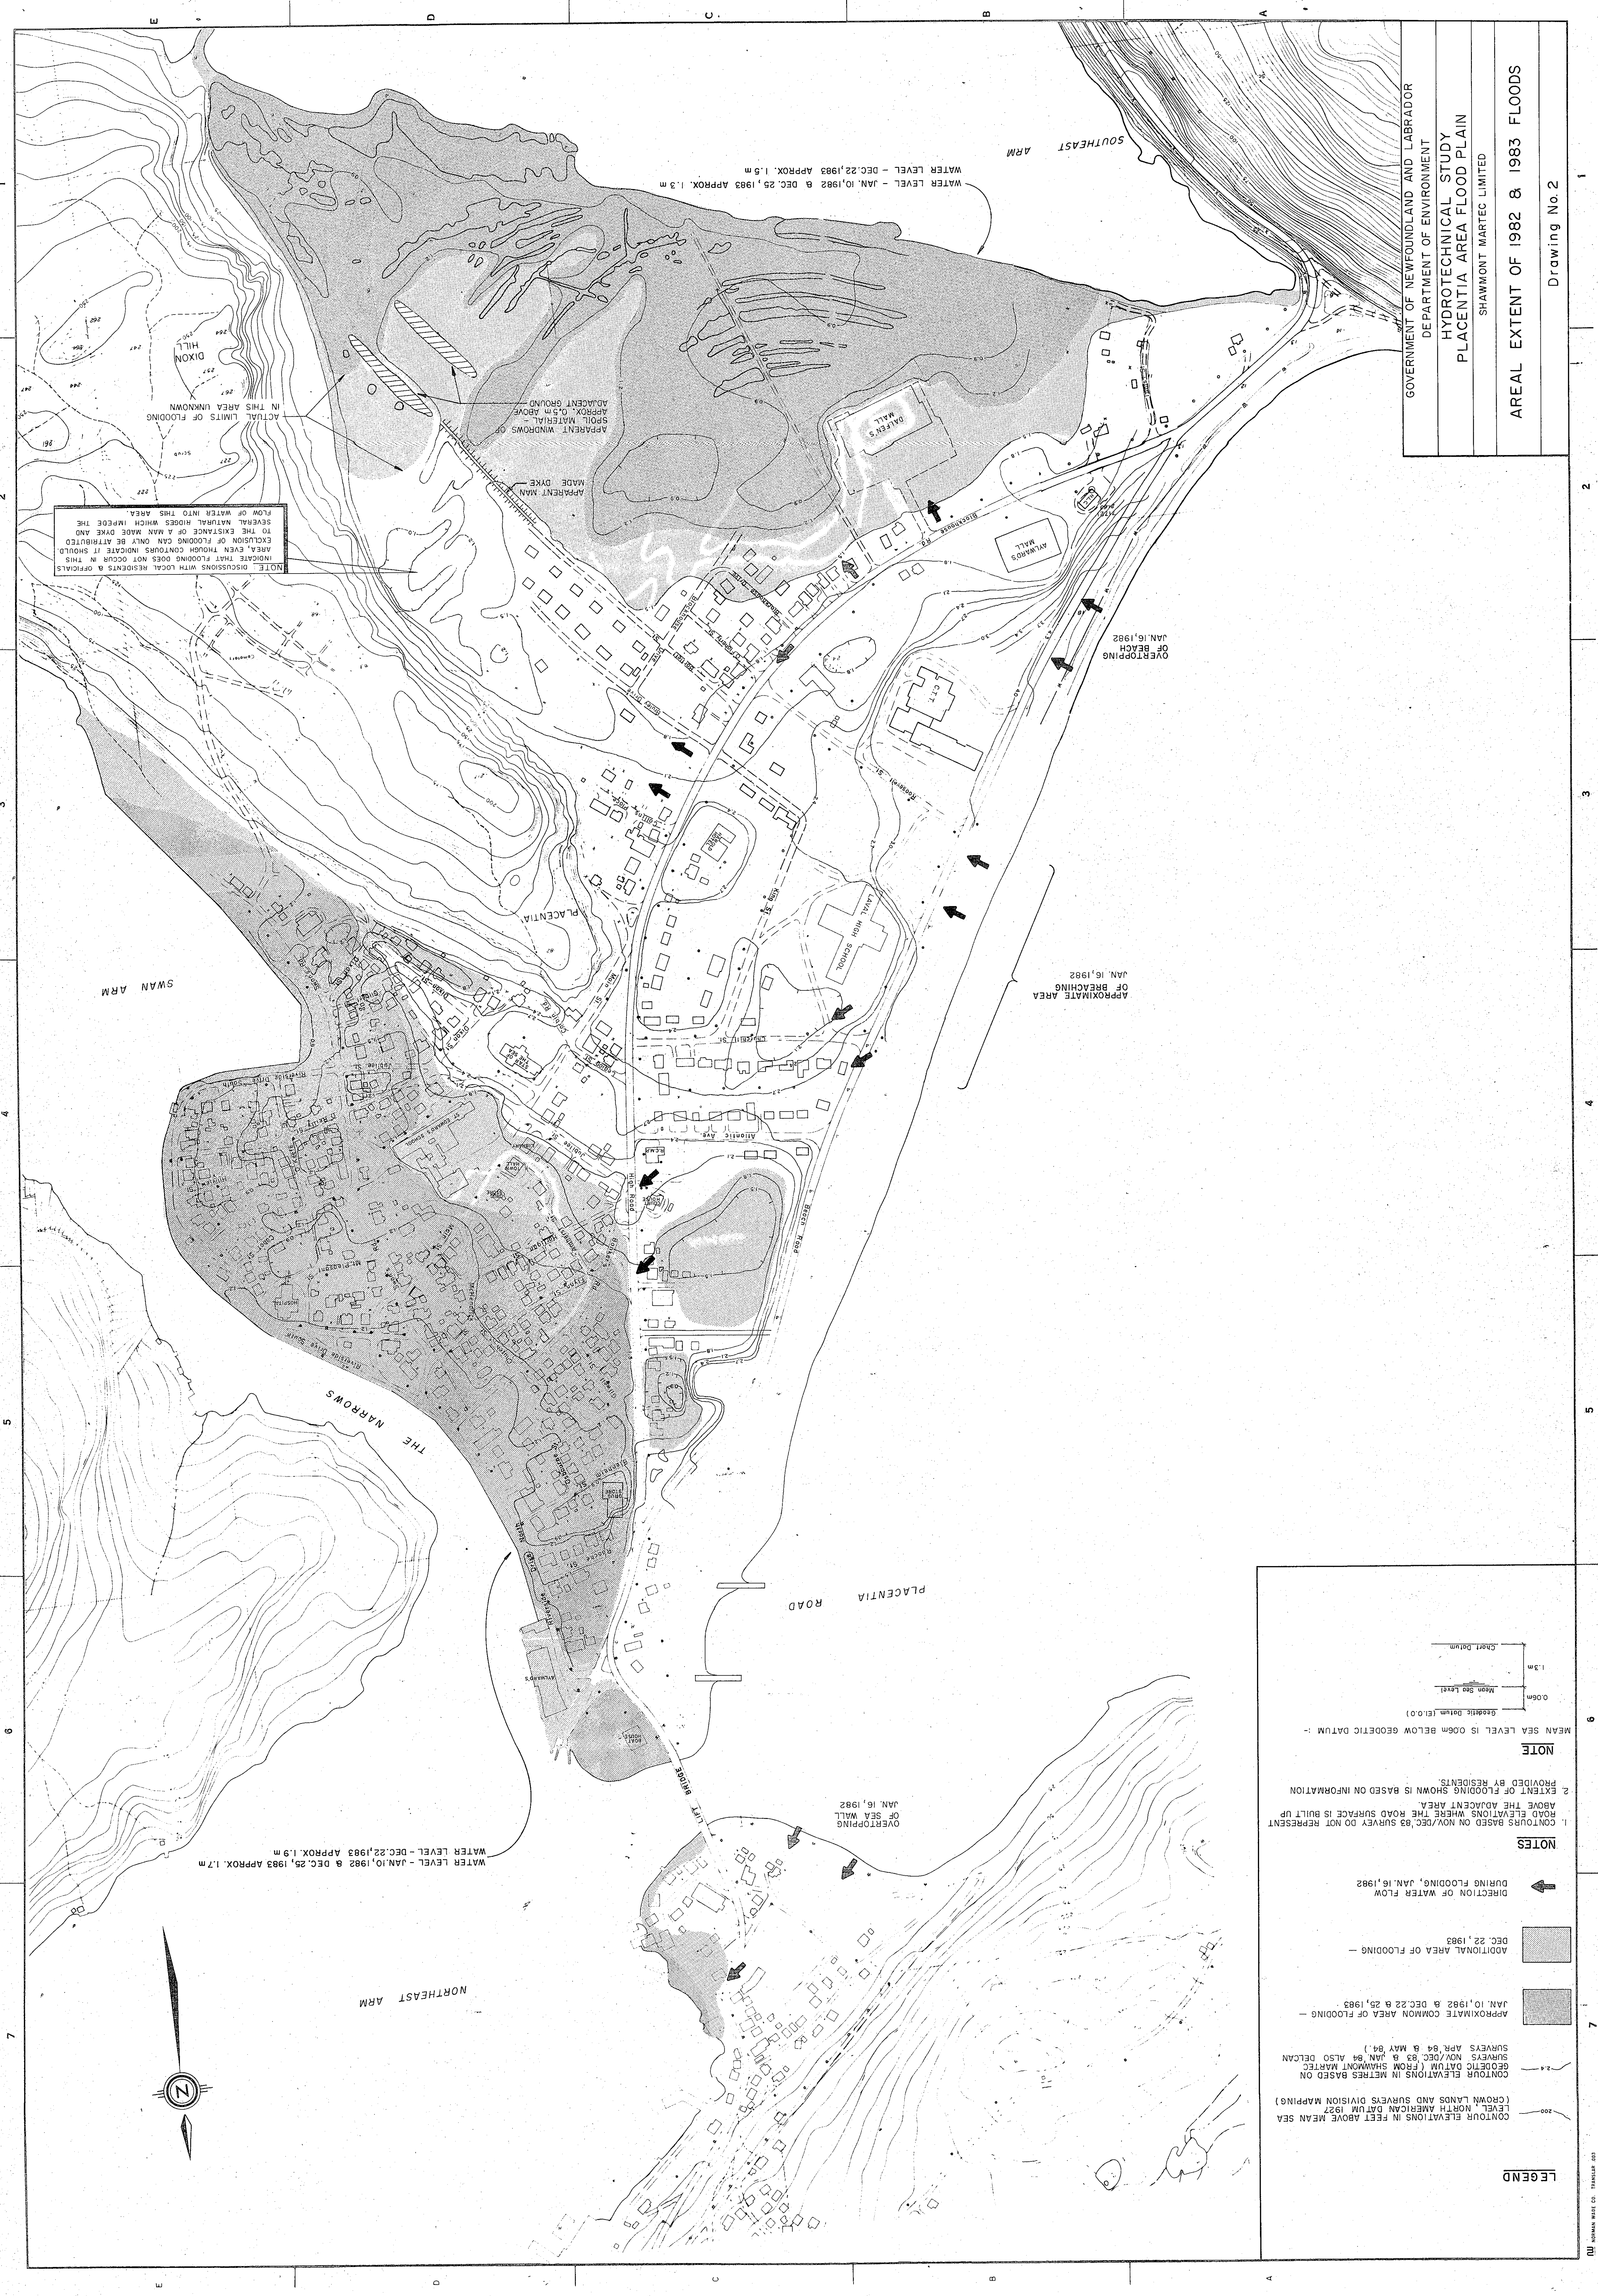
GOVERNMENT OF NEWFOUNDLAND AND LABRADOR
DEPARTMENT OF ENVIRONMENT
HYDROTECHNICAL STUDY
PLACENTIA AREA FLOOD PLAIN
SHAWMONT MARTEC LIMITED
AREAL EXTENT OF 1982 & 1983 FLOODS
Drawing No. 2

Using available photographs and information received from residents of Placentia, the maximum flood levels of particular flood events were determined. The areal extent of particular flood events are shown on Drawing 3.
