Canada - Newfoundland
**Flood
Damage
Reduction
Program**

Hydrotechnical Study of the Badger and Rushy Pond Areas

MAIN REPORT

BADGER AND RUSHY POND HYDROTECHNICAL STUDY

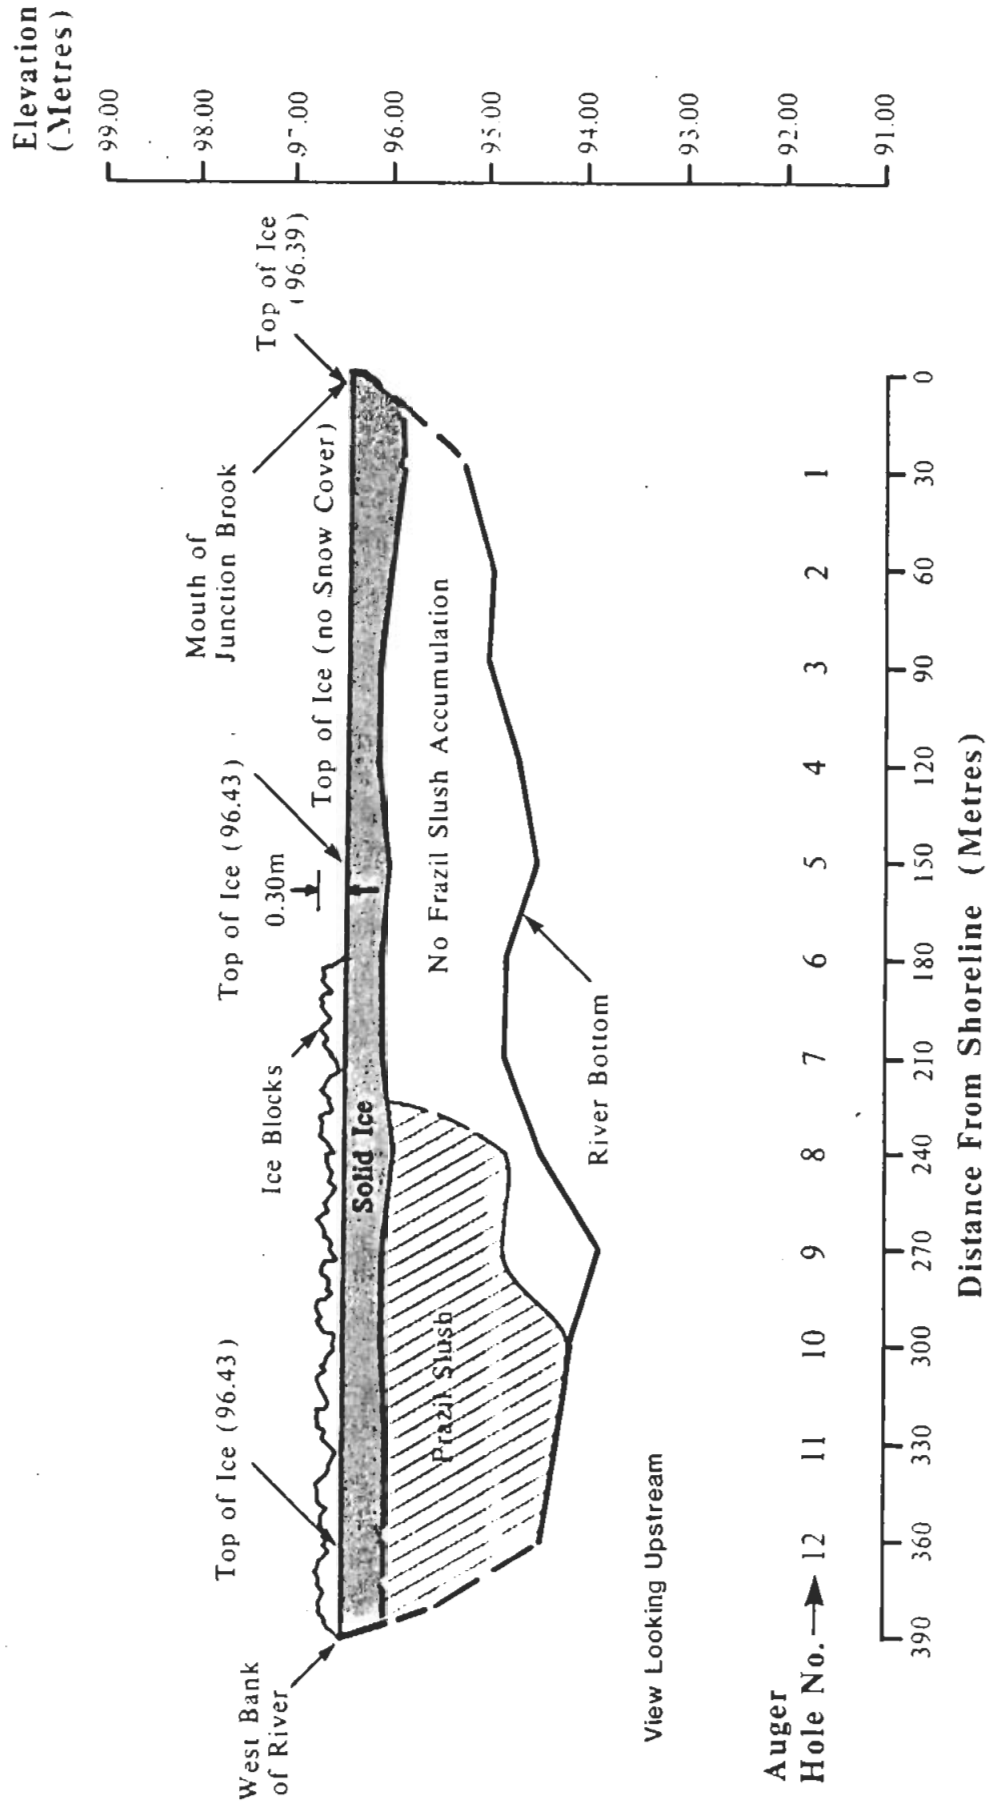
FIGURE 4.2

Cross-Section 4, Jan. 27, 1984

Notes: ~~~~~ ice or bottom contour approximate

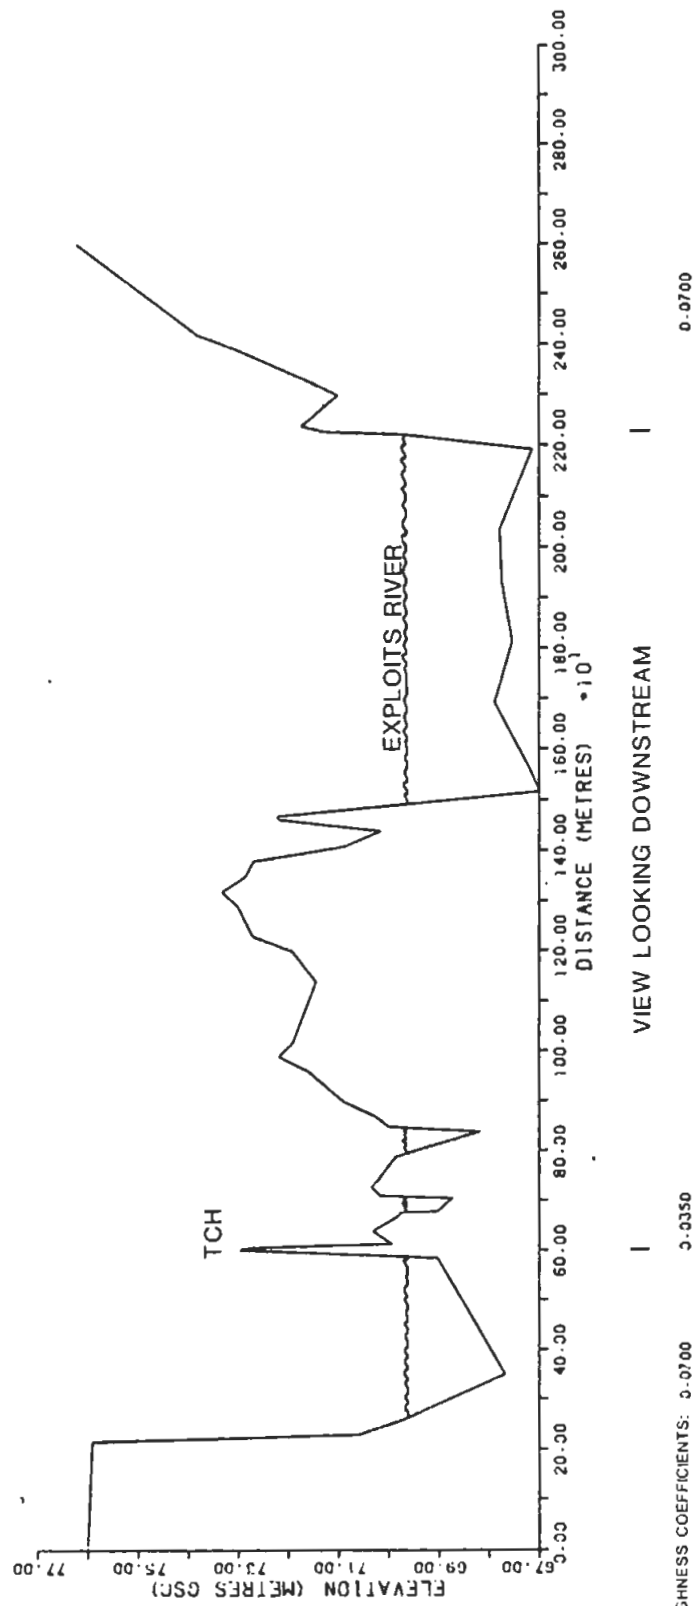
FIGURE 4.11

EXPLOITS RIVER
 CROSS SECTION NUMBER 3250.
 HEC-2 MODEL

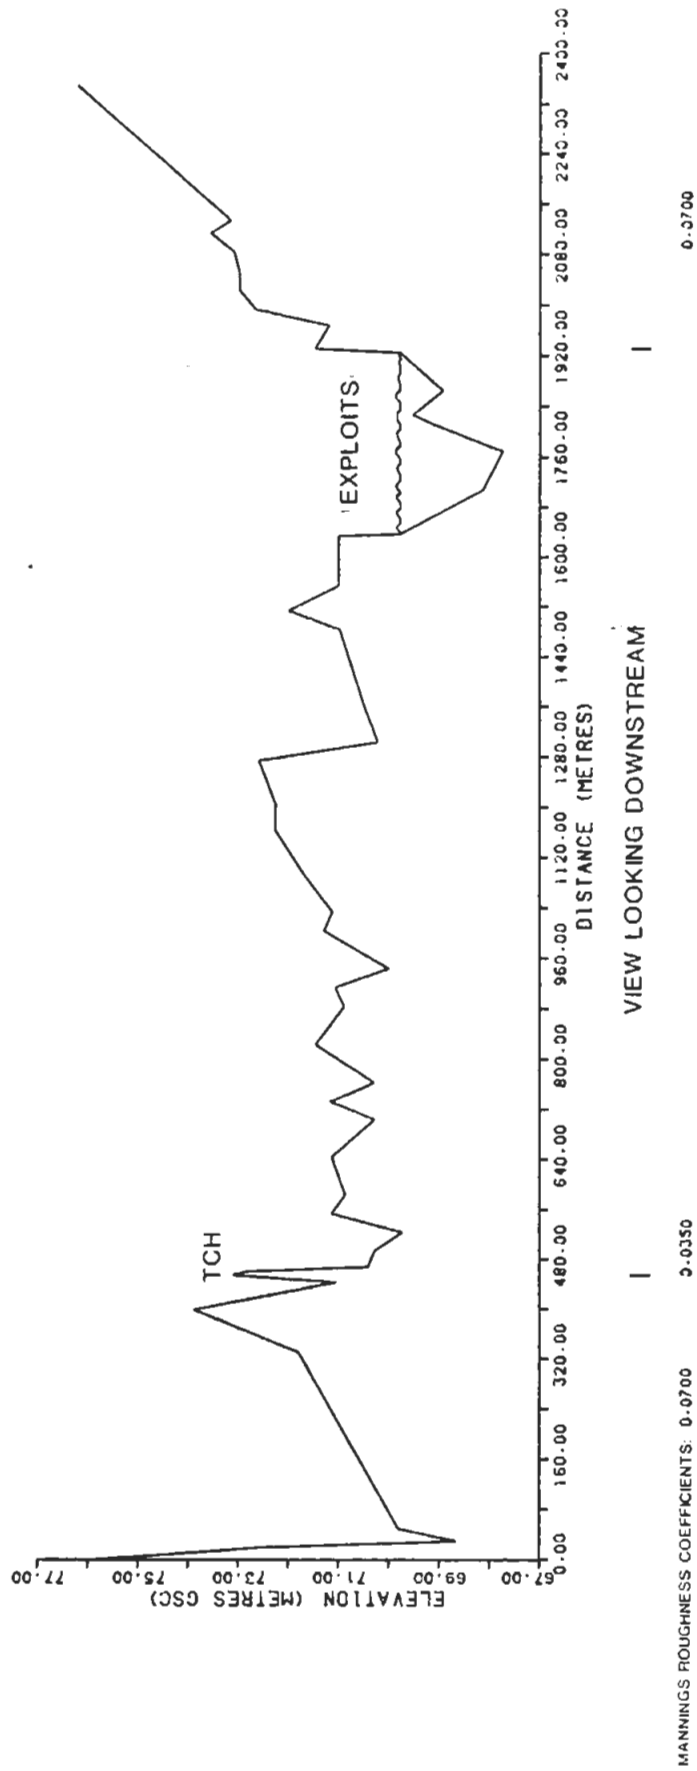
FIGURE 4.12

EXPLOITS RIVER HEC-2 MODEL
CROSS SECTION NUMBER 5100.

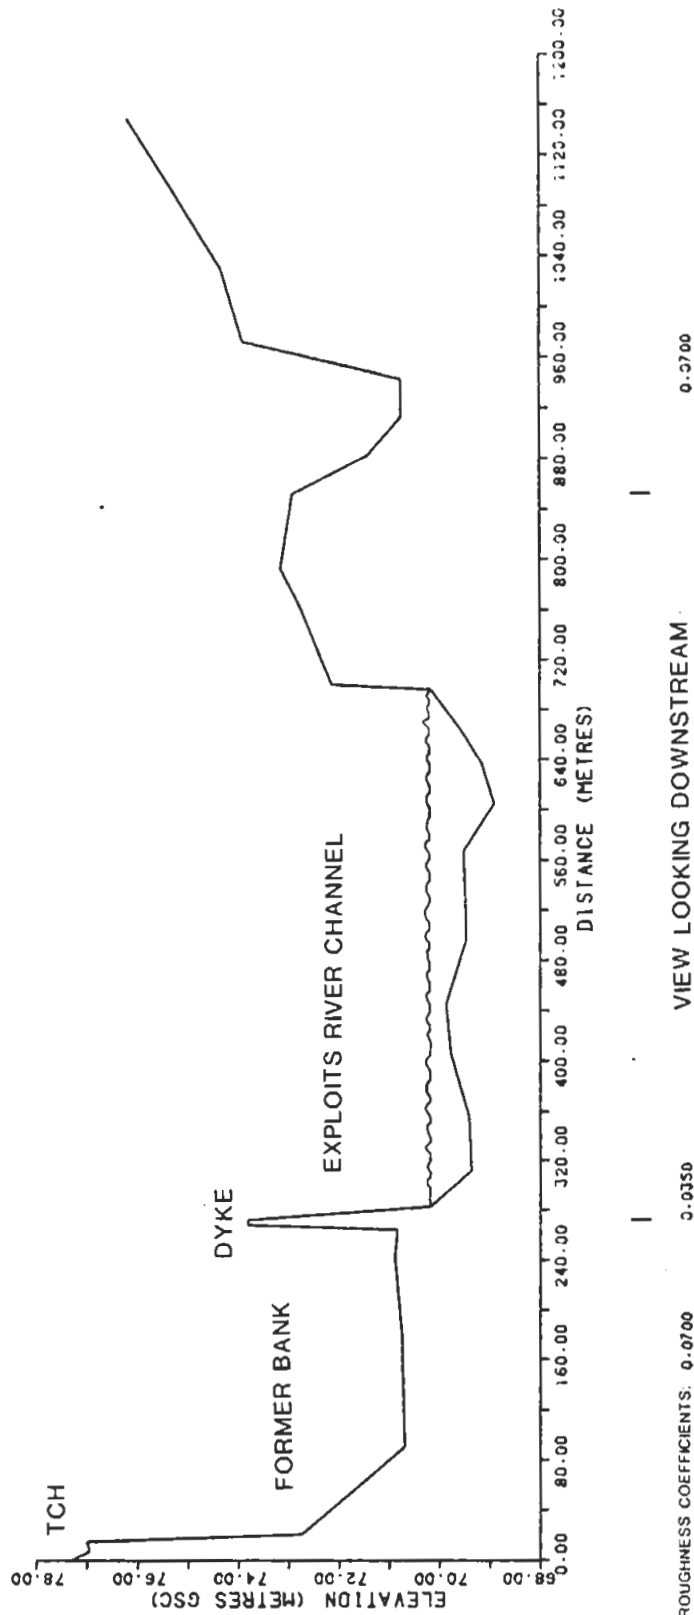
FIGURE 4.13

EXPLOITS RIVER HEC-2 MODEL
CROSS SECTION NUMBER 6050.

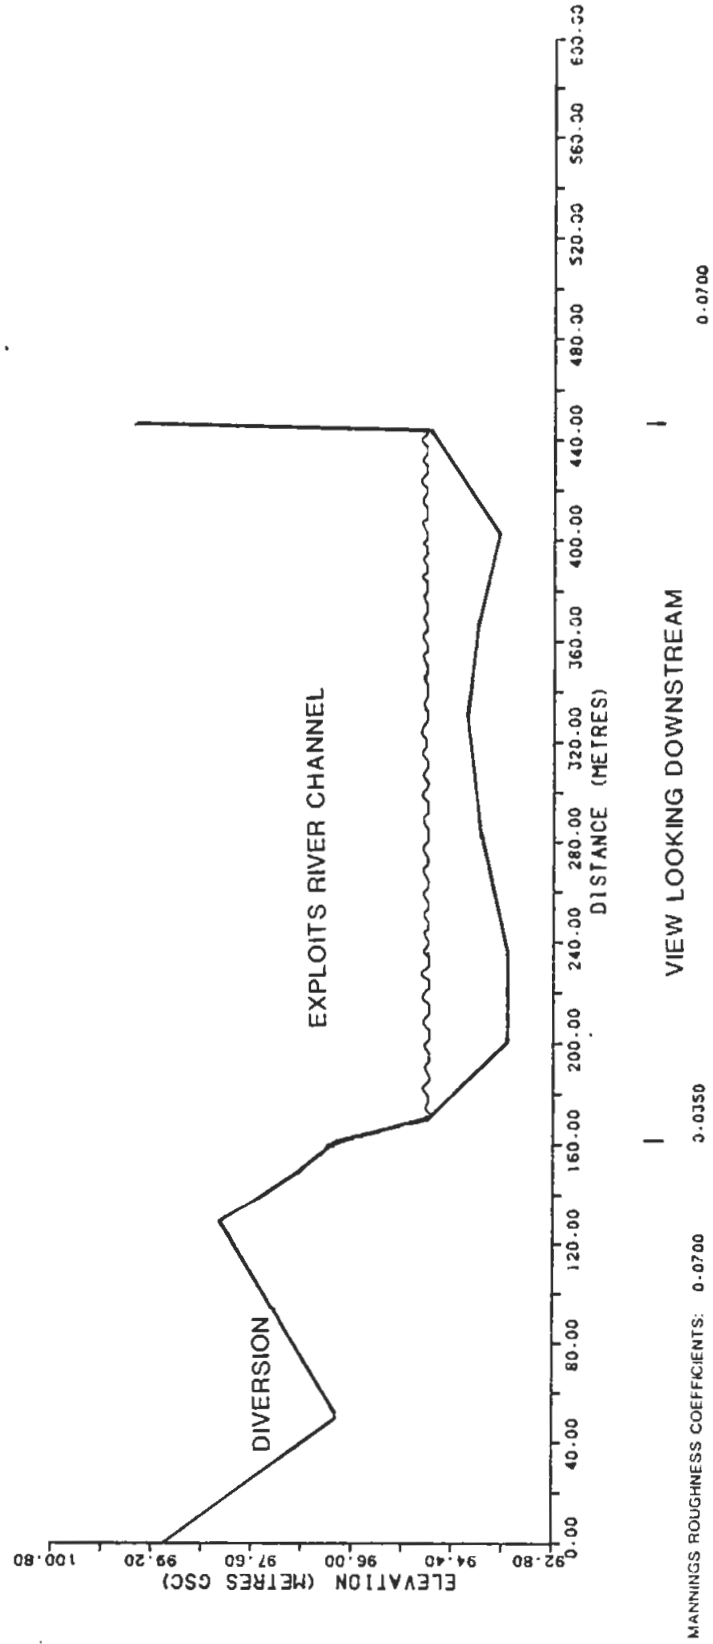
FIGURE 4.14

EXPLOITS RIVER
 CROSS SECTION NUMBER 27090
 HEC-2 MODEL

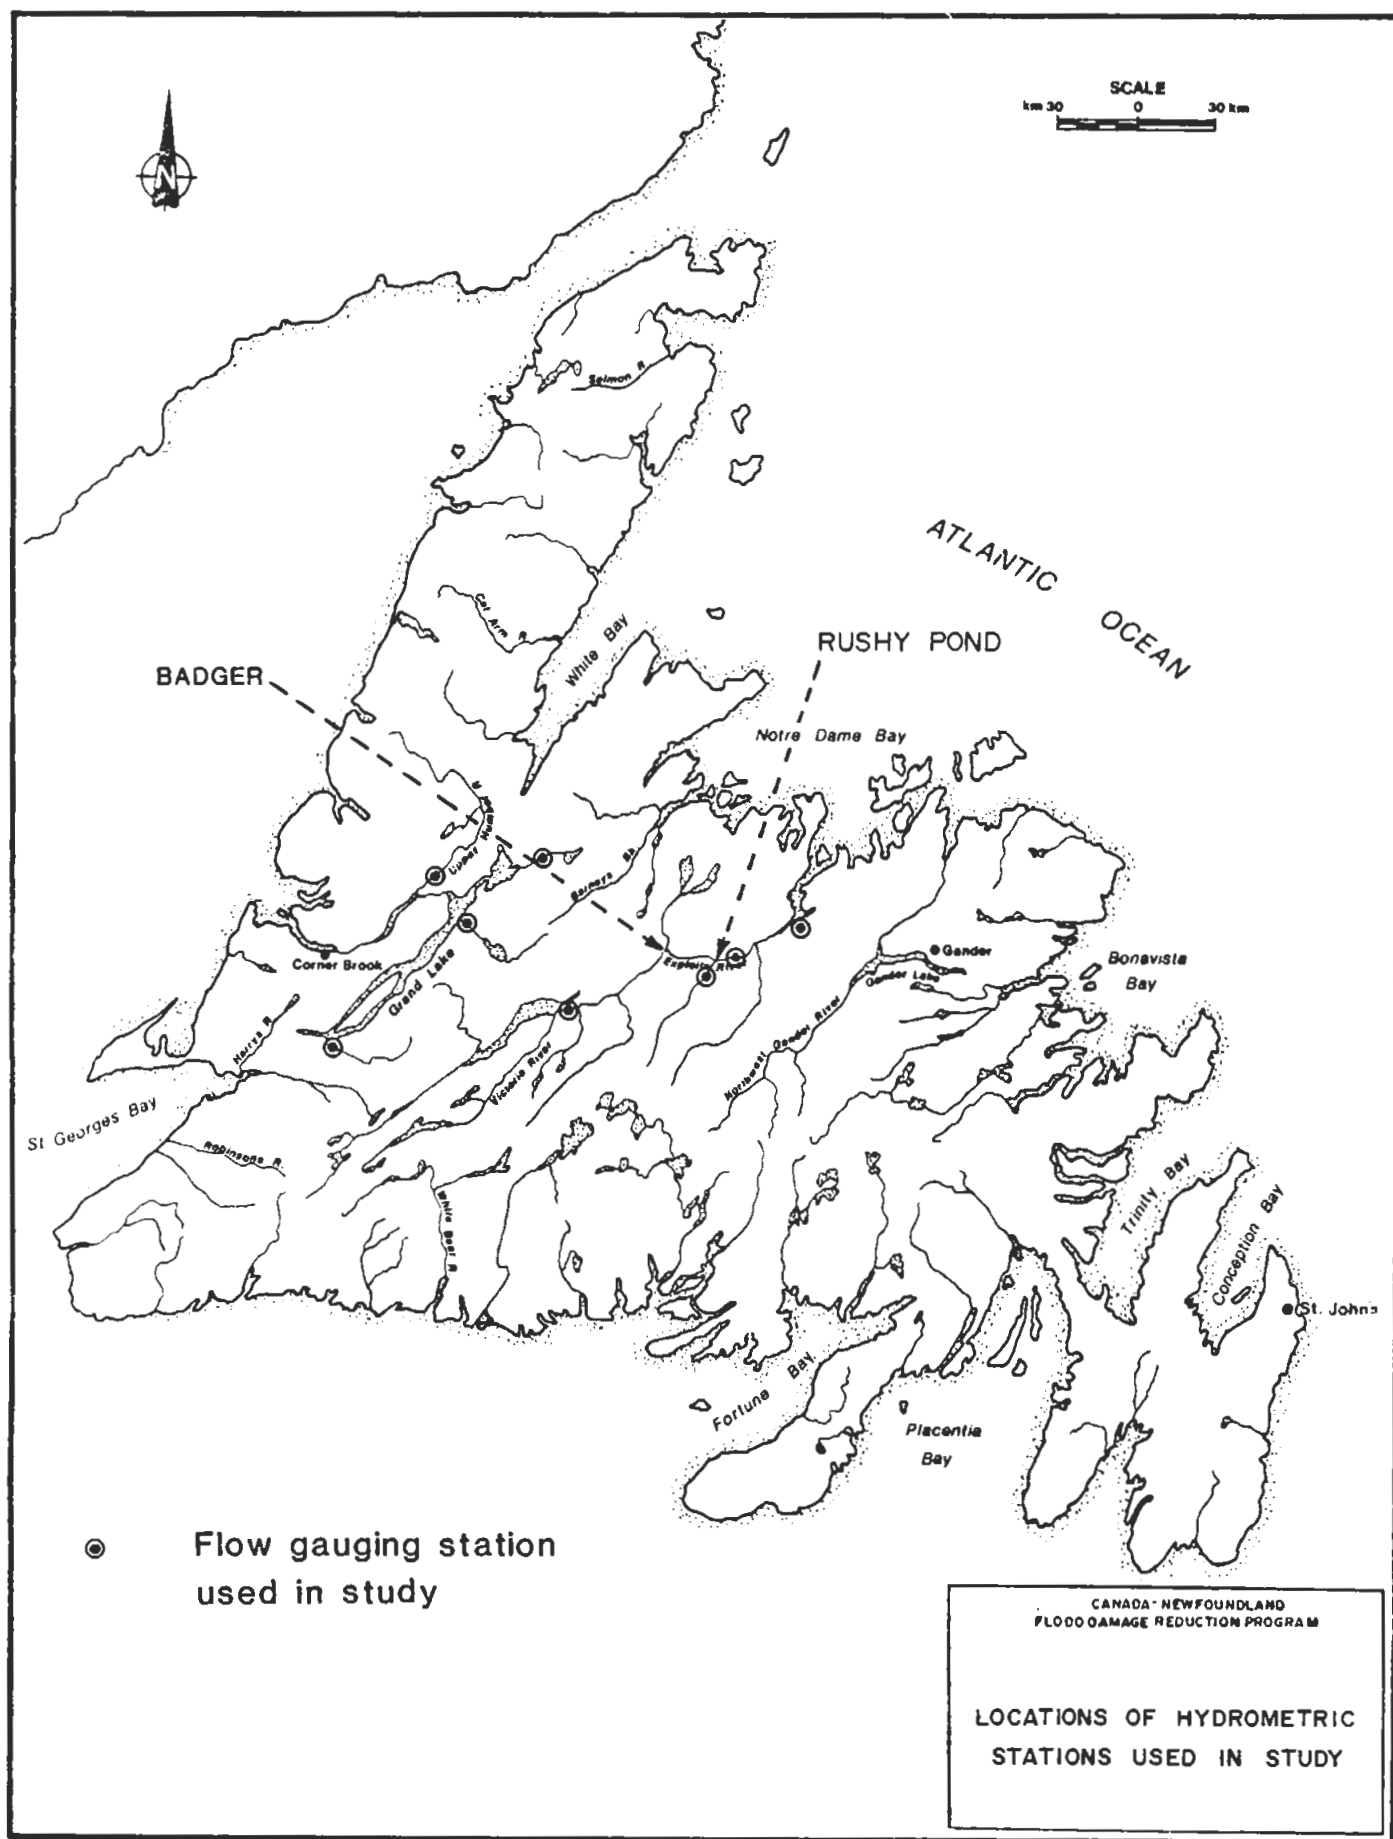
FIG. 5.1

As Figure 5.1 indicates, the Badger location is "bracketed" by the flow records at Exploits Dam and Grand Falls Dam. With a drainage area of 6653 km² just upstream of the confluence with Badger Brook, this location is approximately at the mid point of the two gauged locations. The method selected for estimation of design flows was therefore to utilize an area weighted average of the flows resulting from single station frequency analyses of the upstream and downstream records. Again, the period of record selected for analysis was from 1934 to 1983 inclusive.

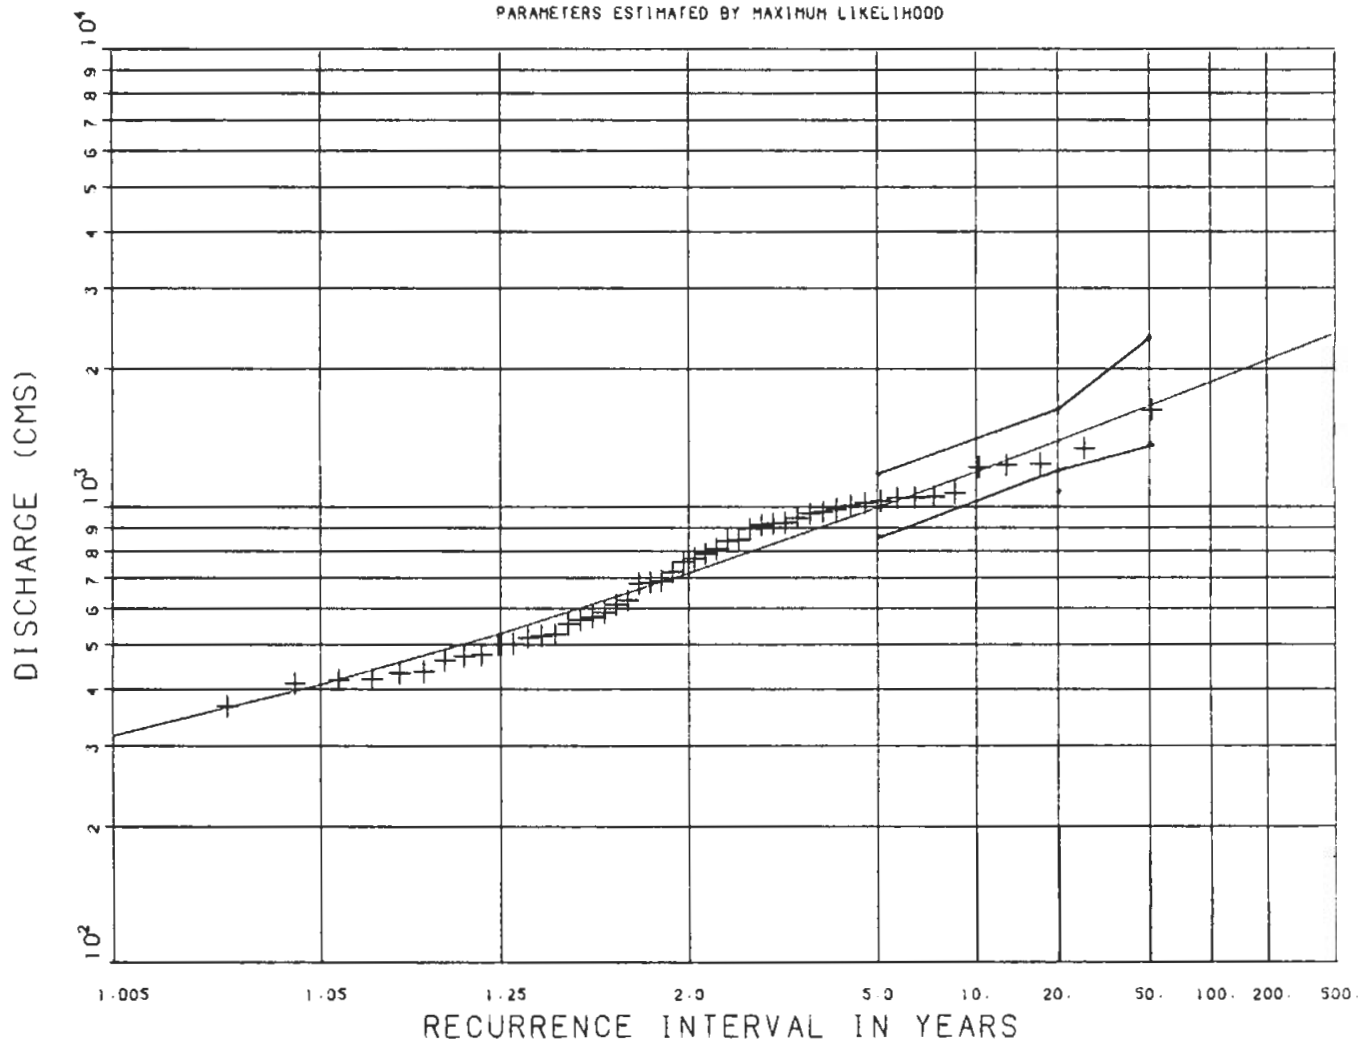
FIG. 5.2

GRAND FALLS DAM 1934 - 1983 PRE 70 ADJUSTED
THREE PARAMETER LOG-NORMAL DISTRIBUTION
PARAMETERS ESTIMATED BY MAXIMUM LIKELIHOOD

FREQUENCY ANALYSIS OF
MAXIMUM ANNUAL MEAN
DAILY FLOW SERIES,
GRAND FALLS, 1934 TO 1983

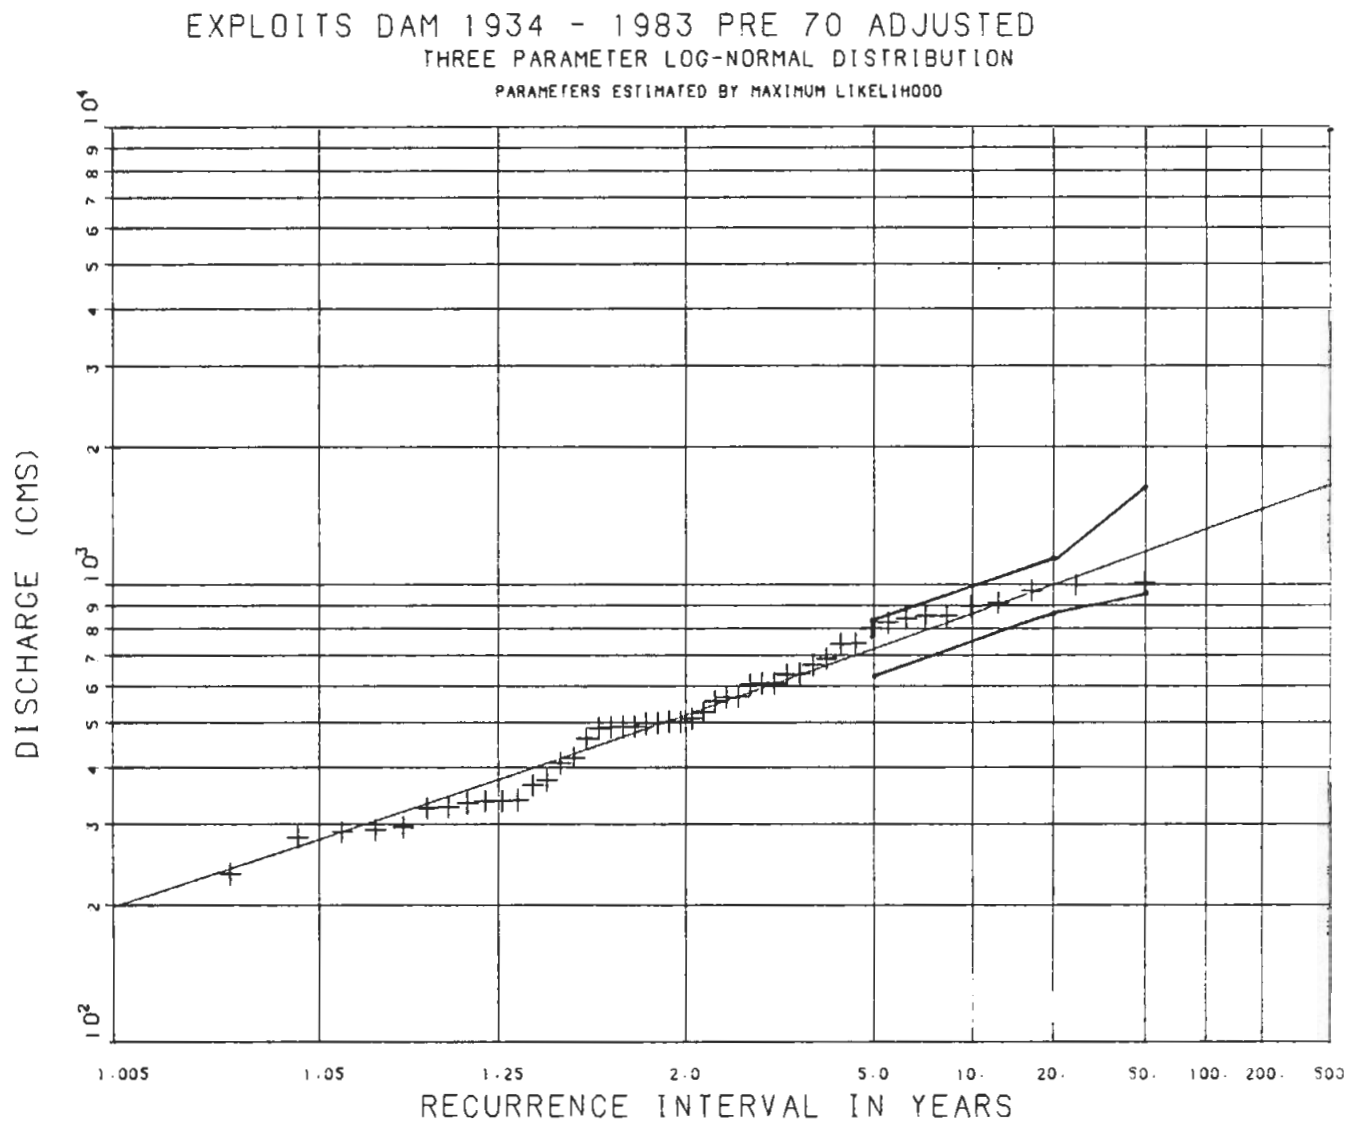
FREQUENCY ANALYSIS OF
ANNUAL INSTANTANEOUS
FLOW SERIES,
EXPLOITS DAM, 1934 TO 1983

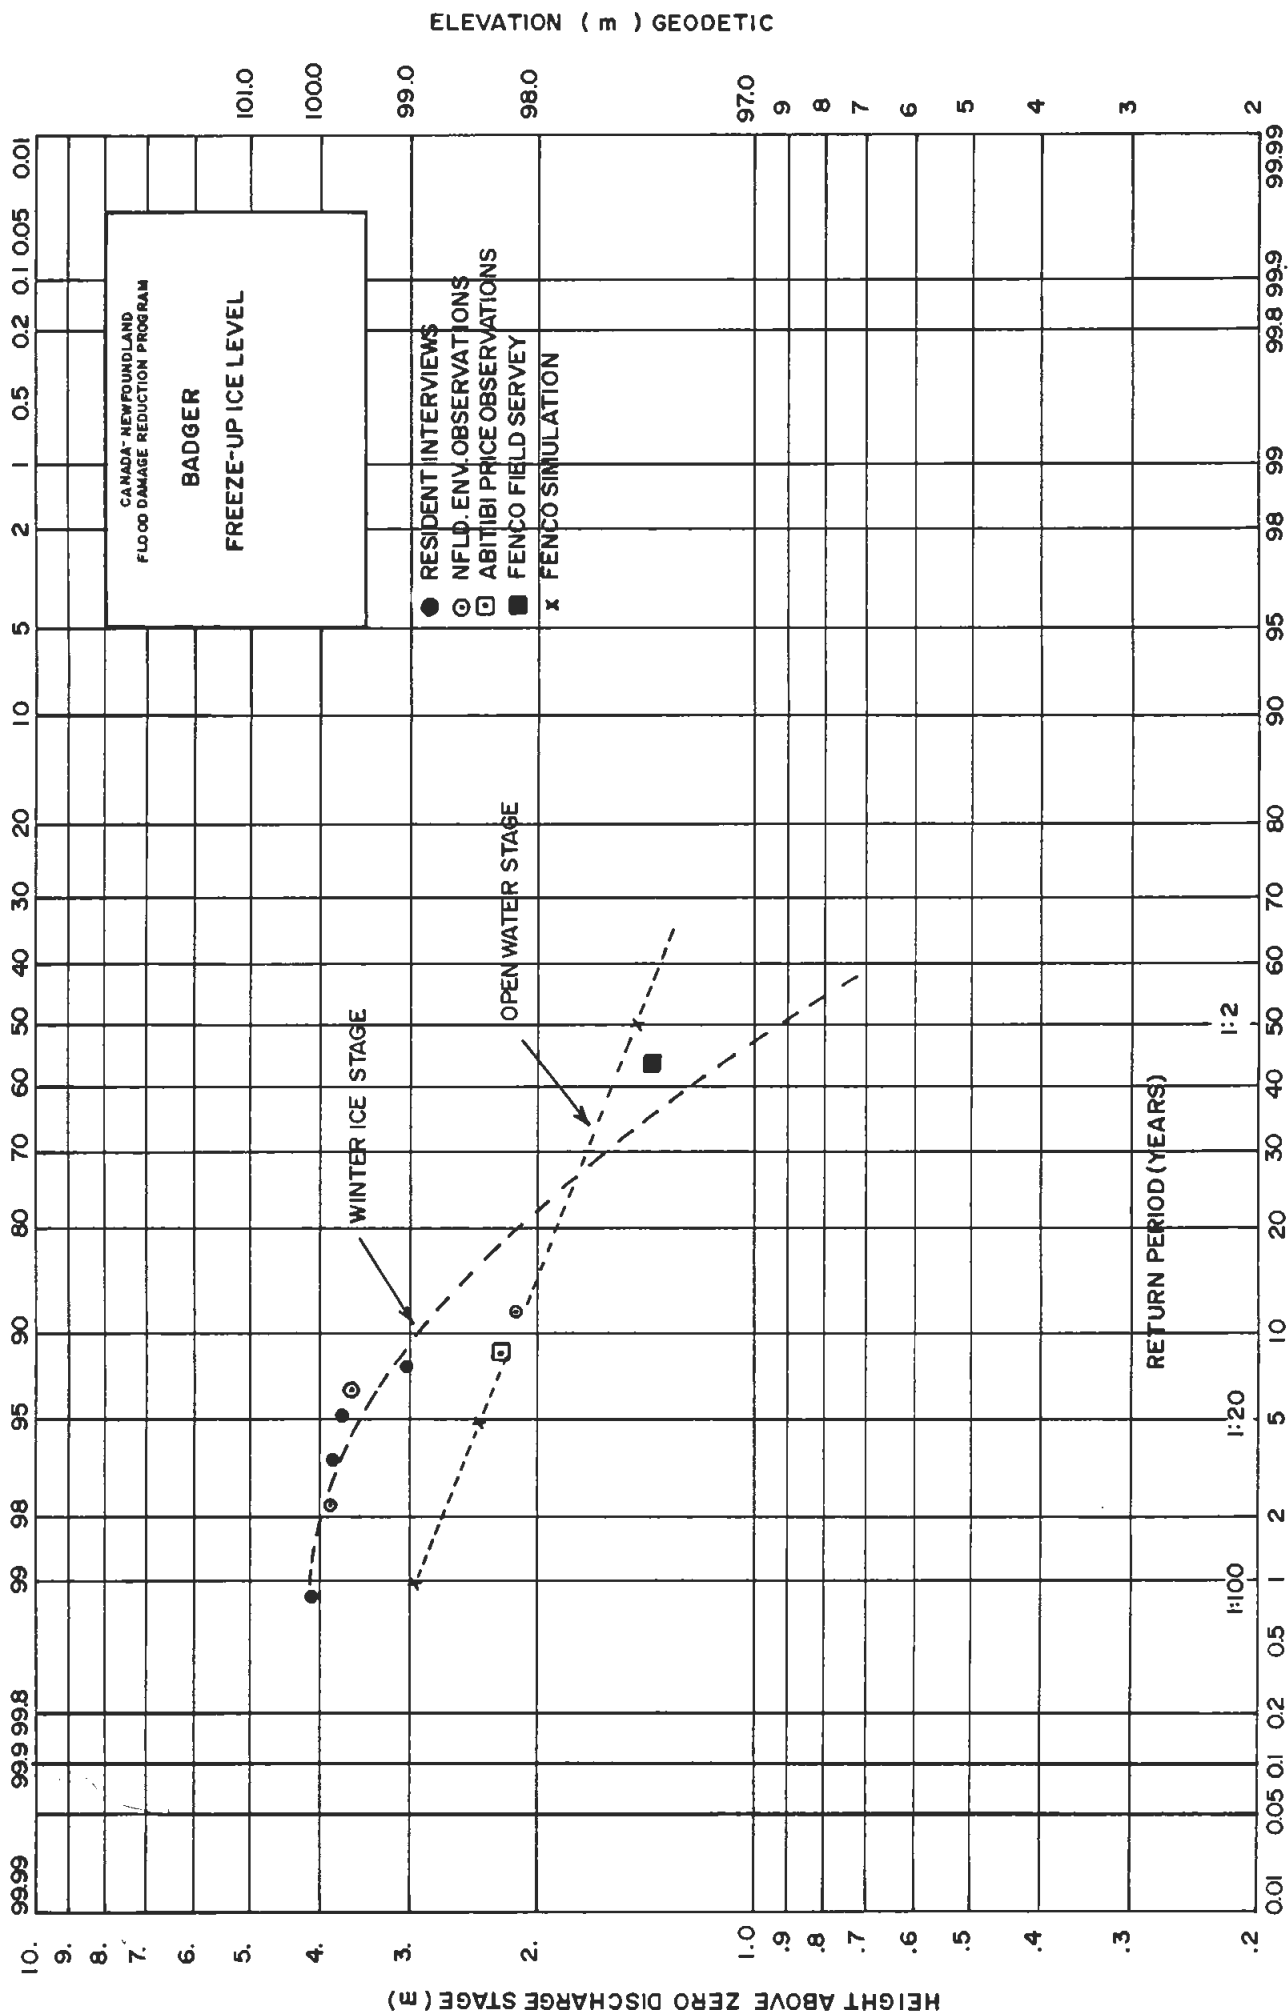
FIG. 7.3

PERCENT PROBABILITY OF STAGE BEING EQUALLED OR EXCEEDED IN ANY YEAR

The following table shows that the second method provides results which are comparable to the "perception" stage approach presented earlier (Figure 7.3, Section 7.4.1).

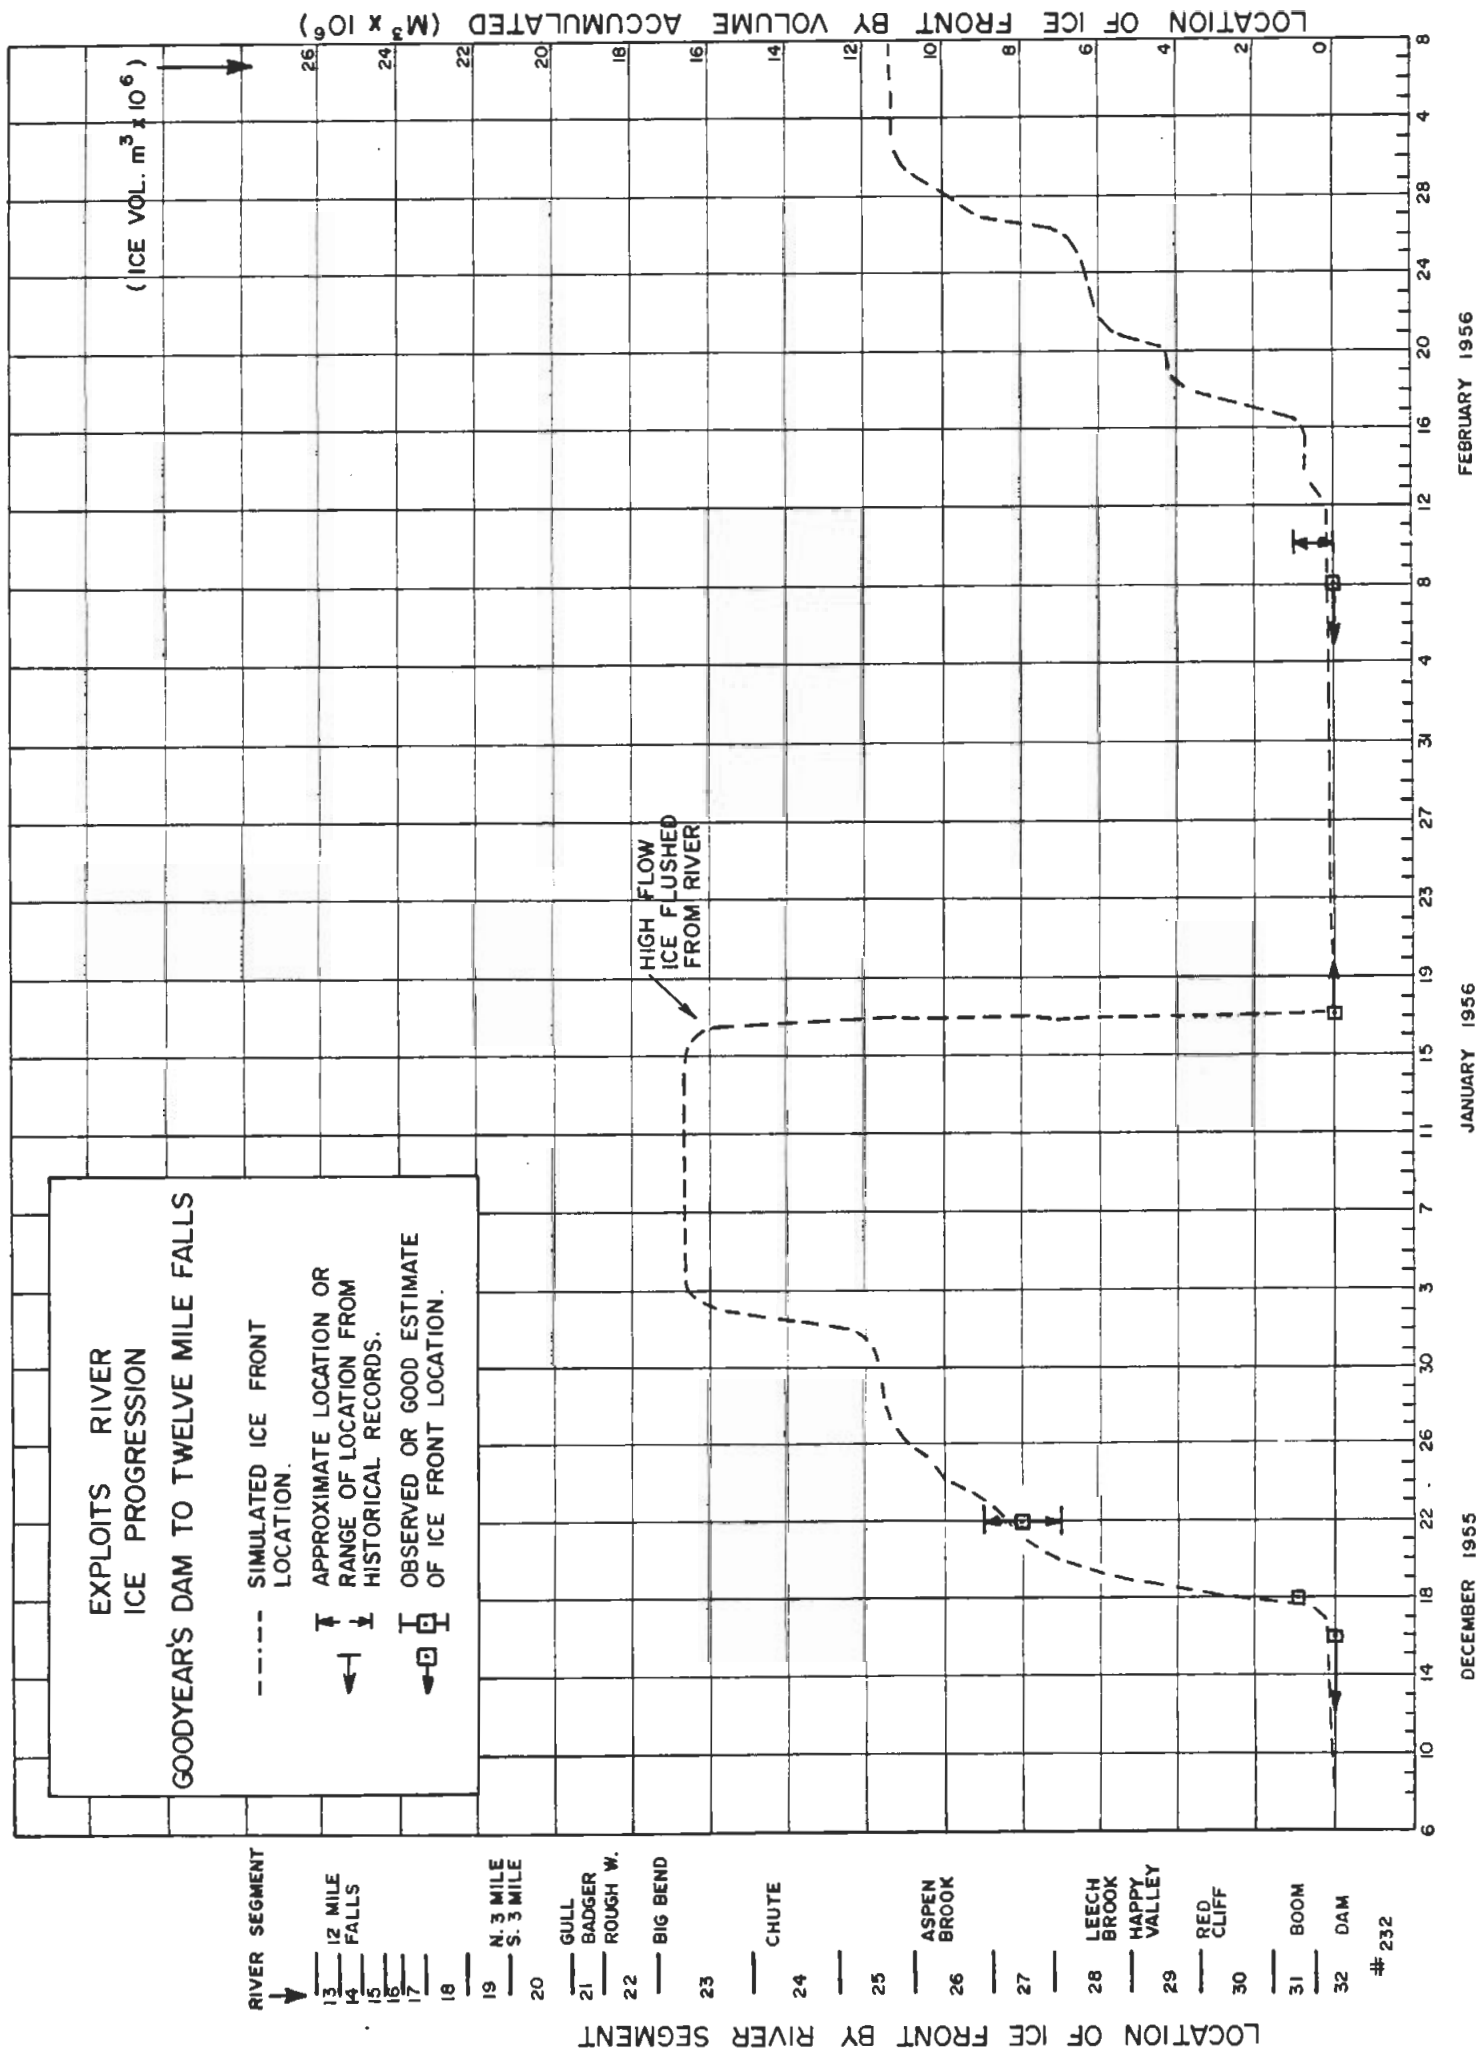
FIG. 7.7

Model calibration data is available through the winter of 1955-56 when attempts were first made to accumulate ice at a boom near Goodyear's Dam. Six ice observations were available from that year and Figure 7.7 shows the calibrated case.

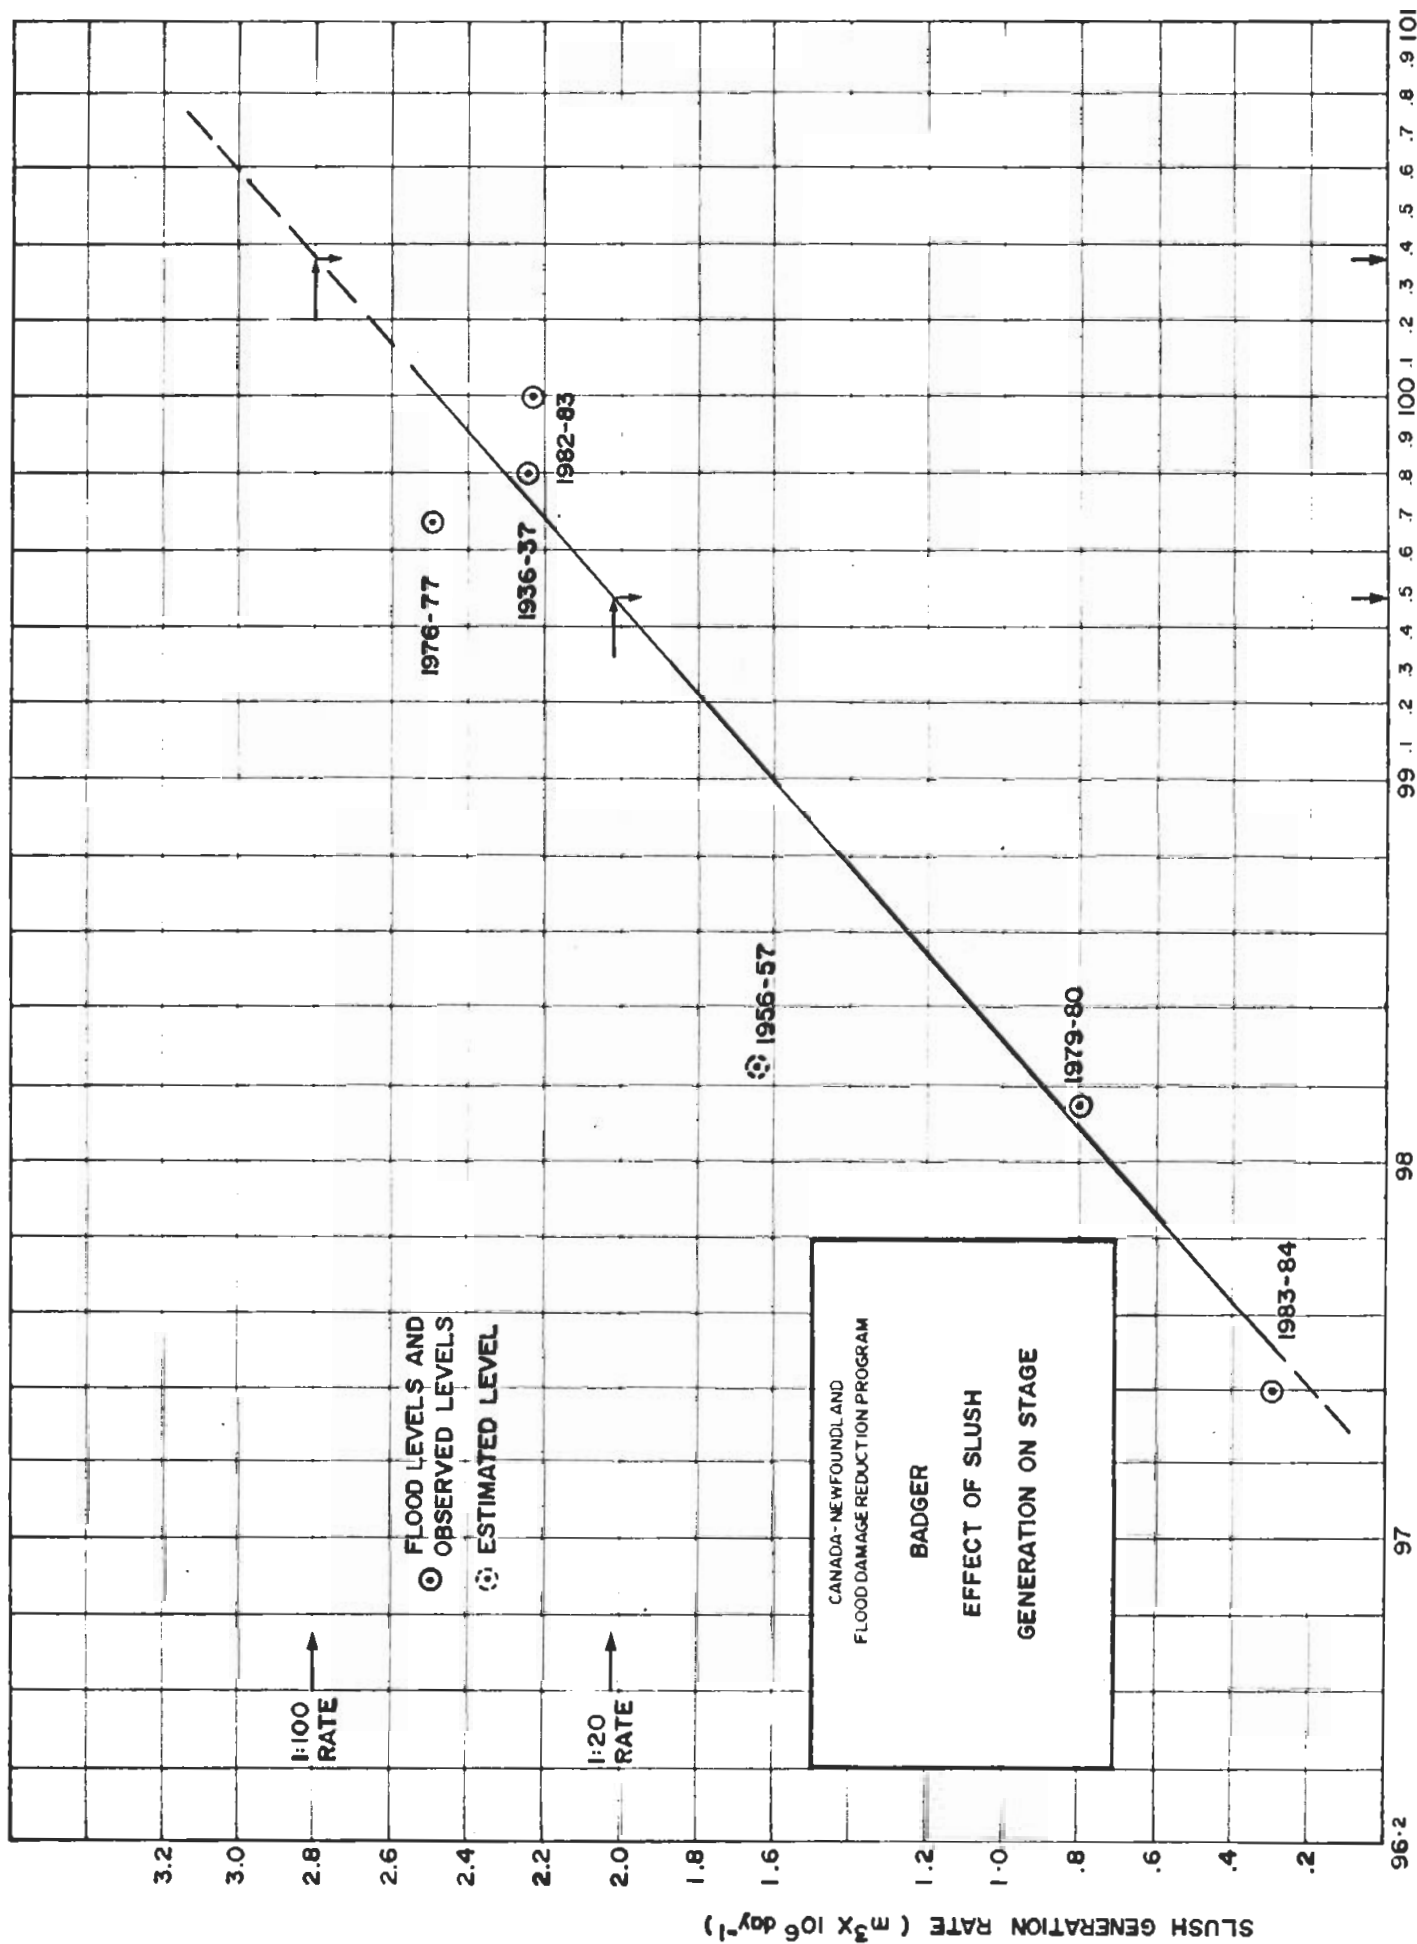
FIG-7.10 FREEZE-UP ELEVATION (m) AT BADGER STADIUM (SECTION : 28675)
