Canada - Newfoundland
**Flood
Damage
Reduction
Program**

Hydrotechnical Study of the Badger and Rushy Pond Areas

MAIN REPORT

BADGER AND RUSHY POND HYDROTECHNICAL STUDY

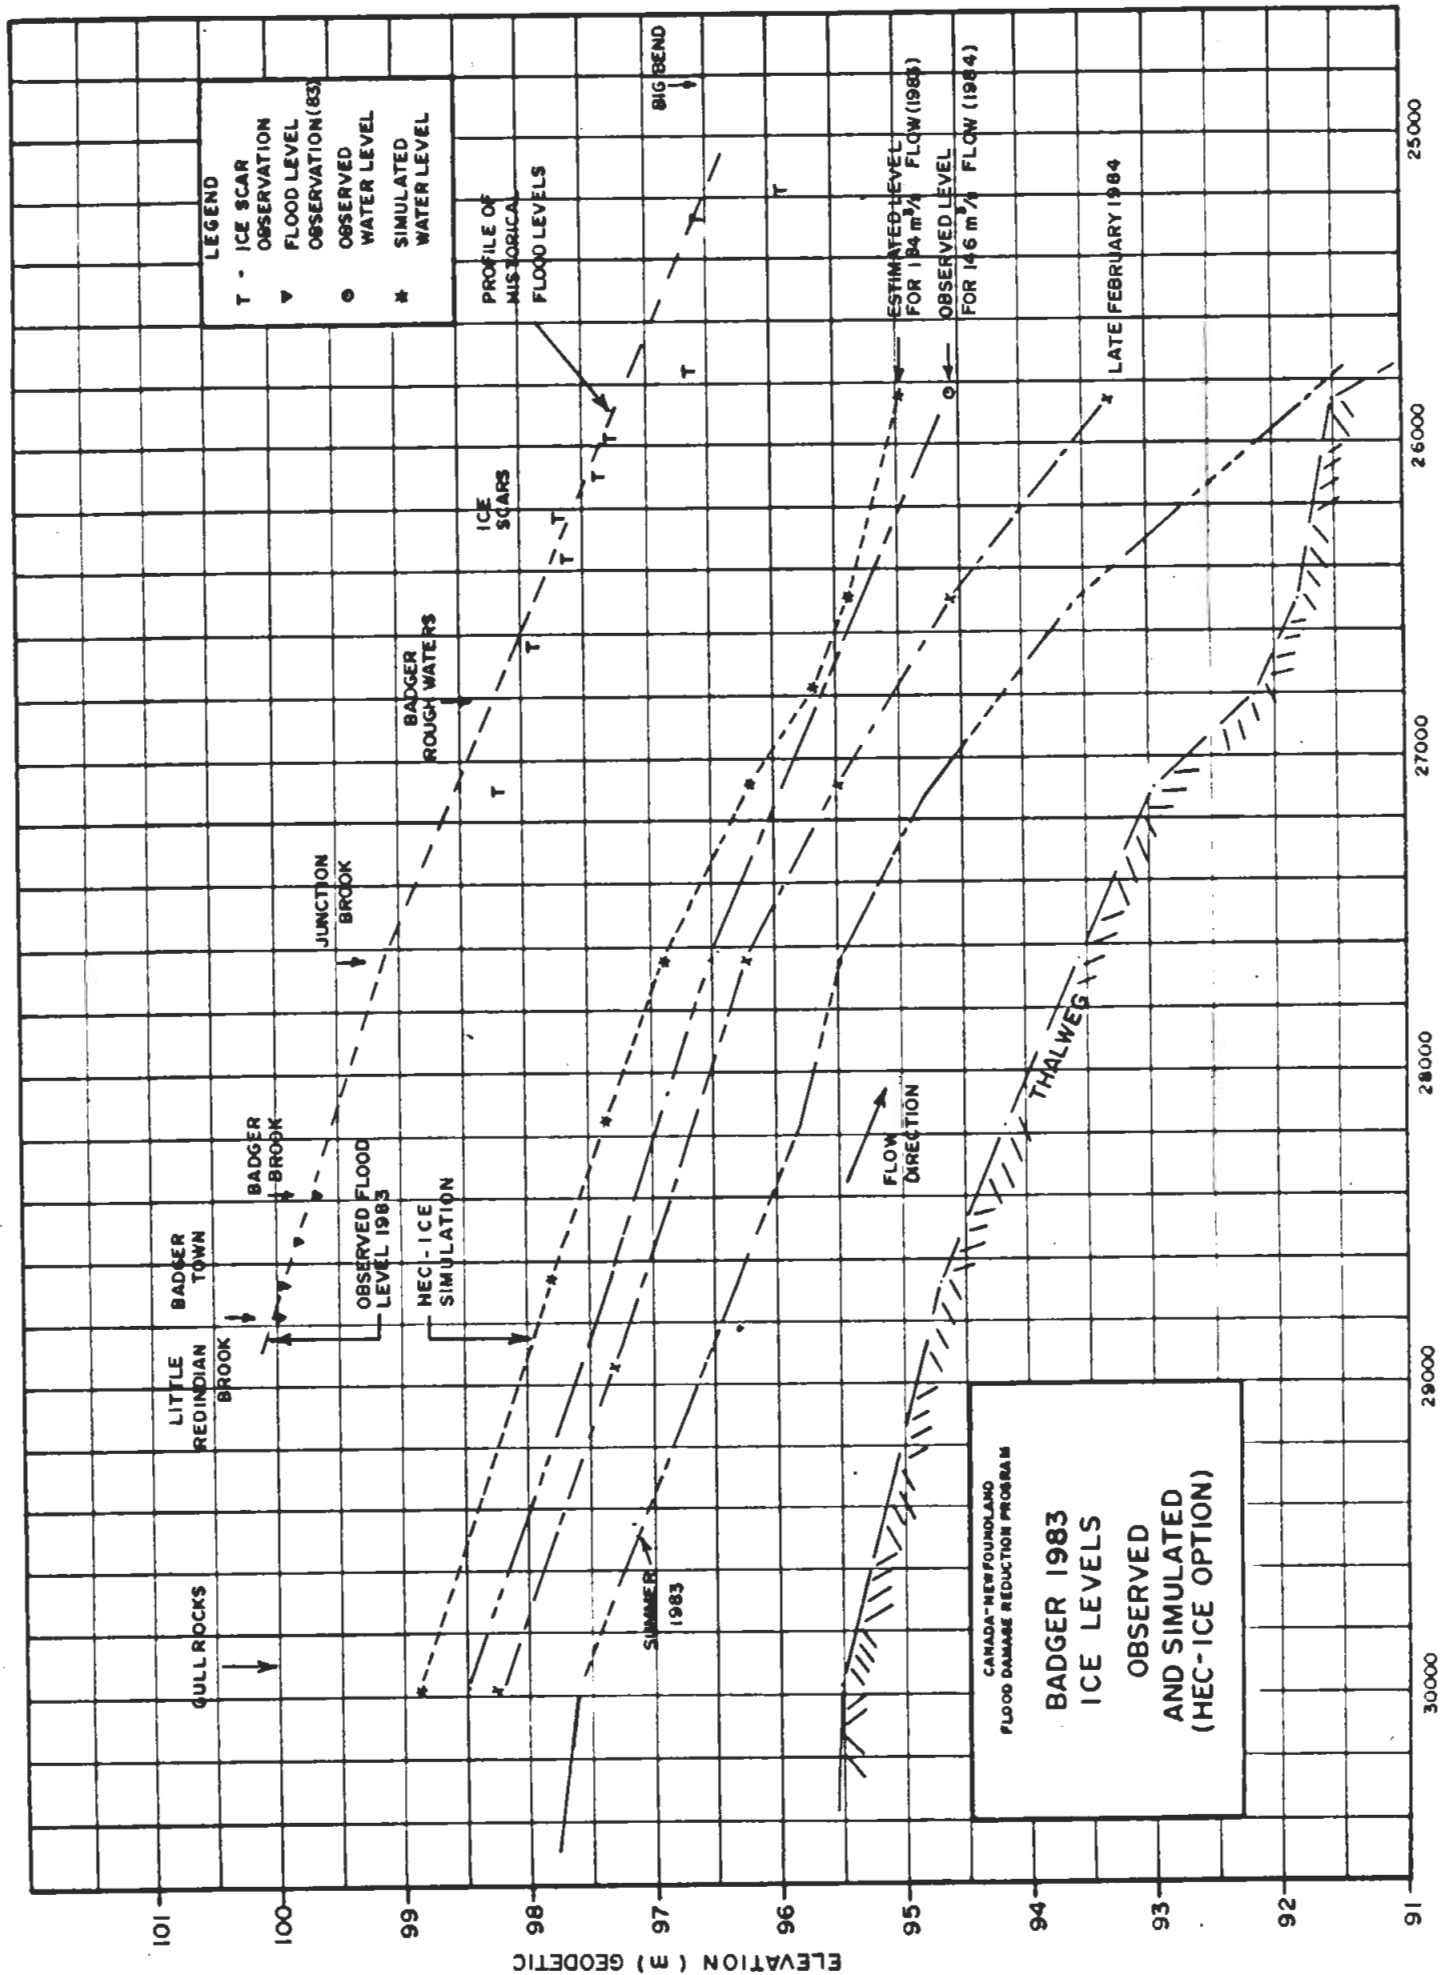
FIG. 7.13

Figure 7.13 presents the same information as Figure 7.12 and ice levels simulated with the HEC-2 model for the flood of February 1983. In this flood period, the discharge on the Exploits River was larger than in January 1984, and the flood stage at Badger reached approximately 99.91 m. In the February 1983 simulation using HEC-2, it was necessary to increase the ice thickness just below Badger to provide a stable condition (Table 7.3). A significant increase in thickness was not required to achieve ice cover stability, and as a result the simulated flood levels reach only 97.8 m - or about 2.1 m below the observed flood stage for that discharge.

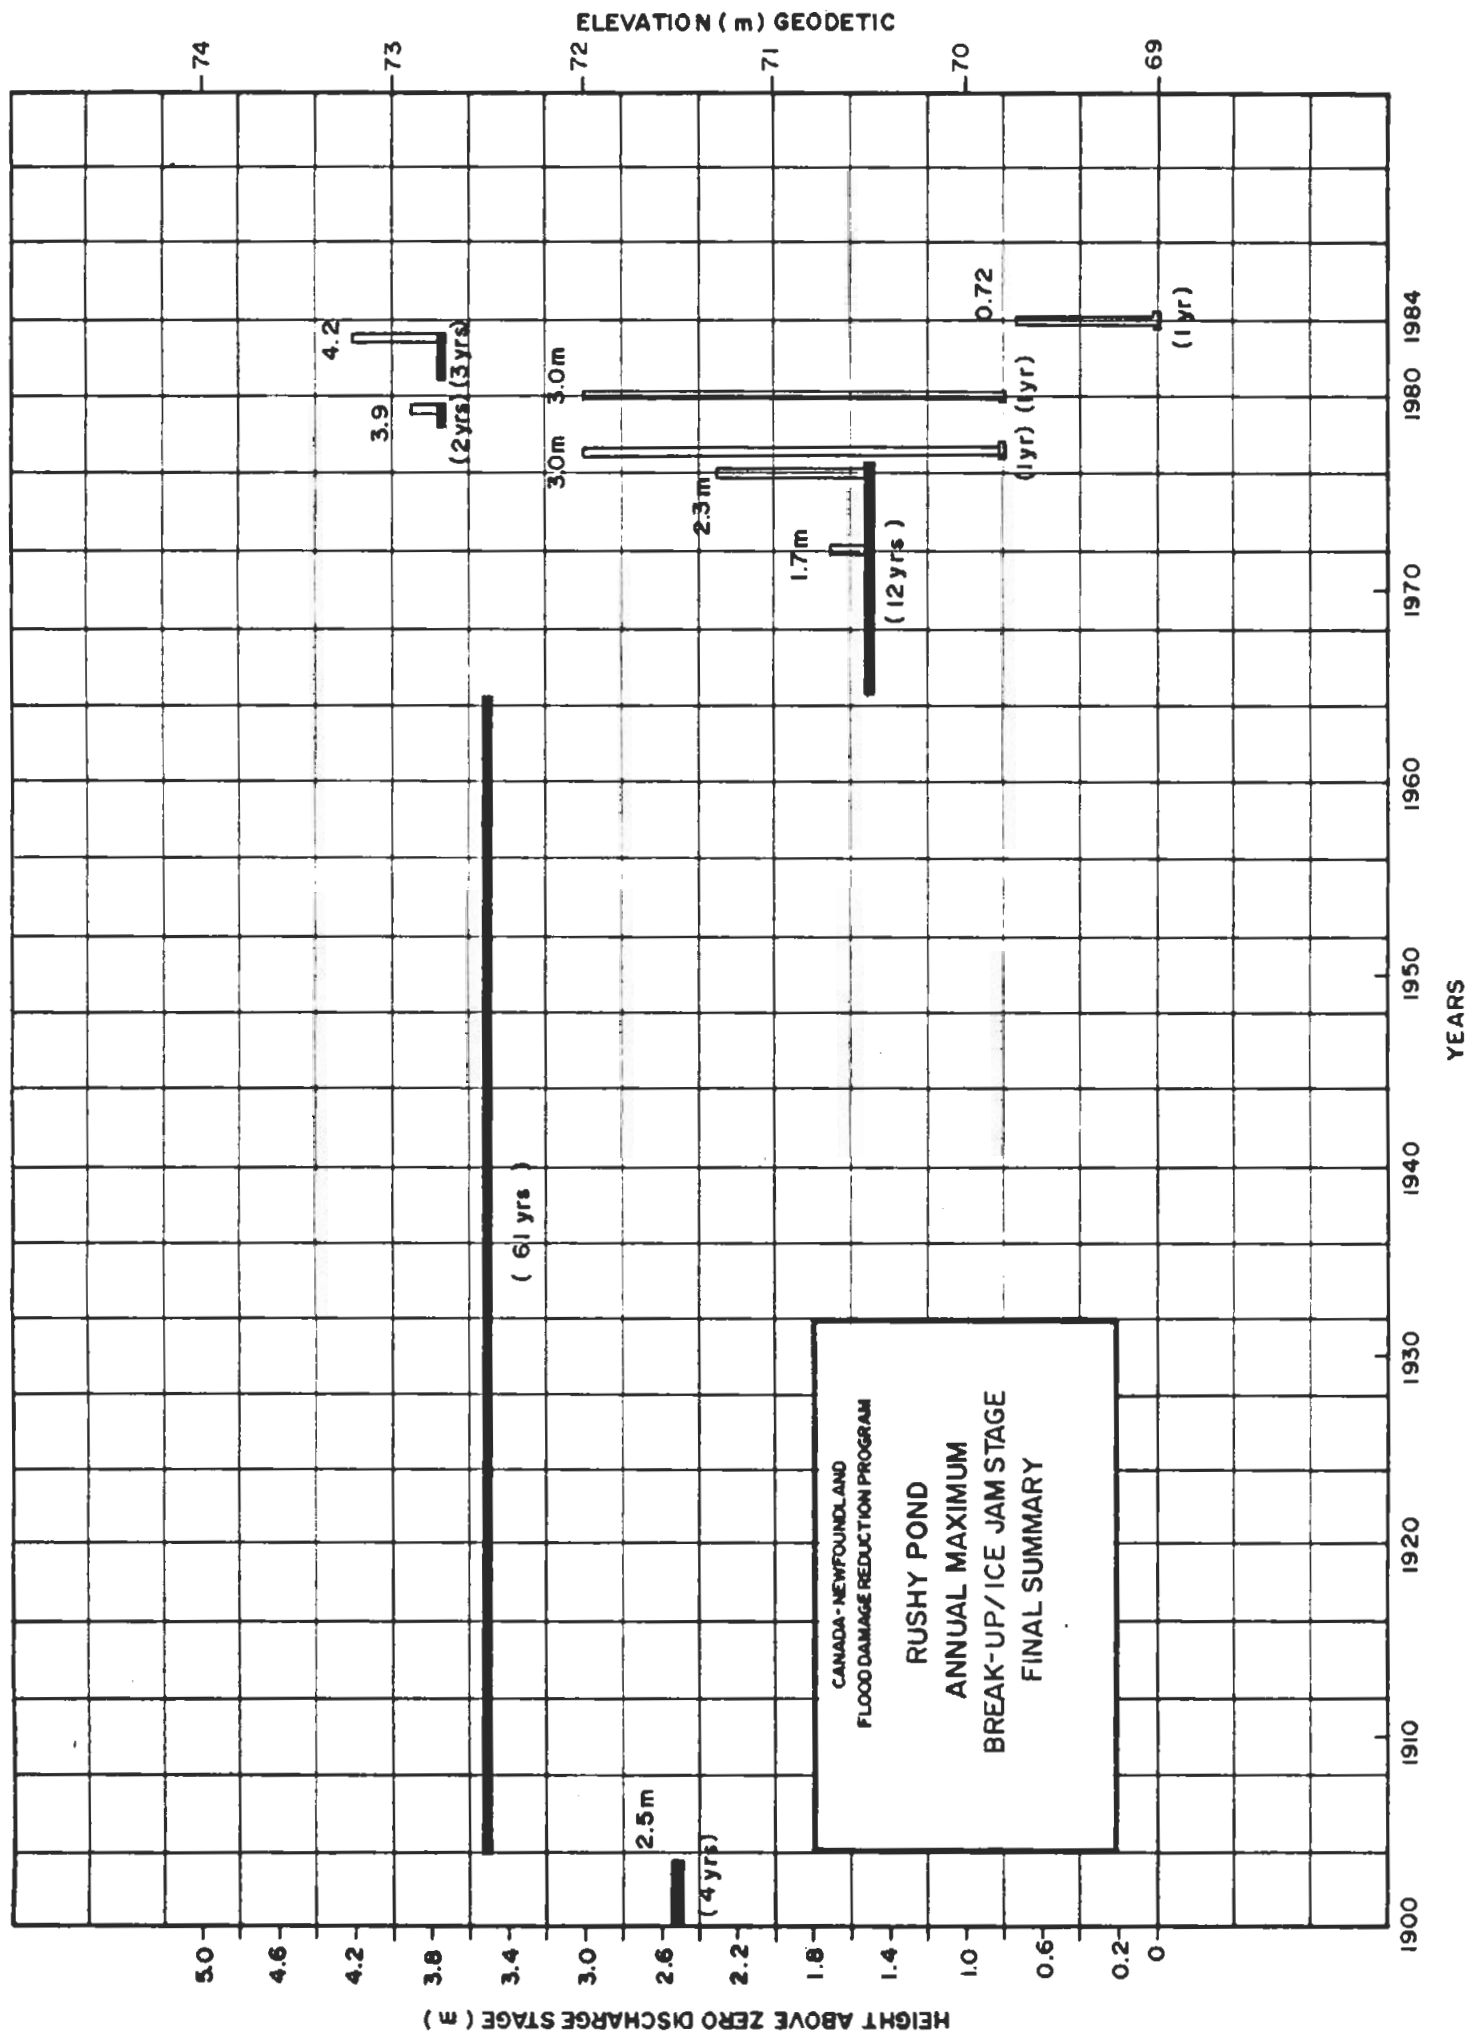
FIG 7.15

The rank and record length associated with each peak is determined from Figure 7.15 and summarized in the following table:

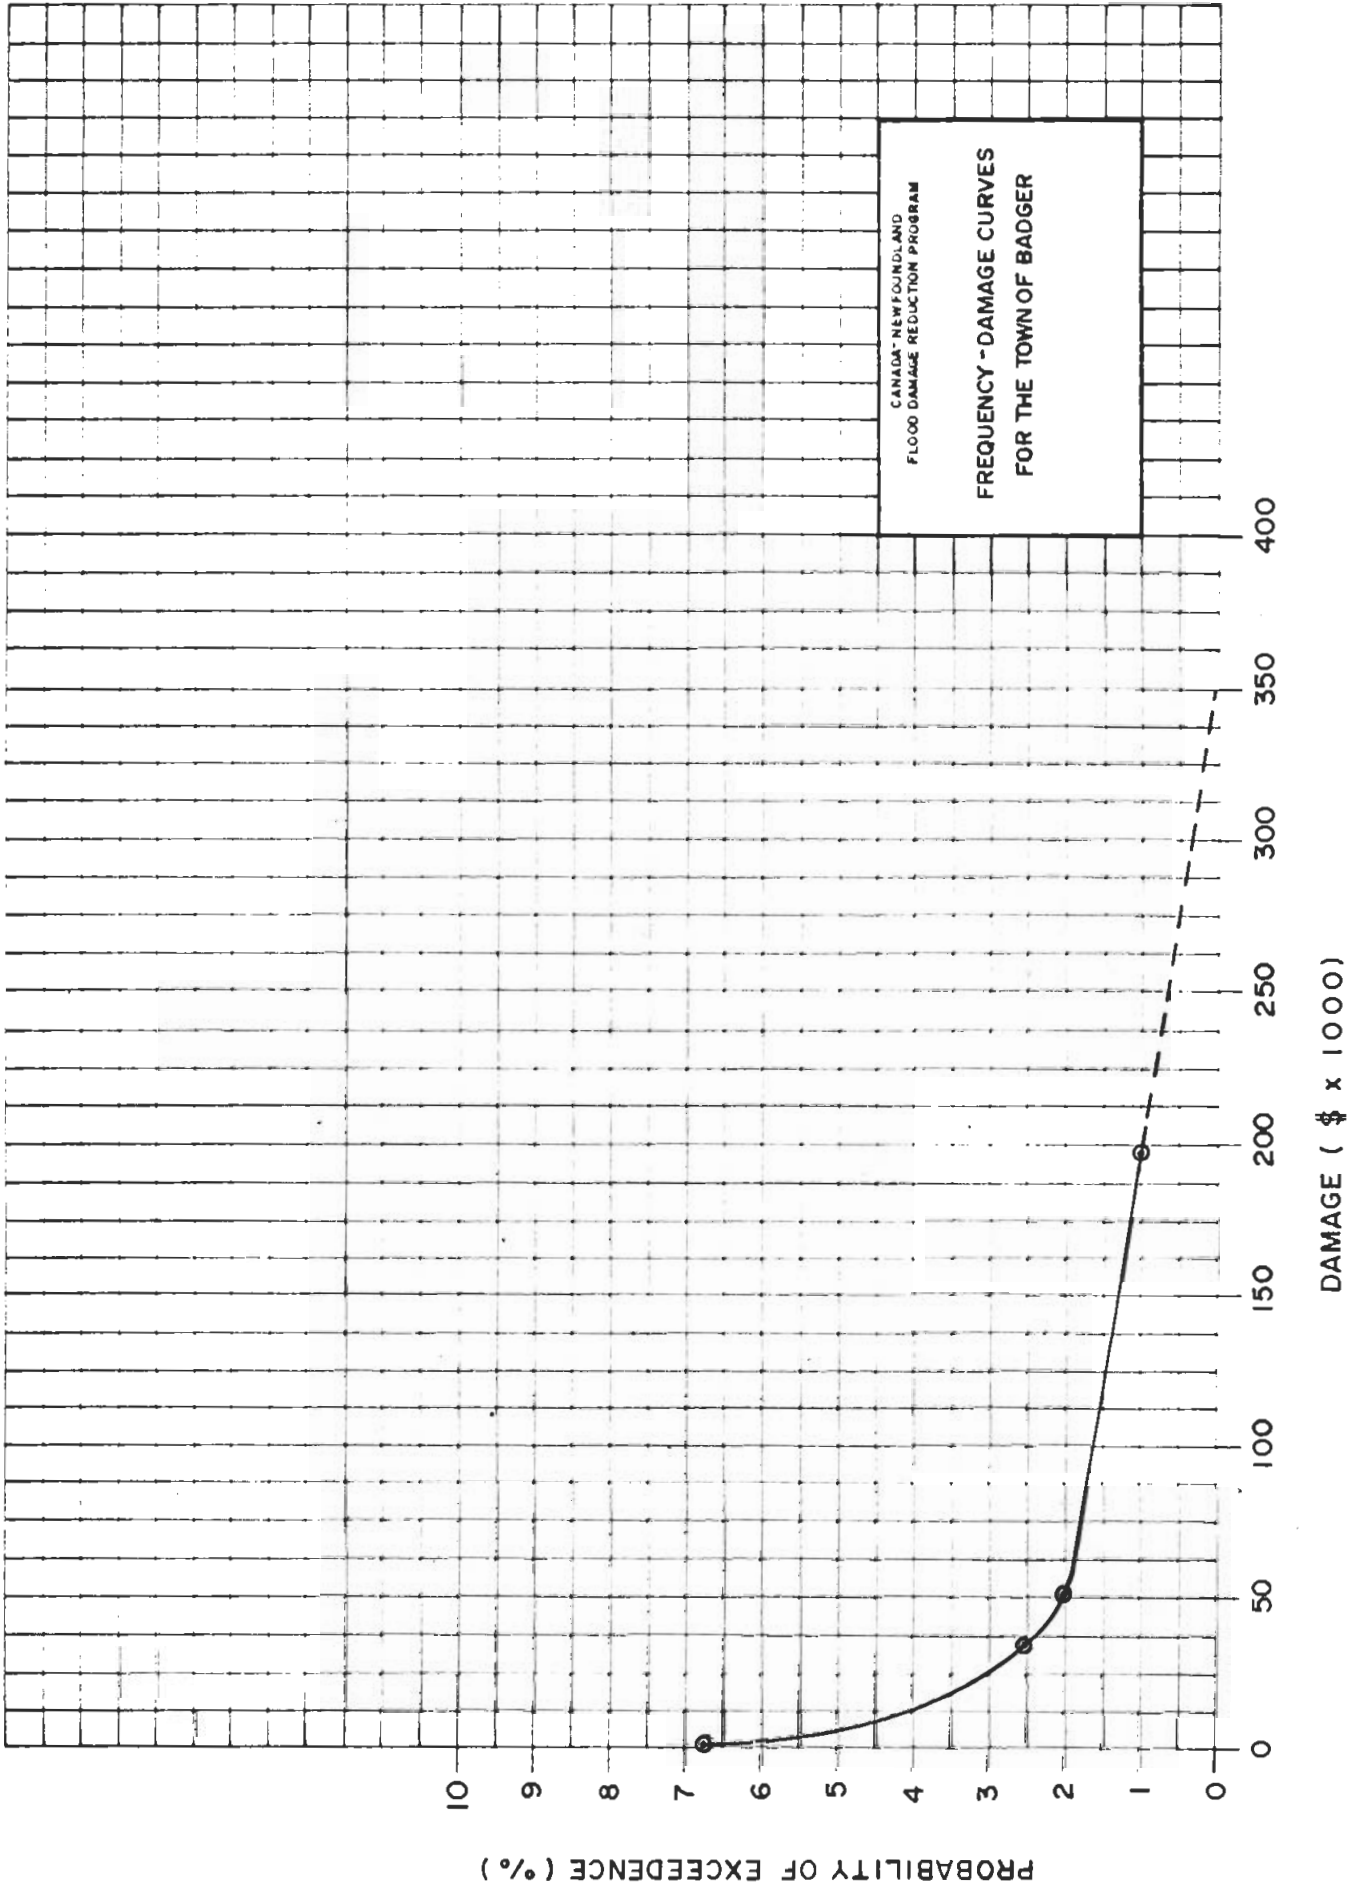
FIG. 8.2

A damage-frequency curve was plotted to compute the expected average annual value for the Badger flood prone area. This curve was developed by combining the information from the water level-frequency curves of Figure 7.11 with the damage-water level curves of Figure 8.1. From these two curves one may select a water level and then find both the average return period of that level and the expected resulting damage value. This was done over a range of water levels to obtain several pairs of points relating an expected damage value to a return period. The inverse of each return period was determined to allow each damage value to be associated with a probability of exceedence. The damage-frequency curve for the Town of Badger is shown in Figure 8.2.

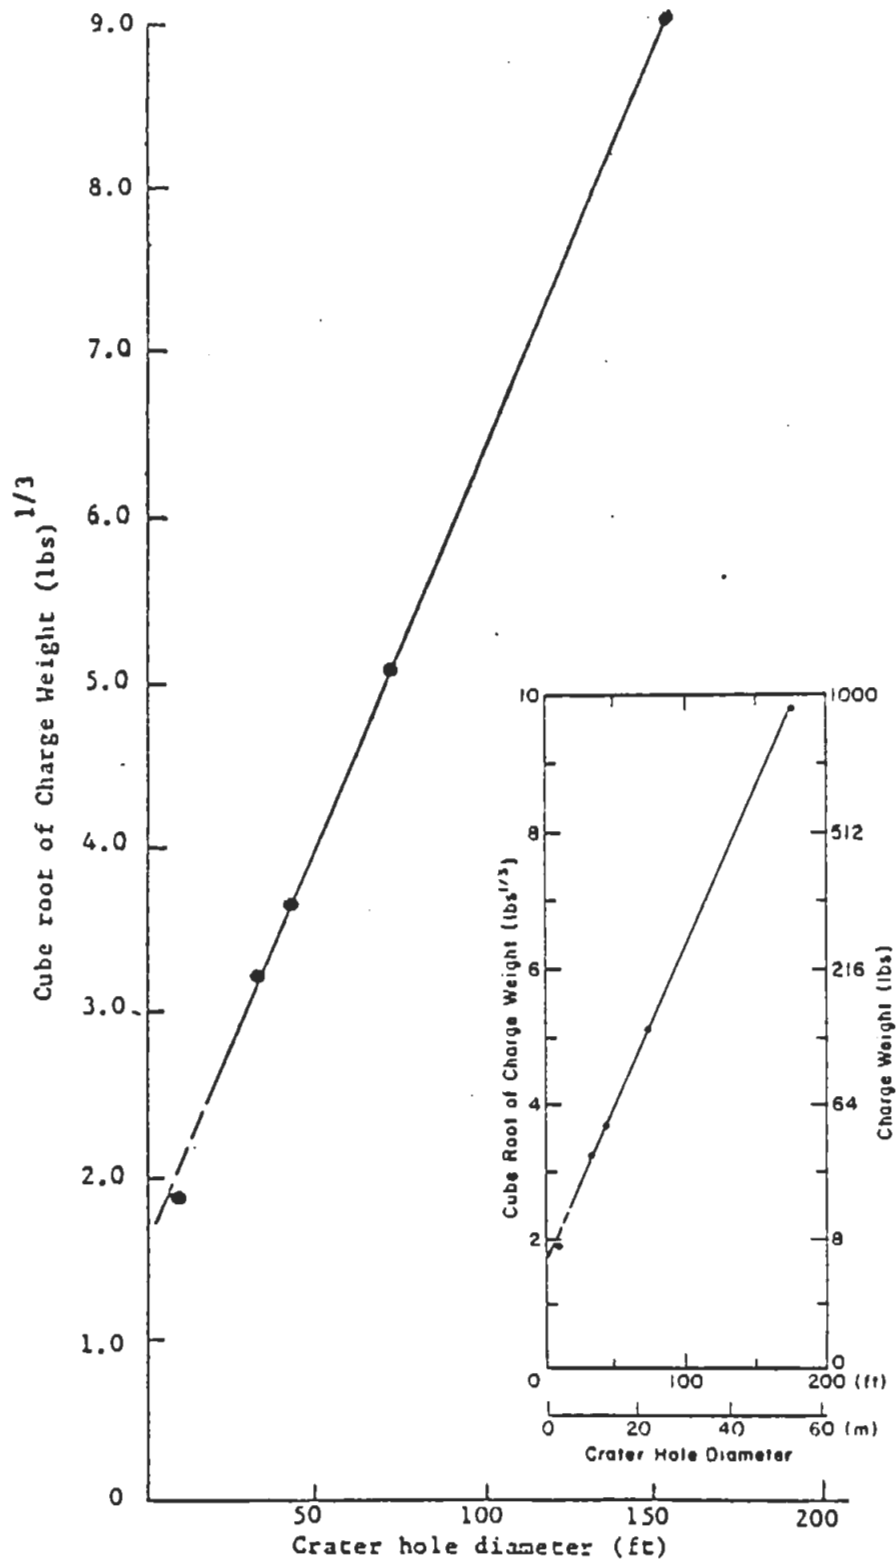
FIGURE 9.4

CANADA - NEWFOUNDLAND
FLOOD DAMAGE REDUCTION PROGRAM
"CHARGE WEIGHT VERSUS
CRATER HOLE DIAMETER"

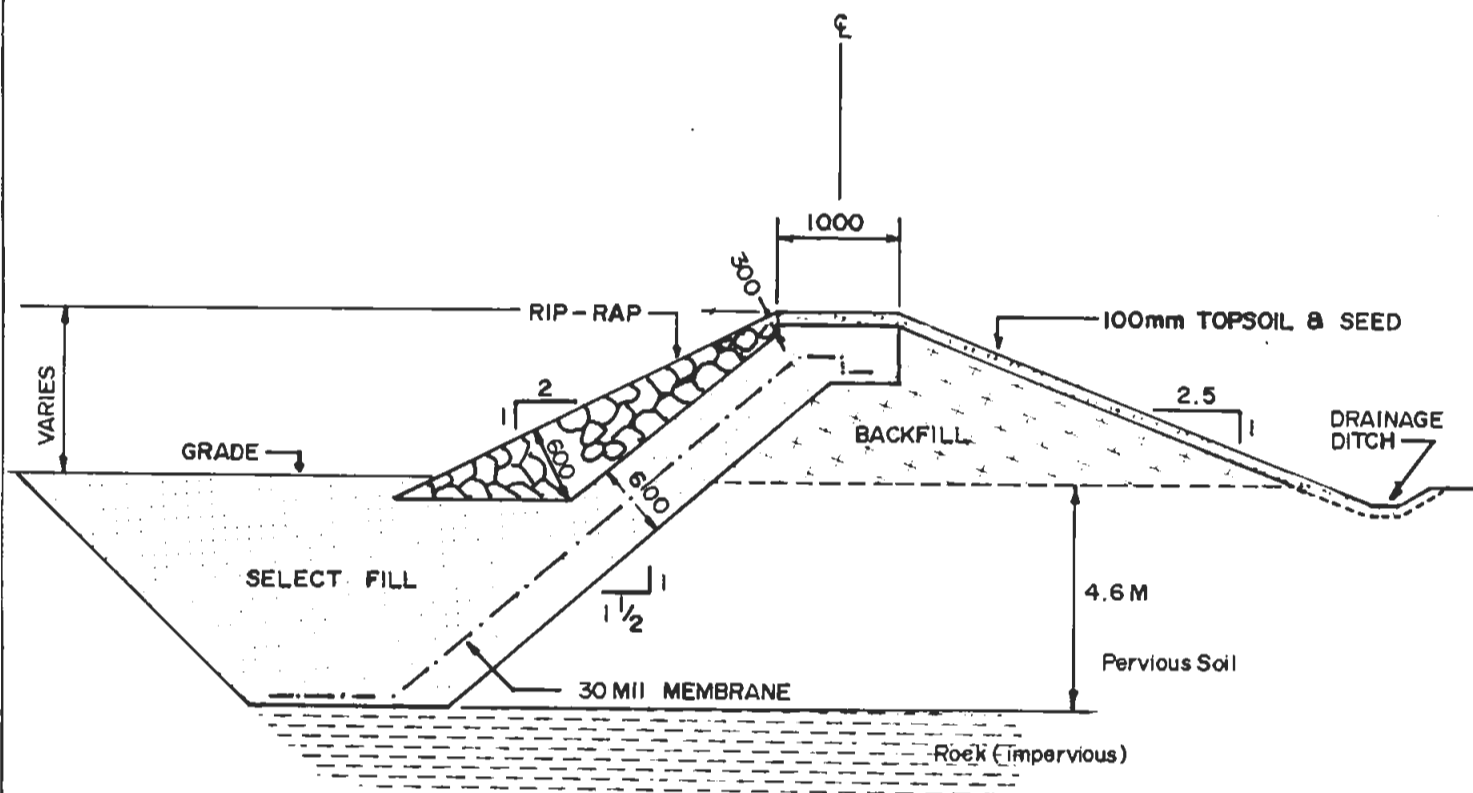
TYPICAL DYKE DETAIL

Both of the "passive" systems outlined above will require: significant excavation, dewatering provisions, placement of an impervious barrier, rip rap facing along the Exploits River portions of the dyke, and provisions for collection and disposal of incidental seepage and storm/melt water runoff which may gather inside the dykes during a flood. The latter will pass through a set of gated culverts (flap gates) except during flood conditions on the Exploits River. In flood events, the gates will remain closed and temporary pumping

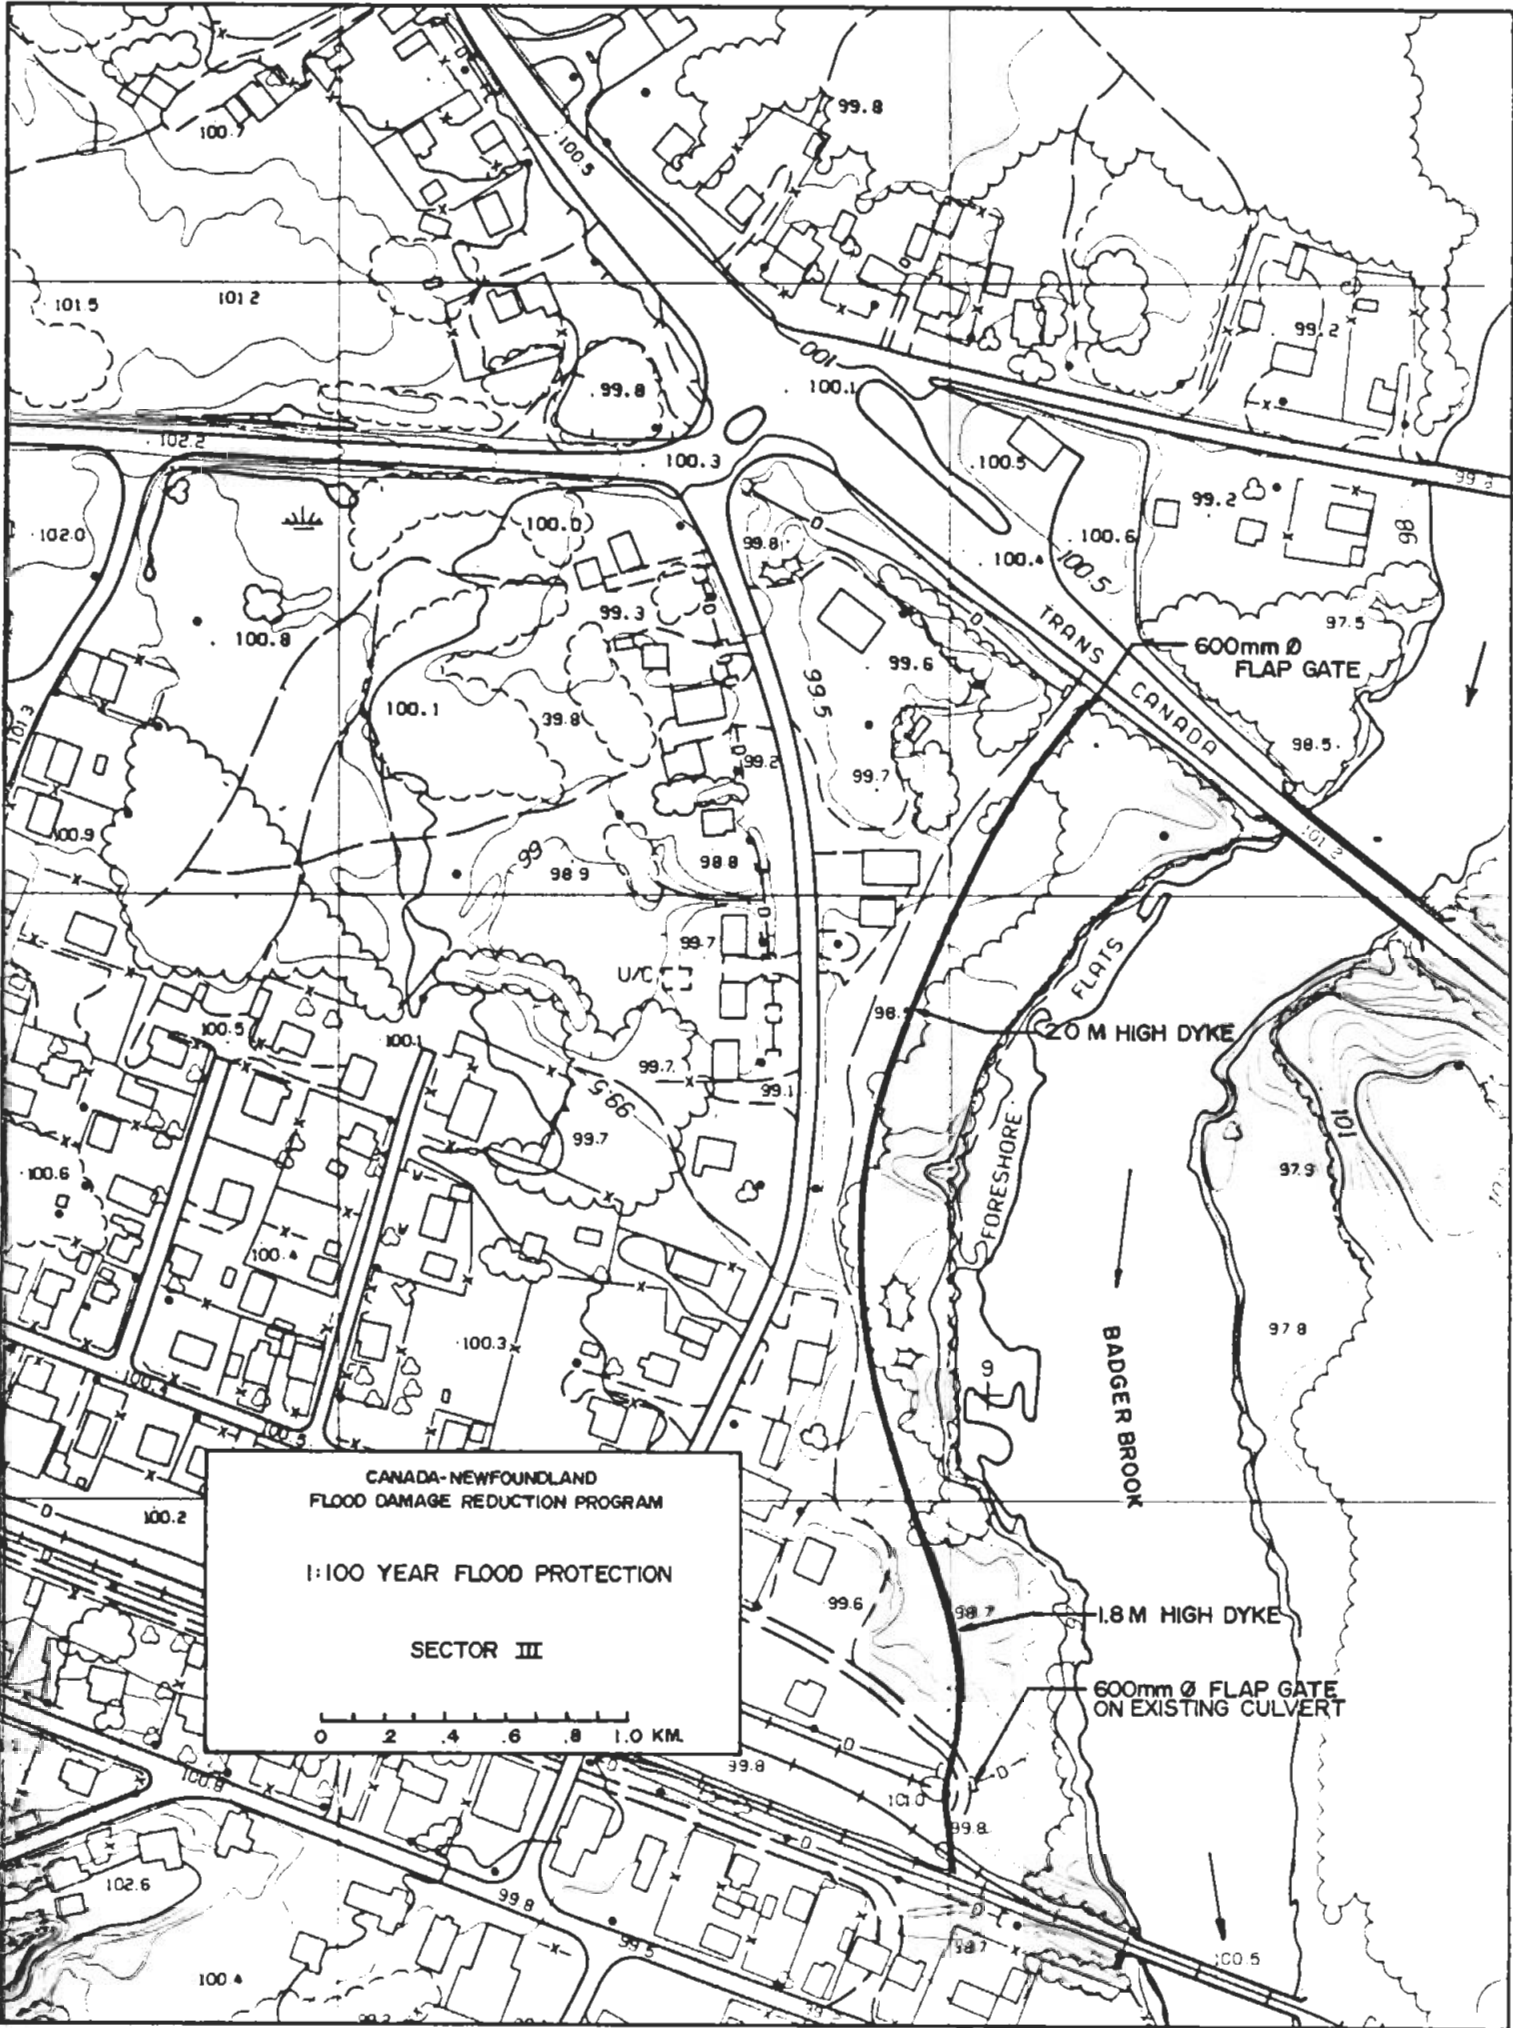
The proposed 1:100 year dyke for the Main Street area extends from the CNR bridge to the new Trans-Canada Highway Bridge as shown in Figure 10.5. The dyke is about 400 m long and the height varies from 1.8 m to 2.0 m. The top of dyke elevation in this area is a minimum of 100.45 m. Two flap gates are
