**Flood Risk Mapping Study
of
Portugal Cove, St. Philips, and Outer Cove**

**FINAL REPORT
Volume I**

March 1996

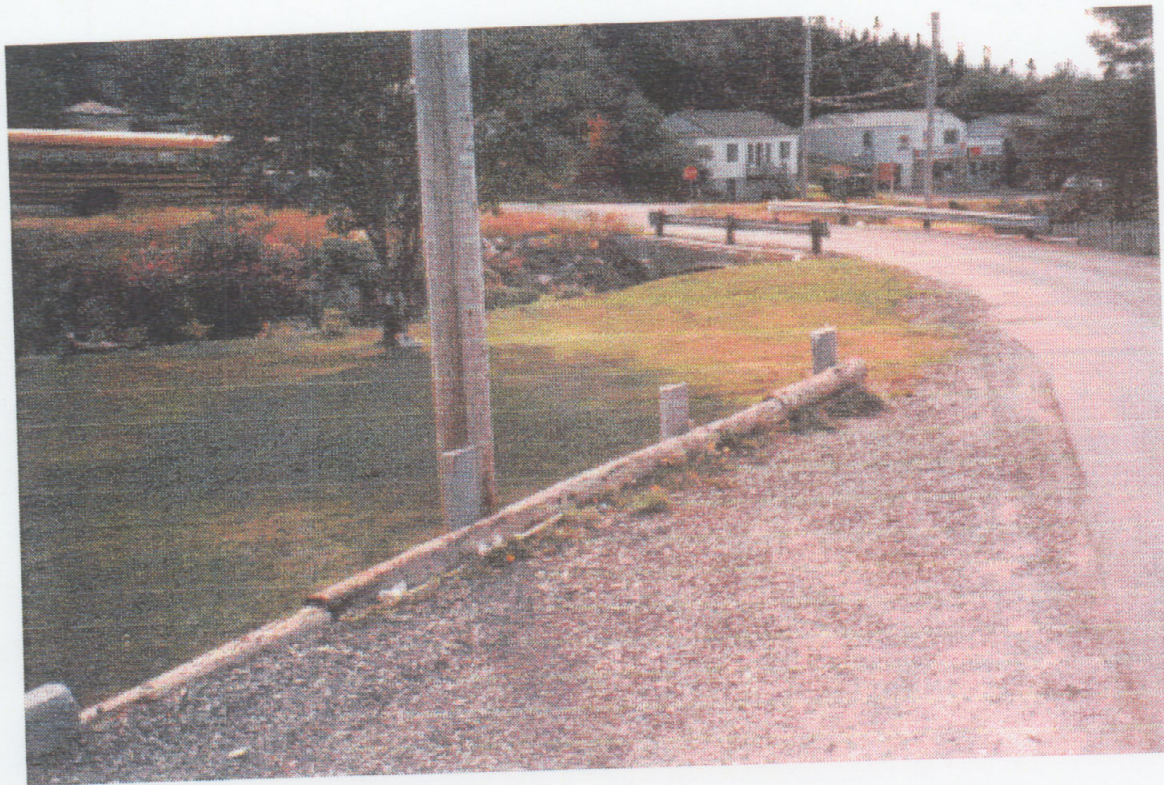
PHOTOGRAPH 1: Main River, Portugal Cove, in the background. Evidence of flooding denoted by brown patch in lawn in center of photo.

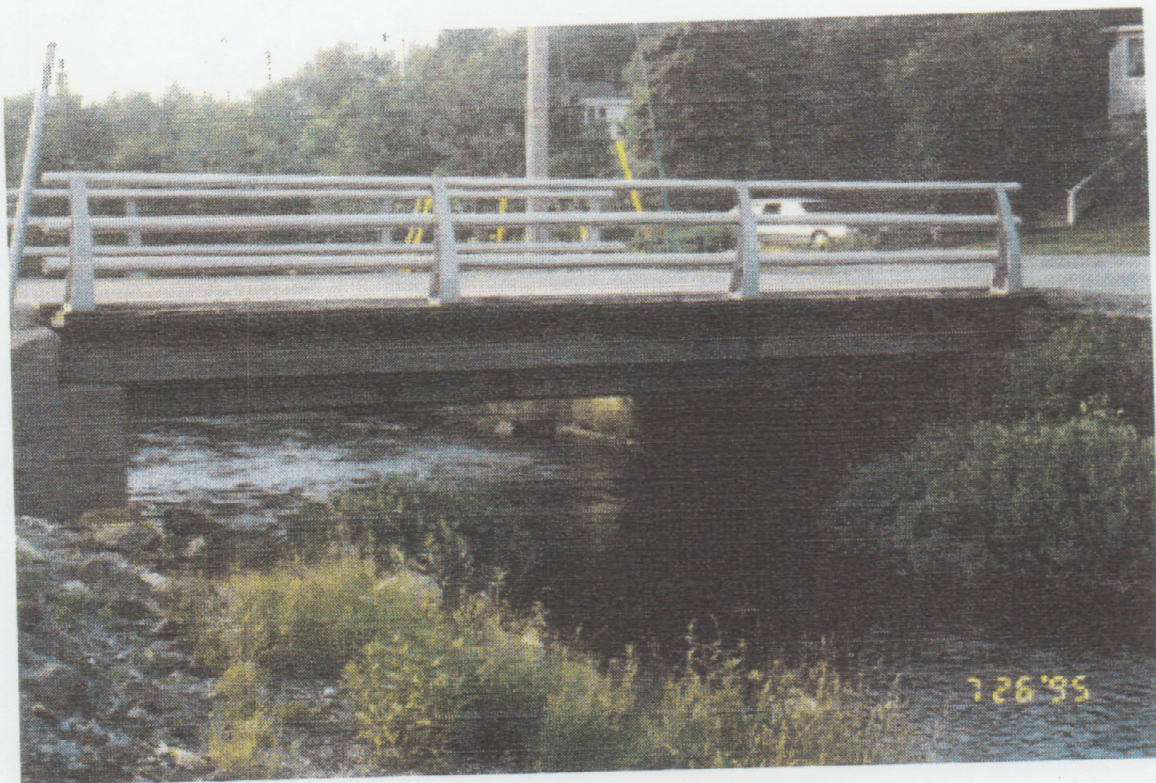
PHOTOGRAPH 3: Bridge over Broad Cove River, St. Philips, at Dogberry Hill Road.

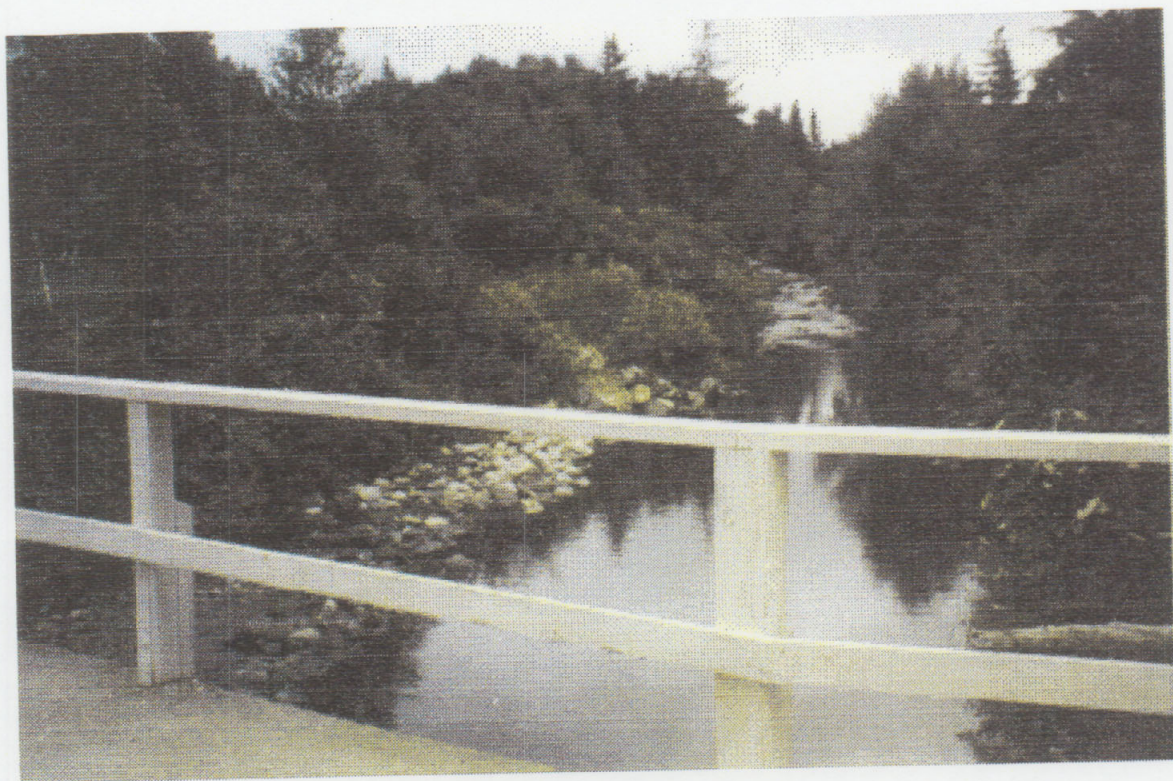
PHOTOGRAPH 4: Bridge over Broad Cove River, St. Philips, on private residence downstream of Dogberry Hill Road.

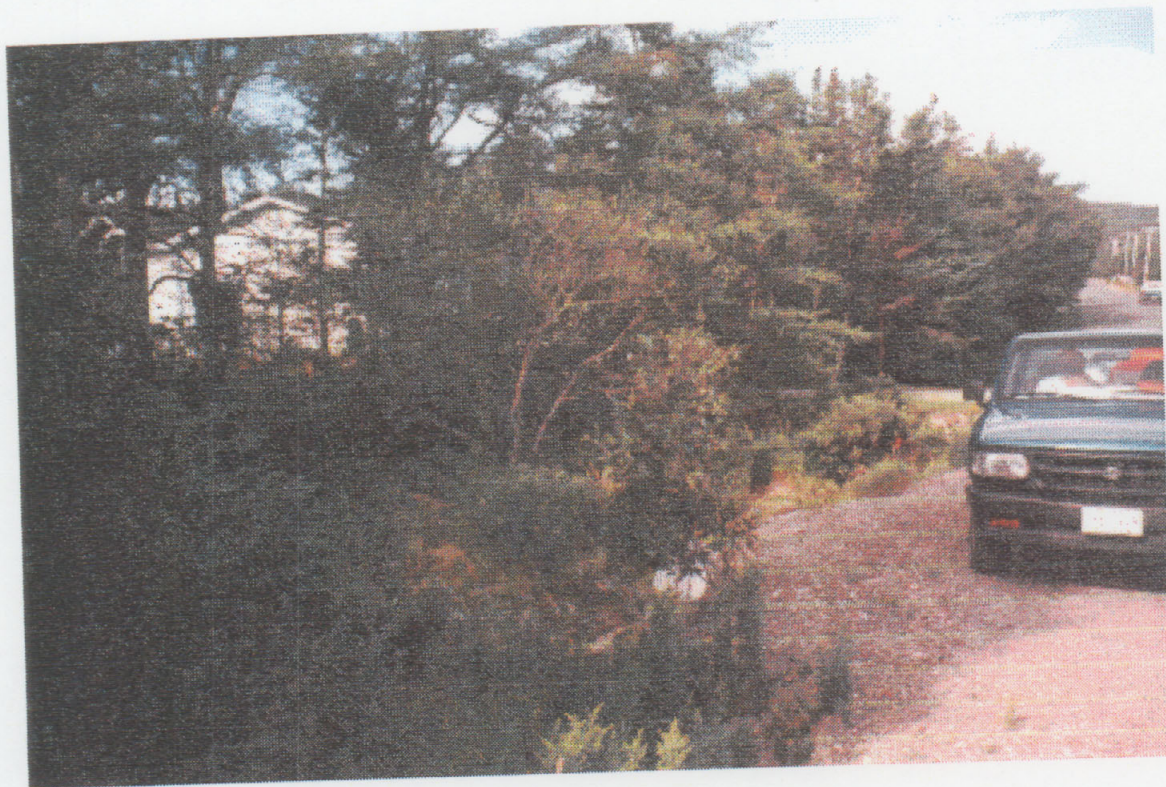
PHOTOGRAPH 5: Andrew Caddigan's residence - location of flooding problems in Logy Bay.
Note arch culvert below center of photo.

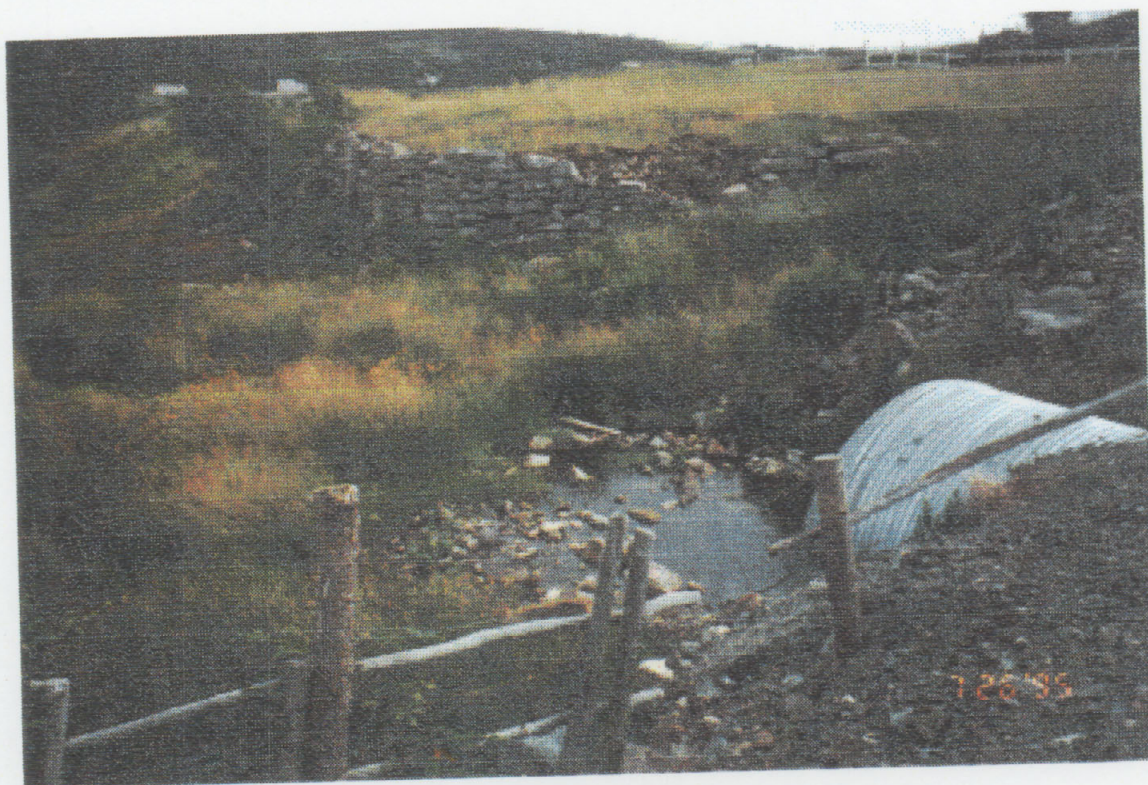
PHOTOGRAPH 6: Downstream view of arch culvert on Caddigan's Road, Logy Bay.

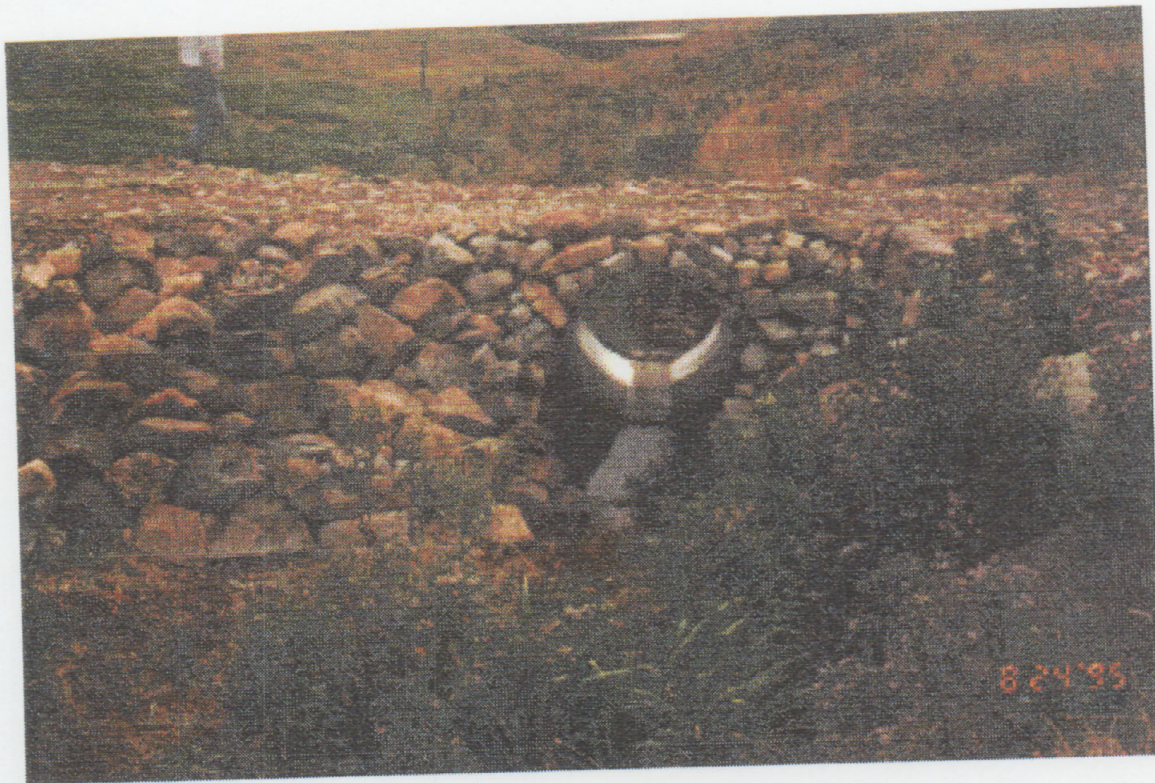
PHOTOGRAPH 7: Culvert through back lawn of residence above Collision Clinic, Outer Cove.

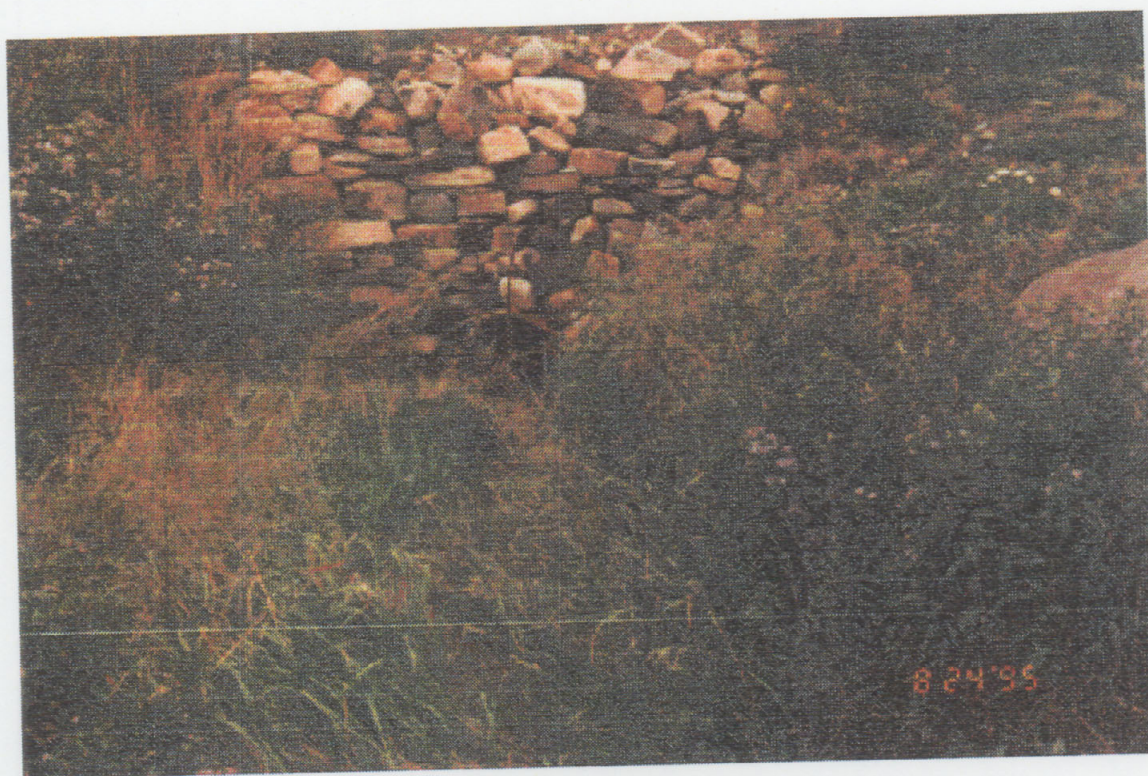
PHOTOGRAPH 8: Intake of culvert running under Collision Clinic parking lot, Outer Cove. Note smaller size of culvert compared with upstream culvert in photo 7.
