Canada - Newfoundland
**Flood
Damage
Reduction
Program**

HYDROTECHNICAL STUDY OF THE STEADY BROOK AREA

Volume 1 of 2 MAIN REPORT

NOLAN DAVIS & ASSOCIATES LIMITED
in association with
CUMMING-COCKBURN & ASSOCIATES LIMITED

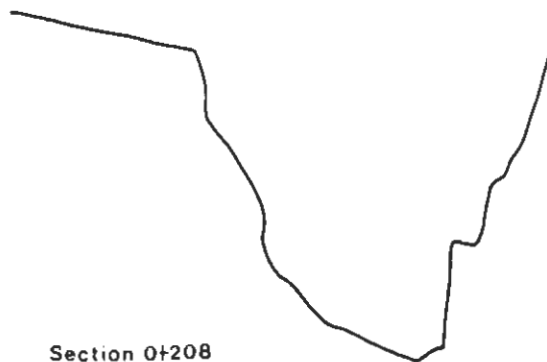
Canada-Newfoundland
Flood Damage Reduction Program**Typical Cross Sections**Note: Sections looking upstream
Sections not to scale.Nolan Davis
& Associates Ltd.Cumming Cockburn
& Associates Limited**Figure 4.1**

Section 0+208

Corner Brook to Steady Brook

Section 0+150

Confluence to CNR Trestle

Section 9+088

Steady Brook to Humber Village

Section 0+650

Upstream of CNR Trestle

Section 16+263

Humber Village to Deer Lake Outlet
