**AN EVALUATION OF FLOODING
IN
STEPHENVILLE, NEWFOUNDLAND**

**WATER PLANNING AND MANAGEMENT BRANCH,
INLAND WATERS DIRECTORATE,
ATLANTIC REGION,
HALIFAX, NOVA SCOTIA,
DEC. 1975.**

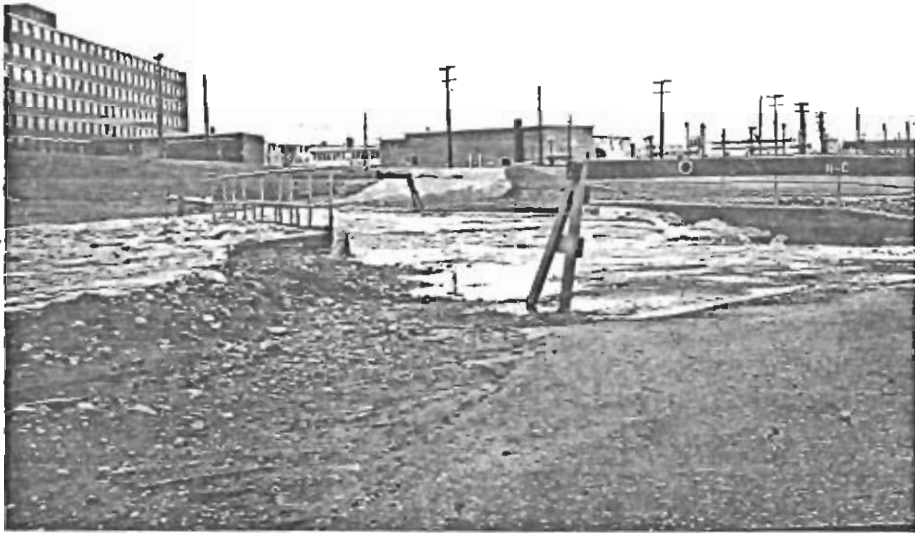
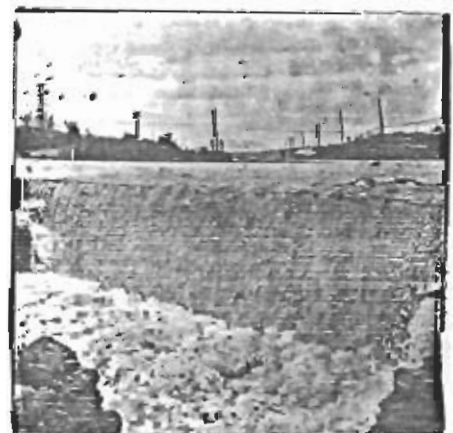
FLOOD OF MAY 15 - 17, 1972
SELECTED PHOTOGRAPHS

Spring runoff combined with rainfall caused Warm Creek to rise, wash out the causeway at Mississippi Drive, and threaten the bridge on Caroline Avenue. It was necessary to erect temporary dykes along the edge of Warm Creek to protect the low ground around the Harmon gymnasium and the brewery.

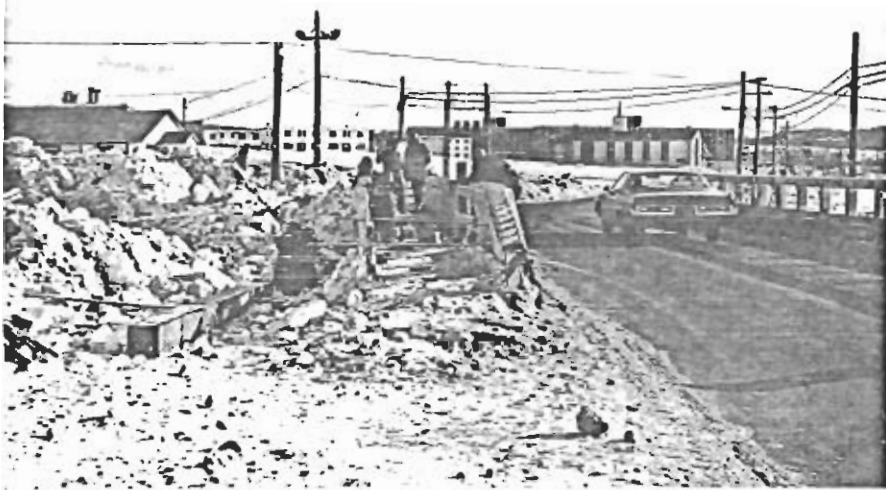
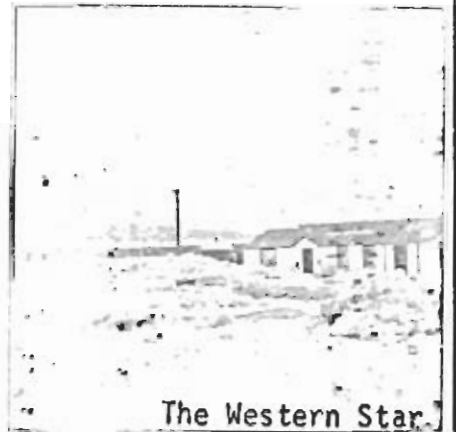
FLOOD OF FEB. 2-3, 1973
SELECTED PHOTOGRAPHS

The worst recorded ice conditions in the history of the Town occurred on Blanche Brook when floating ice piled up across the Main Street Bridge (see Figure 5). The wooden sidewalk on the Bridge had to be replaced, but the bridge itself was not damaged. The Canada Manpower Office and Building 450 on the Harmon Complex were slightly damaged when ice was forced against them.

All buildings close to the Main Street Bridge had their parking lots blocked with ice which was piled up to 10 feet high in places. Water rose almost to the floor level of the Indian Head Co-op, and also flooded Minnesota Drive opposite the brewery. Flooding of the brewery was prevented by the temporary dykes which had been built in the Spring of 1972 when similar, but less extensive flooding occurred in the area.

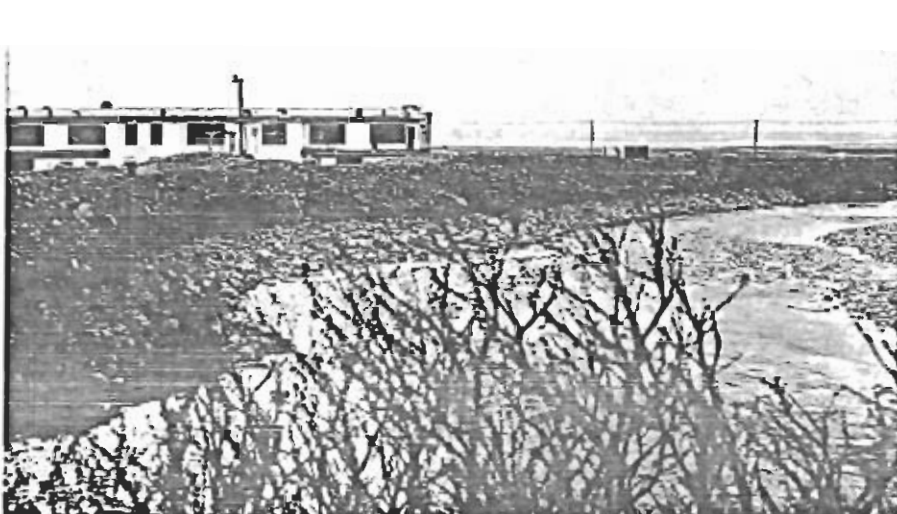
DYKE NEAR LABATT'S
BREWERY

Heavy rain caused flooding problems at Cold Brook, Noel's Pond and Stephenville. The community of Cold Brook was isolated by the washout of the wooden bridge on the main road connecting that community with Stephenville. Residents of Noel's Pond (Wheeler's area) were also reported to have experienced flooding. The Blanche Brook channel had become swollen and the Town's Works Department was hard pressed to prevent debris from piling up underneath the Hanson Highway Bridge (see Figure 5).

13. The existing dyke along Blanche Brook at the brewery is not considered to be structurally competent to withstand the hydrostatic and erosional forces which will occur under major flooding events. Signs of erosional damage and sloughing are already evident.

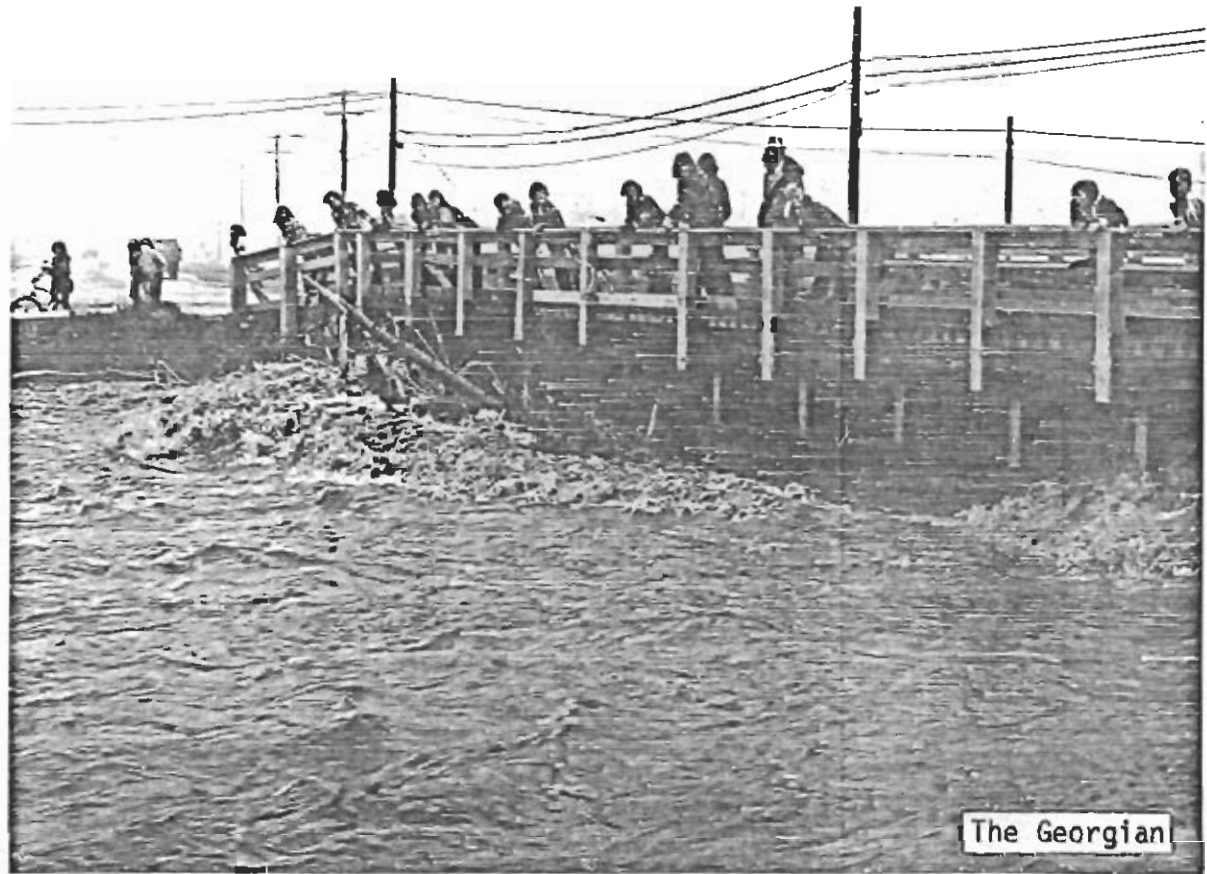
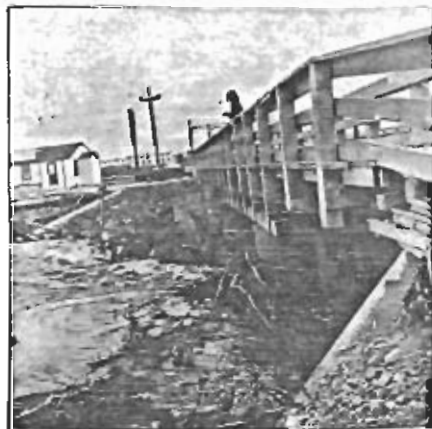
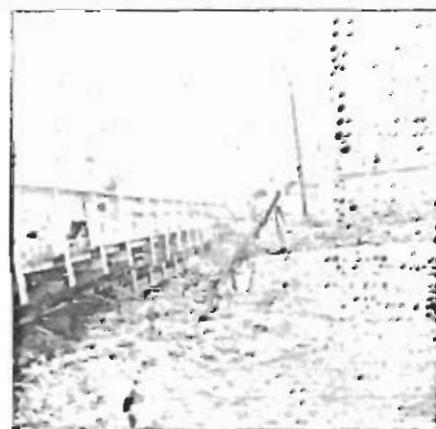
FLOOD OF AUG. 2-3, 1973
SELECTED PHOTOGRAPHS

Potentially severe damages were averted at the Hanson Highway and Main Street bridges by clearing several truckloads of trees and other debris from behind the bridges. Even so, the bridges were sufficiently blocked to cause some concern for their safety (see Figure 6).

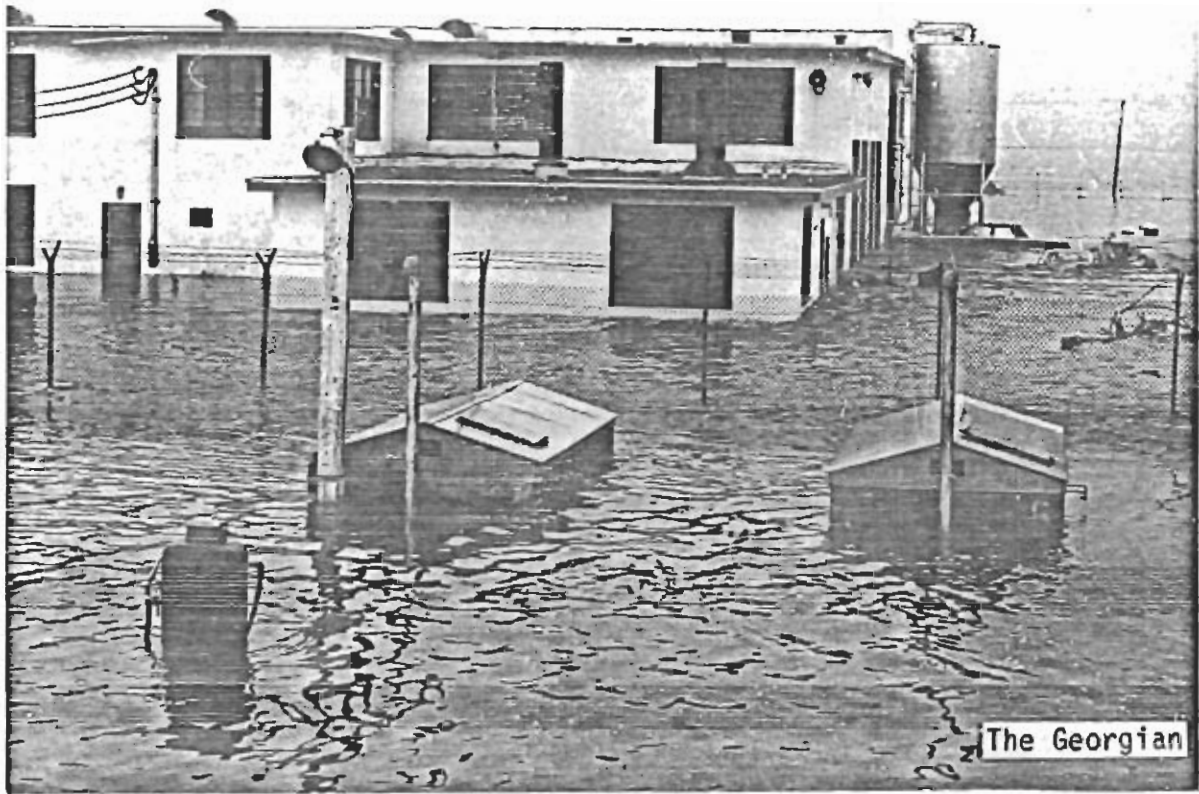
PHOTOGRAPHS OF BREWERY
FLOOD OF AUG. 2-3, 1973

High water broke through the temporary dykes protecting the brewery and reached a height of about 1.5 feet above flood level. Damages of approximately \$70,000 were inflicted on the assets of the brewery (see Figure 7). Interior materials and equipment as well as inventories of both goods in process and finished goods were damaged.

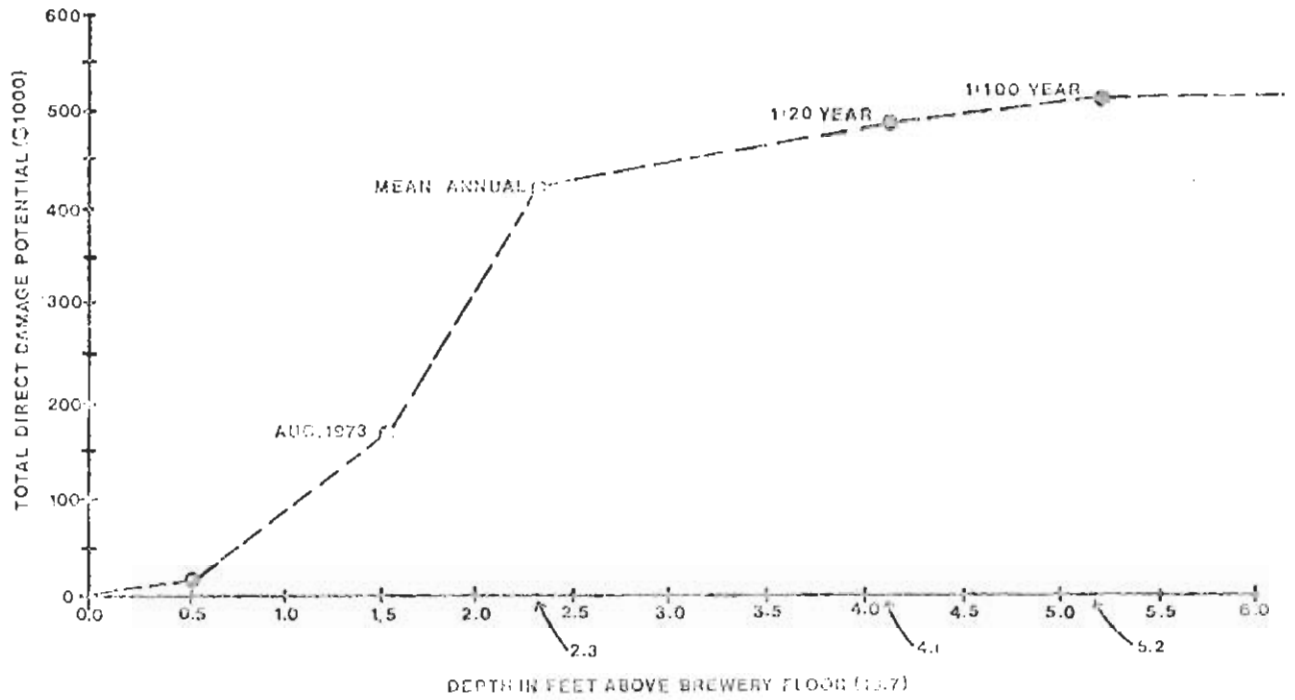
ESTIMATED STAGE-DAMAGE FUNCTION AT LABATT'S BREWERY

An estimate of the potential for damages at the brewery at different stages is shown in Table 4. This illustrates the sensitivity of the stage-damage relationship at the two inflection points mentioned above - i.e. 6 inches and 2 feet.
