Canada - Newfoundland
Flood
Damage
Reduction
Program

Hydrotechnical Study of the Stephenville Area

Physical Surveys and Field Program

February , 1984

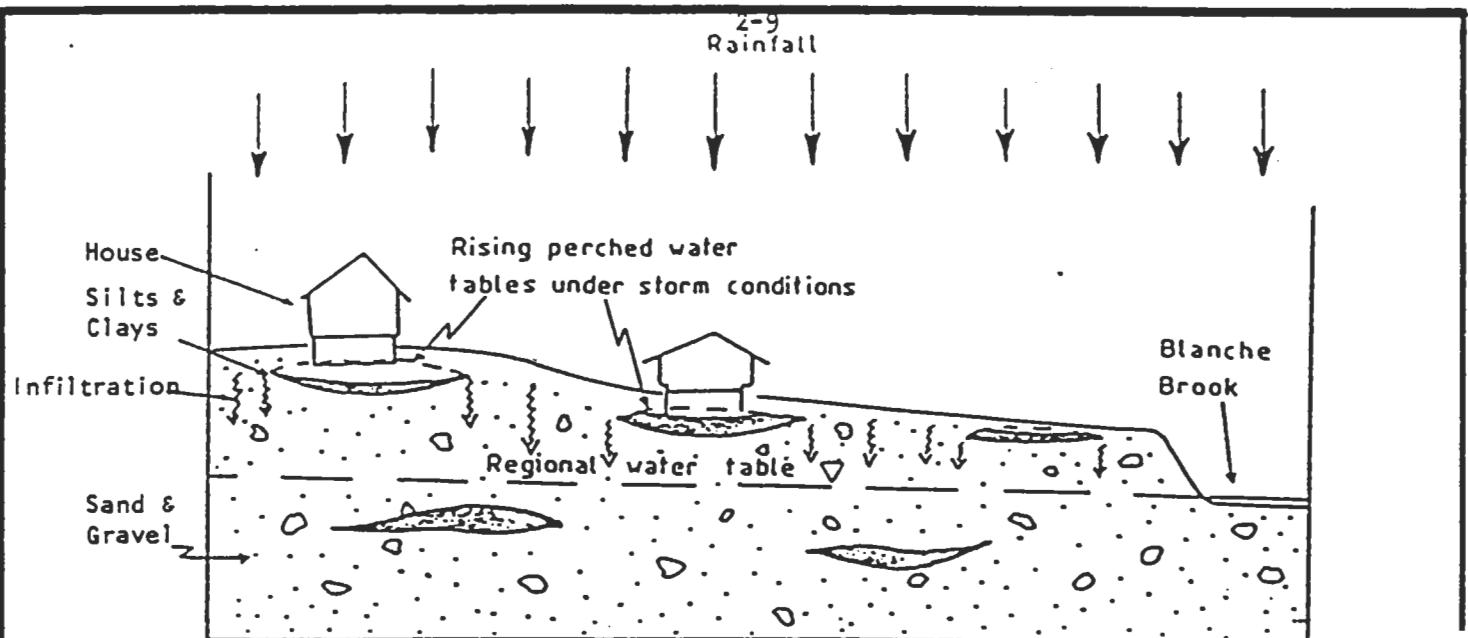
FIGURE 1

SKETCH - EFFECT OF PERCHED WATER TABLES ON BASEMENT FLOODING

These fine grained deposits can be expected to exhibit much lower permeability than the surrounding coarse grained material. The resultant major decline in vertically downward permeability will create a perched water table which could lie at a higher elevation than the water level in the channel. With a rainfall event, this shallow perched water table could be expected to respond rapidly; thereby quickly rising to near the surface and entering any basements which would be vulnerable (see Figure 1). At least one residence recently constructed over a filled-in swale, has been affected by groundwater surcharge of this nature.

The valley morphology and surficial geology are indicative of a near-surface water table in at least two locations (as noted schematically in Figure 1) and having a significant gradient. One near surface location is at the base of the western valley wall and the other is located at the base of a small terrace. Homes built at these locations would tend to notice a quick water table response with basement flooding prior to storm flow conditions in the channel.

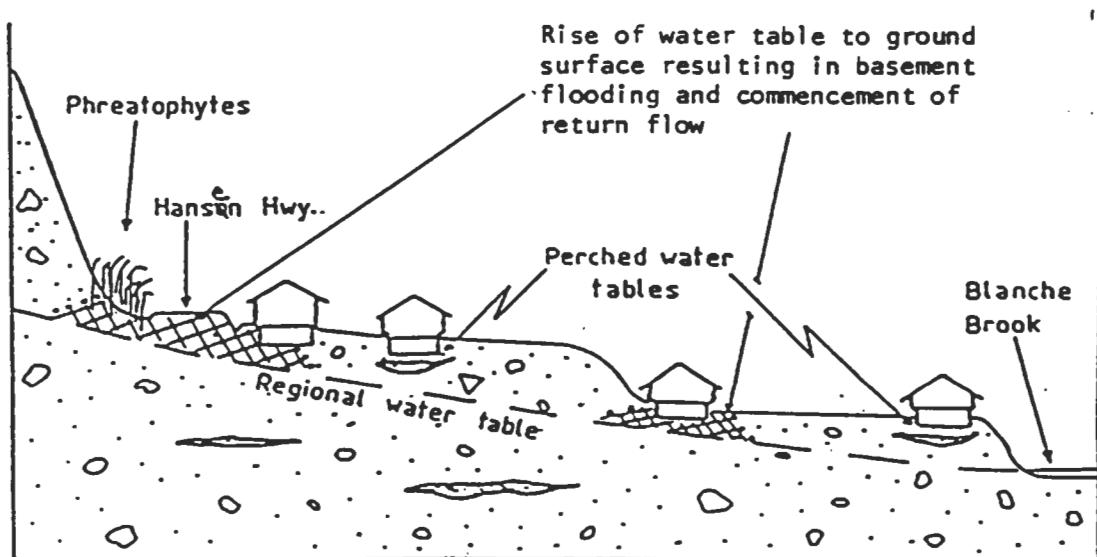
SKETCH - EFFECT OF WATER TABLE GRADIENT ON BASEMENT FLOODING

In both of the above described situations, the water table lies relatively close to ground surface under non-storm flow conditions. As such, under storm conditions, the processes associated with the variable source area-overland flow concept of stream flow generation apply. In this concept, near-stream and near-steep hydraulic gradient increases develop soon after the beginning of the storm event. The speed of this rise is independent of the upland area response and is augmented by the height of the capillary zone and its close proximity to the ground surface. Infiltration quickly converts the tension saturated capillary fringe into a pressure saturated zone and the water table rises almost instantaneously to the ground surface. At this point, water emerges from the ground and runs downslope toward the channel as overland flow. If runoff occurs in sufficient volume, the capacity of existing highway drains in the area could be exceeded, resulting in local flooding within the flood plain prior to a rise in stage in the channel.

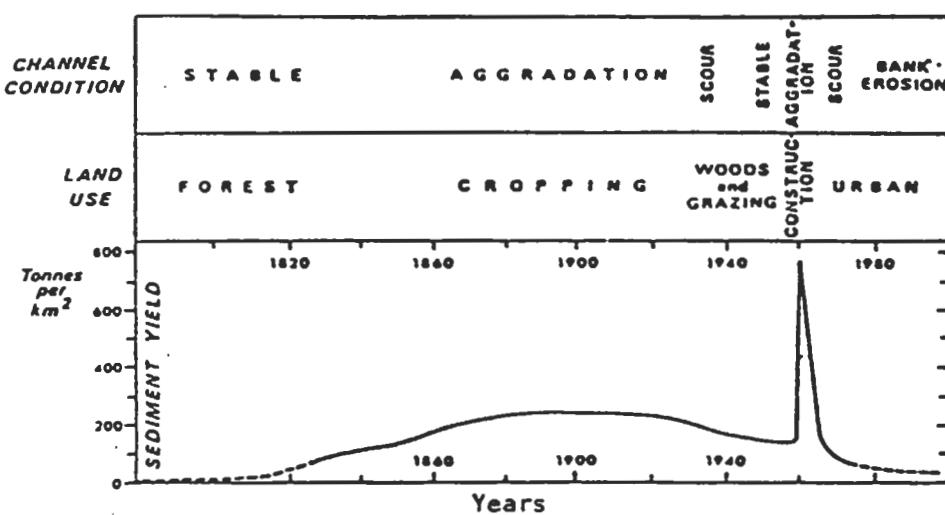
FIGURE 2

Source: Gregory and Walling (1973)

These changes and the resultant effects on channel morphology are partly summarized in Figure 2. Of particular note for further discussion are:

Given the history of development in the watersheds in question, the reaches under investigation primarily receive tributary inflow from the urban area indicated to the far right of Figure 2. The upper portions of the watershed exhibit some "cropping and grazing" although it is predominantly a natural forested area with minimal cutting activity. Although washing of debris during high runoff events contributes somewhat to these changes. Therefore, there are temporal and spatial fluctuations in land use which have and are effecting channel morphology.

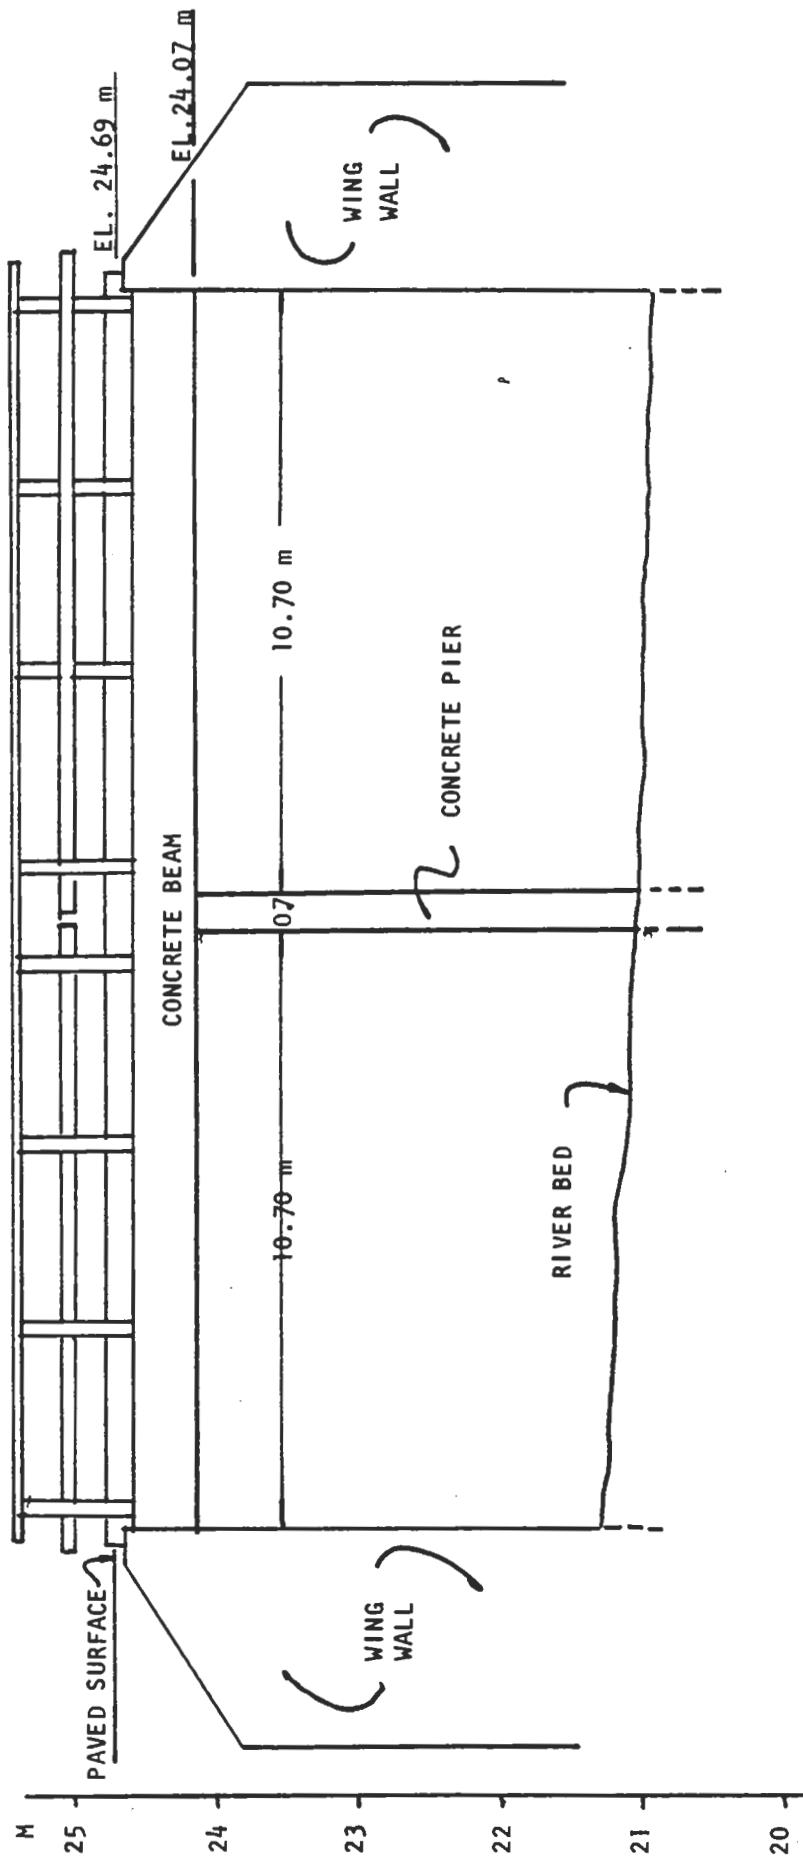
STA. 29+11

WARM CREEK AT CONNECTICUT DRIVE
BRIDGE STRUCTURE LOOKING UPSTREAM

SCALES: H 1:125
V 1:50

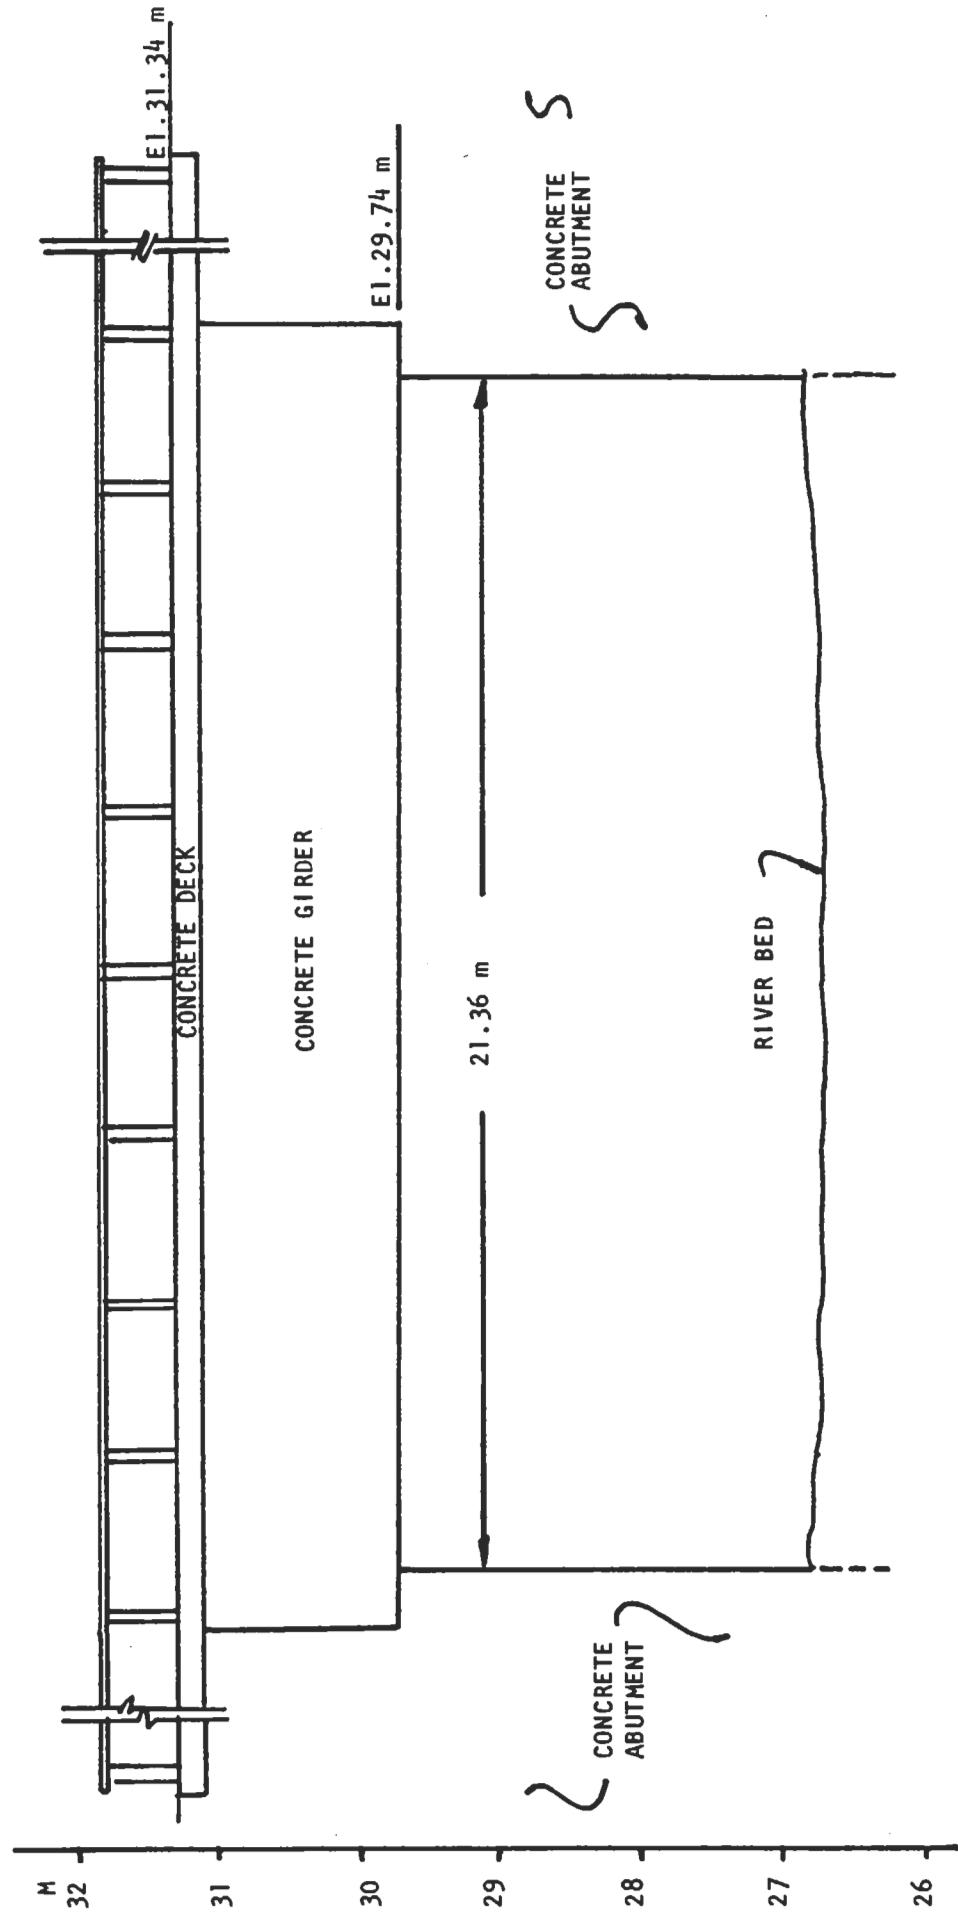
STA. 31+71
BLANCHE BROOK AT HANSEN HIGHWAY (ROUTE 460)

BRIDGE STRUCTURE LOOKING UPSTREAM

SCALES: H 1:125
V 1:50

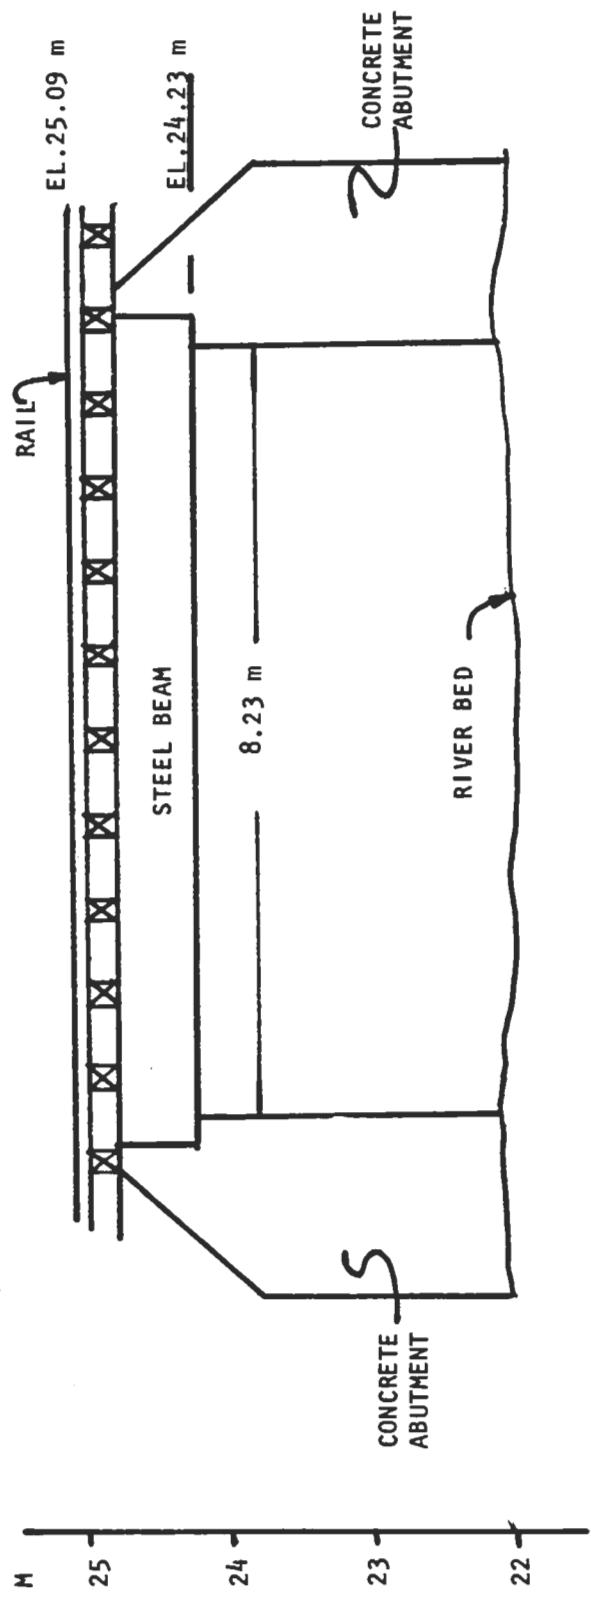
STA. 59+68
WARM CREEK
C.N.R. TRESTLE STRUCTURE TO LINERBOARD MILL
SCALE: H 1:75 V 1:50

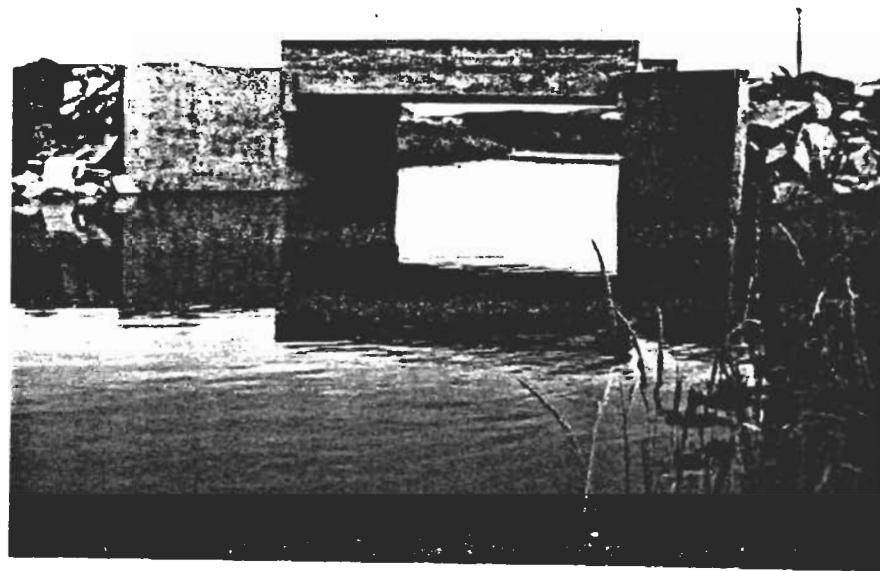
BLANCHE BROOK AT KIN PLACE LOOKING UPSTREAM
STRUCTURE B1 STA. 1+37
PHOTOGRAPH 1

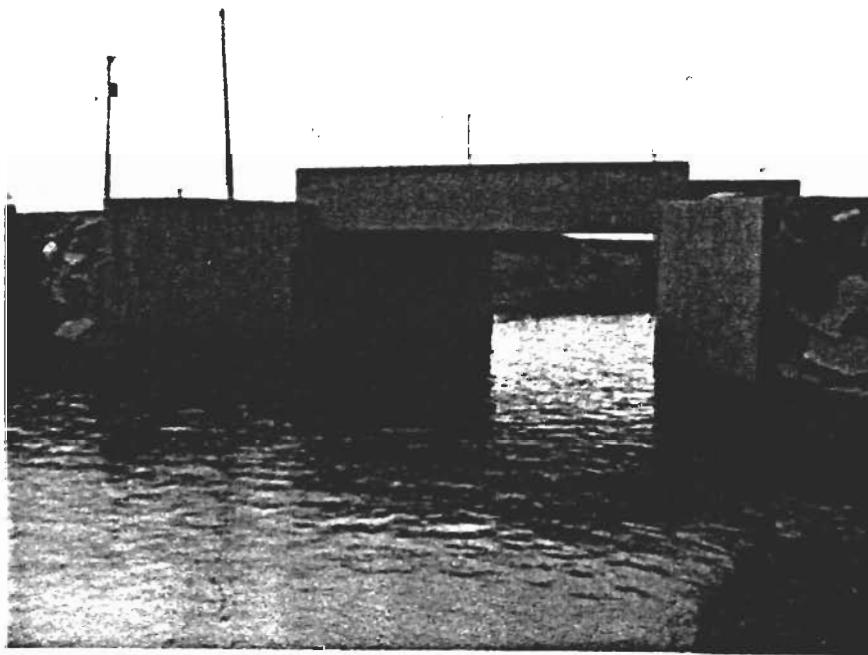
BLANCHE BROOK AT KIN PLACE LOOKING DOWNSTREAM
STRUCTURE B1 STA. 1+37
PHOTOGRAPH 2

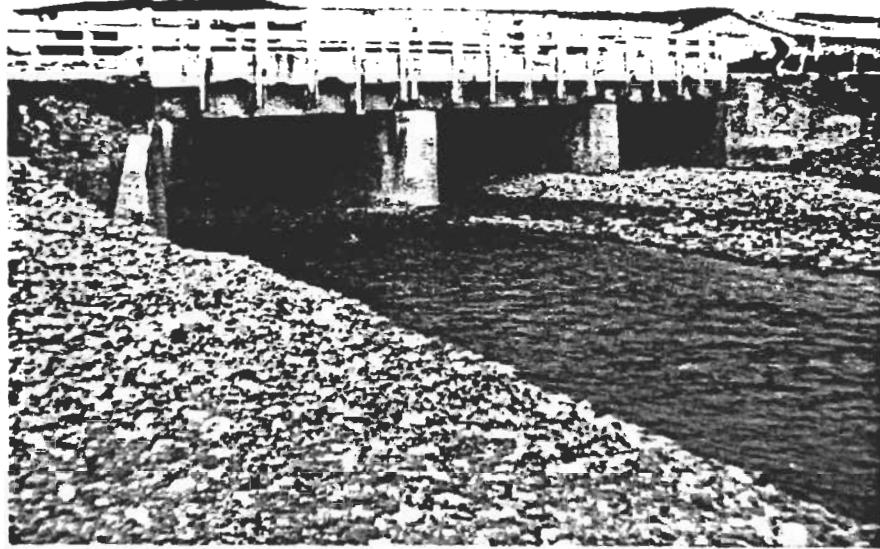
BLANCHE BROOK AT MINNESOTA DRIVE LOOKING UPSTREAM
STRUCTURE B2 STA. 12+74
PHOTOGRAPH 3

Four stations, two on each of the watercourses, were established to facilitate stream discharge measurements as part of the field monitoring program. The stations on Blanche Brook were located coincident with bridge structures B2 and B3 to accommodate uniform flow measurements while Warm Creek measurements were taken at bridge structures B6 and B7. As noted from Table 1, Appendix A, crest gauges were also positioned on these same structures.

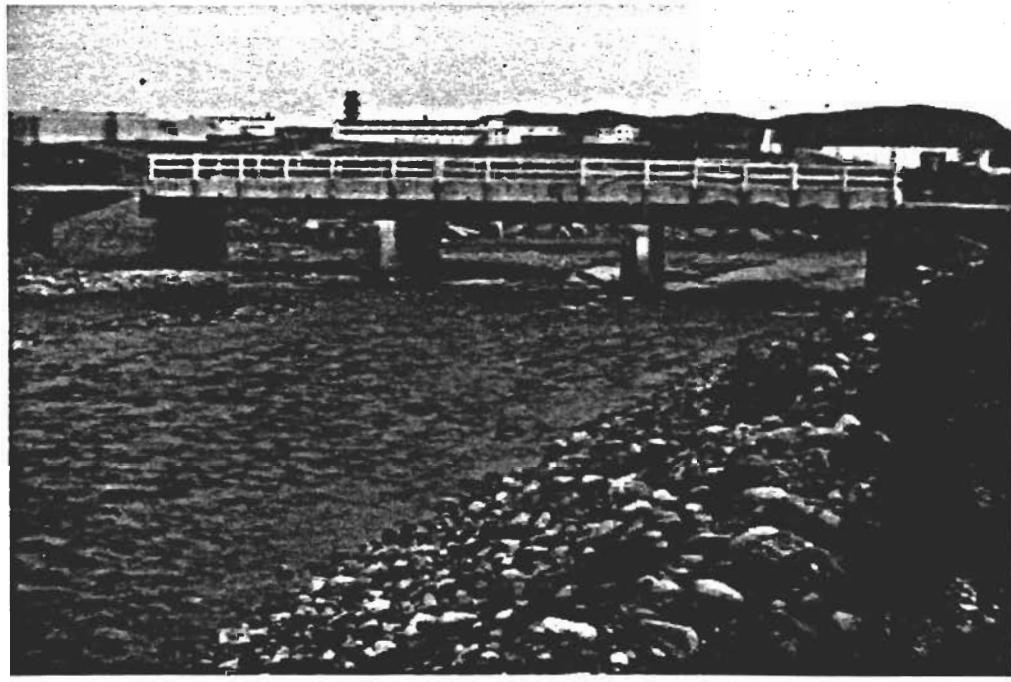
BLANCHE BROOK AT MINNESOTA DRIVE LOOKING DOWNSTREAM
STRUCTURE B2 STA. 12+74
PHOTOGRAPH 4

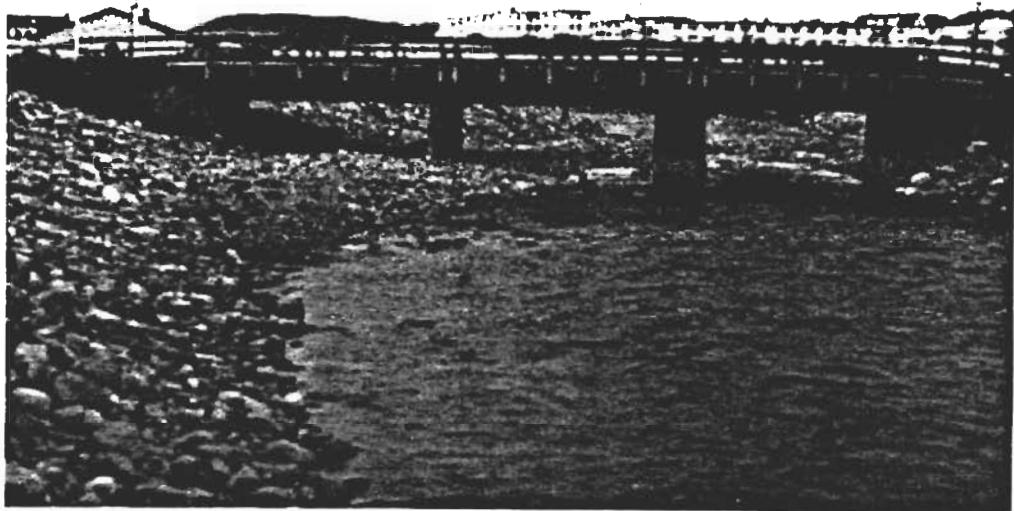
BLANCHE BROOK AT MAIN STREET LOOKING UPSTREAM
STRUCTURE B3 STA. 16+51
PHOTOGRAPH 5

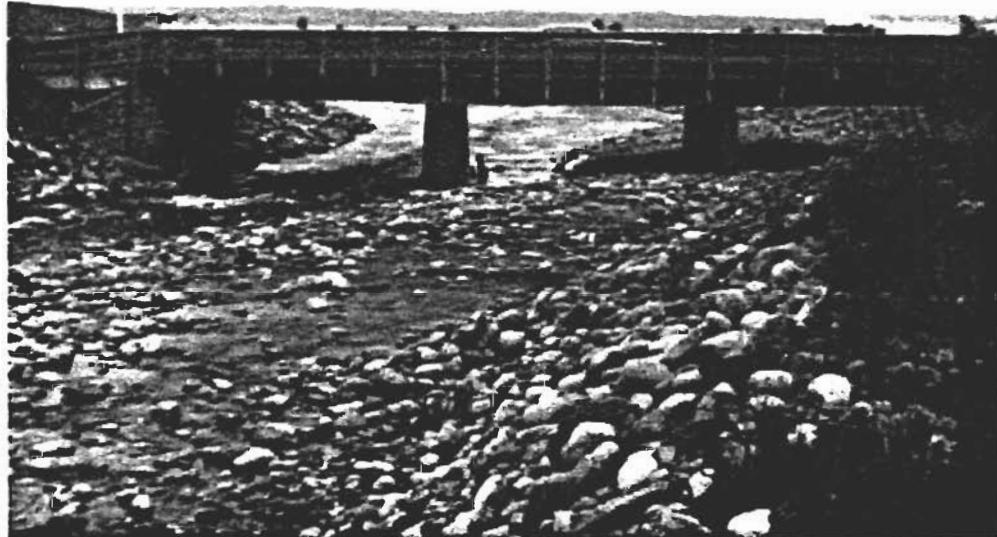
BLANCHE BROOK AT MAIN STREET LOOKING DOWNSTREAM
STRUCTURE B3 STA. 16+51
PHOTOGRAPH 6

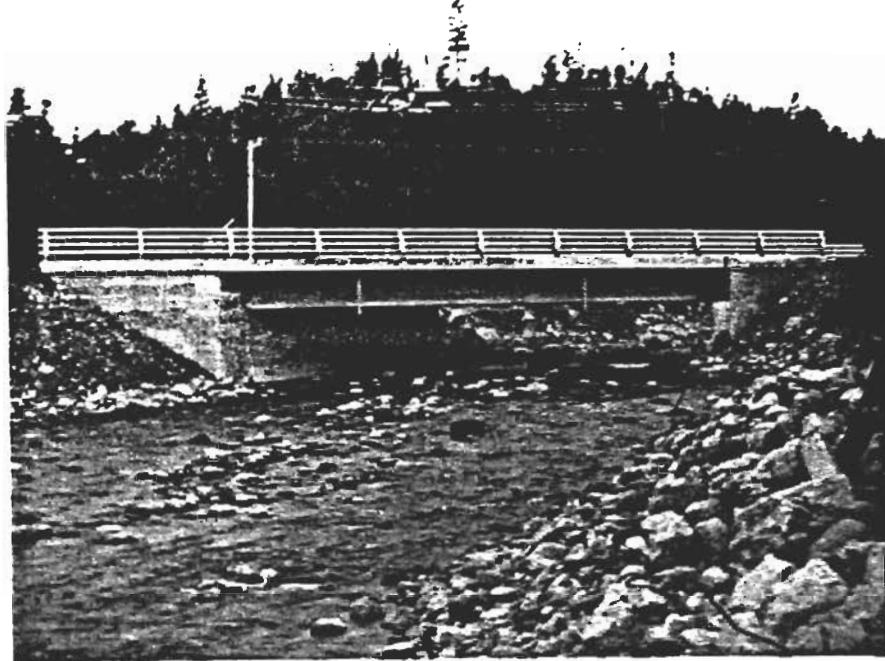
BLANCHE BROOK AT HANSEN HIGHWAY LOOKING UPSTREAM
STRUCTURE B4 STA. 31+71
PHOTOGRAPH 7

Subsequent to installation of the crest gauge on Blanche Brook at the old bridge structure on the Hansen Highway Crossing, field personnel were informed that the structure was going to be demolished. This unit was therefore removed and repositioned on the new bridge. Prior to completion of the field work, an eighth crest gauge was installed on Warm Creek at the Hansen Highway bridge structure on Route 460. Relocation of the Blanche Brook gauge and installation of the above noted eighth gauge was carried out October 6, 1982.

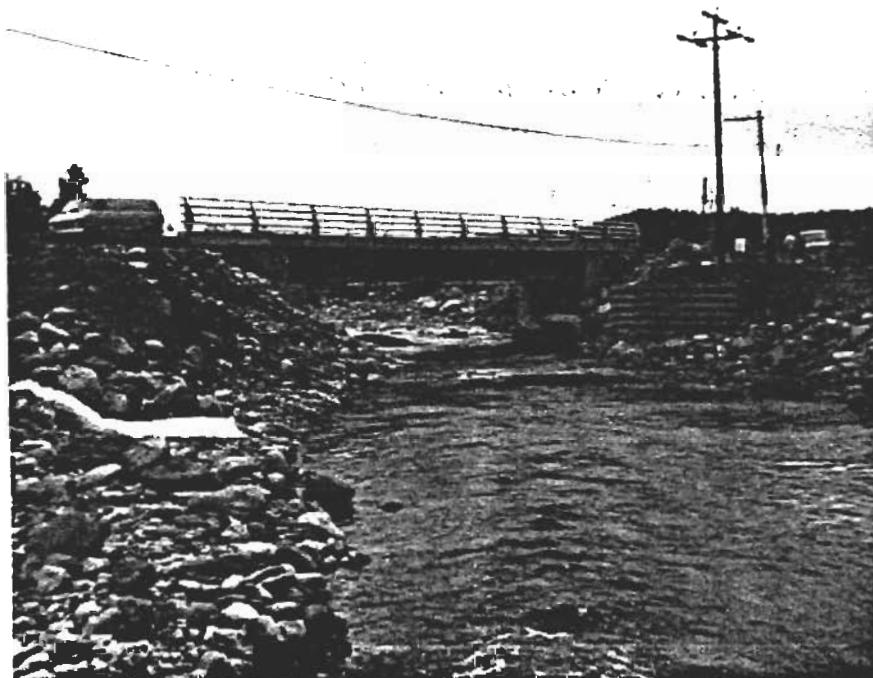
BLANCHE BROOK AT HANSEN HIGHWAY LOOKING DOWNSTREAM
STRUCTURE B4 STA. 31+71
PHOTOGRAPH 8

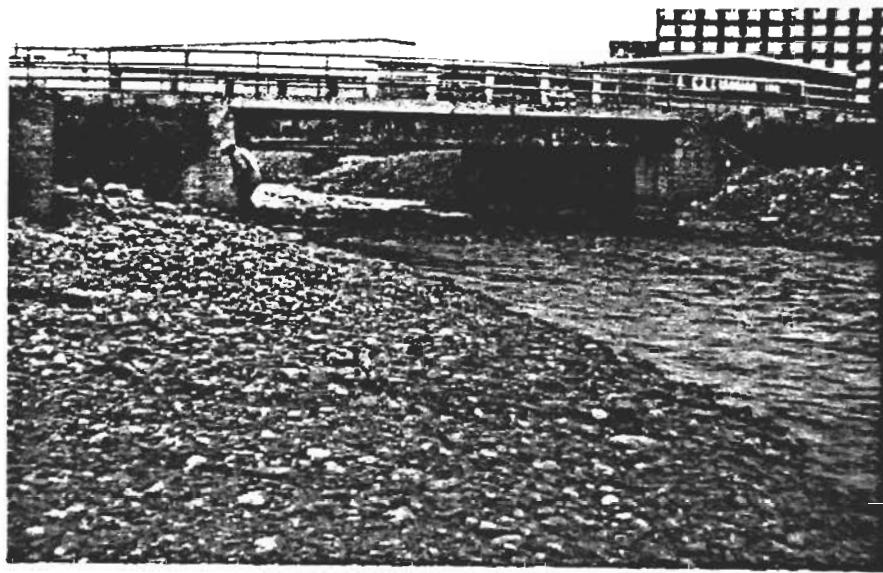
WARM CREEK AT CAROLINA AVENUE LOOKING UPSTREAM
STRUCTURE B5 STA. 3+62
PHOTOGRAPH 9

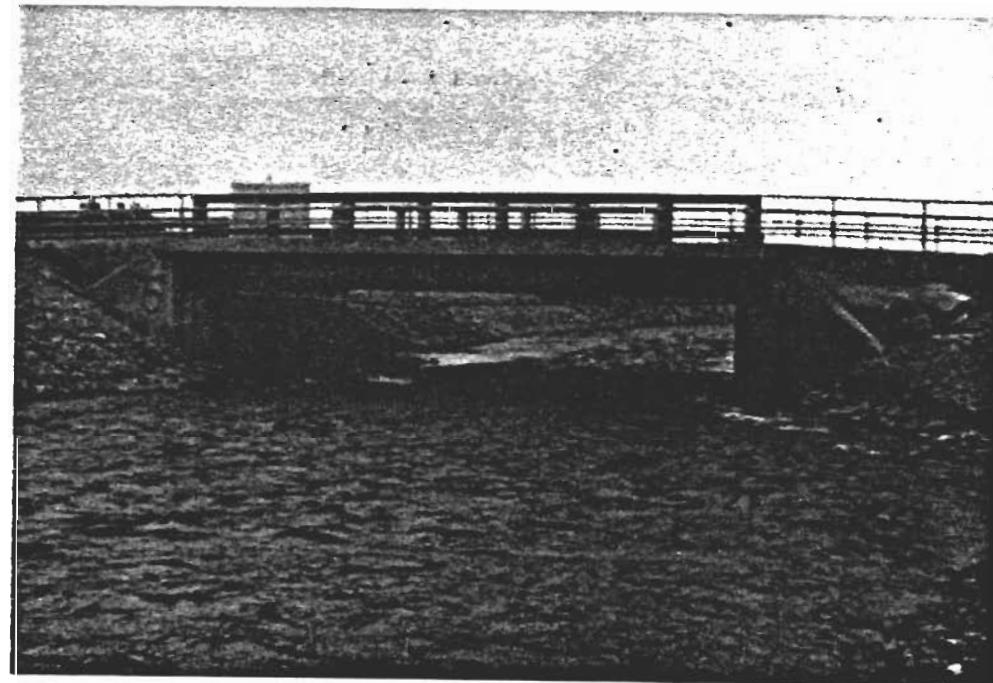
WARM CREEK AT CAROLINA AVENUE LOOKING DOWNSTREAM
STRUCTURE B5 STA. 3+62
PHOTOGRAPH 10.

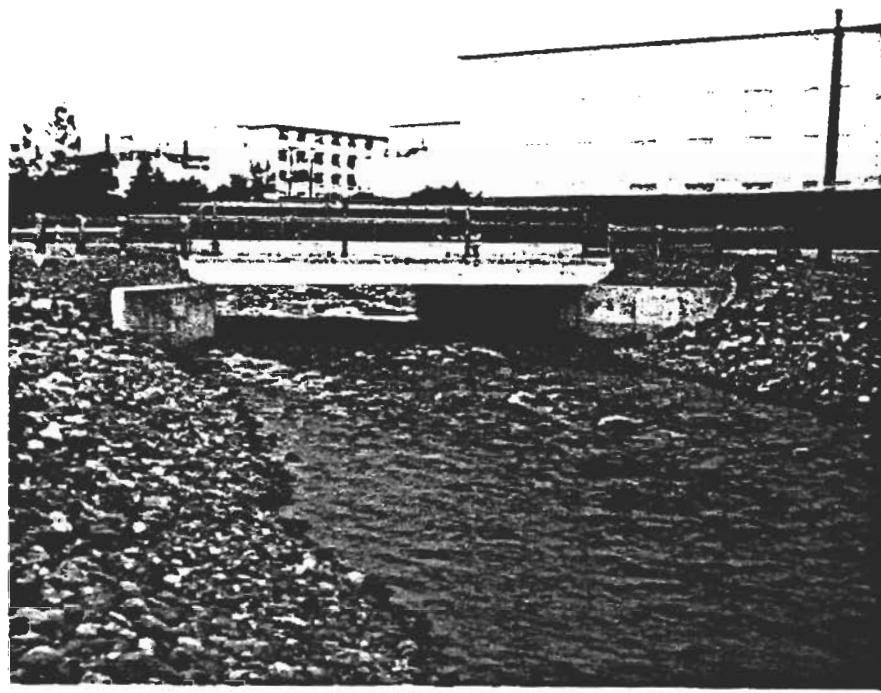
WARM CREEK AT MISSISSIPPI DRIVE LOOKING UPSTREAM
STRUCTURE B6 STA. 5+64
PHOTOGRAPH 11

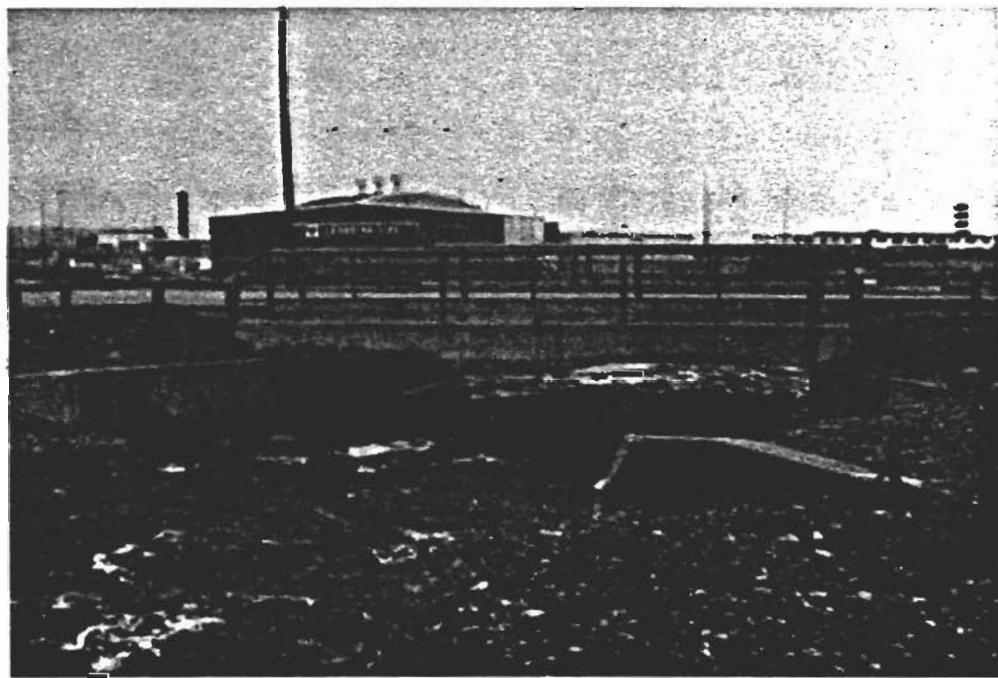
WARM CREEK AT MISSISSIPPI DRIVE LOOKING DOWNSTREAM
STRUCTURE B6 STA. 5+64
PHOTOGRAPH 12

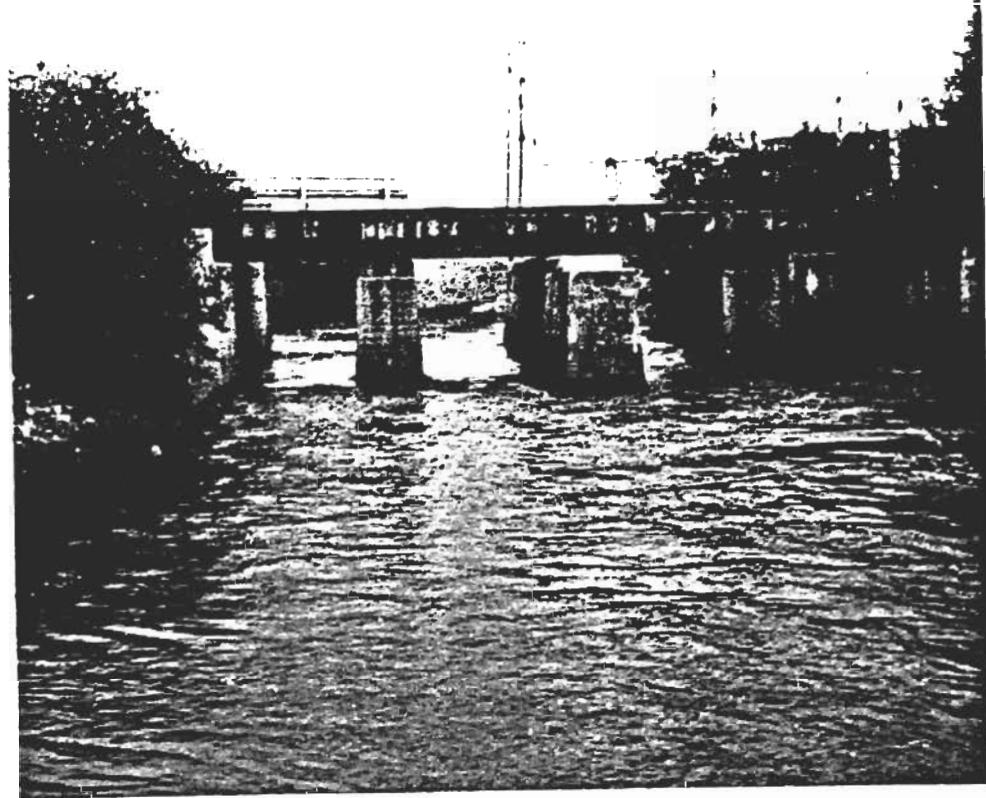
C.N.R. TRESTLE ON WARM CREEK AT CONNECTICUT DRIVE LOOKING UPSTREAM
STRUCTURE B7a STA. 28+23
PHOTOGRAPH 13

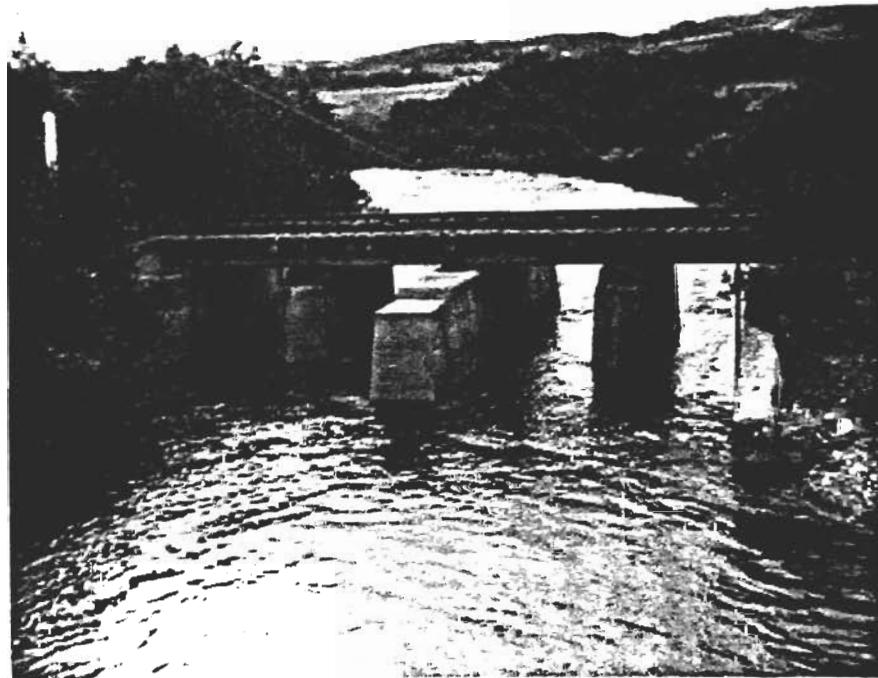
C.N.R. TRESTLE ON WARM CREEK AT CONNECTICUT DRIVE LOOKING DOWNSTREAM
STRUCTURE B7a STA. 28+23
PHOTOGRAPH 14

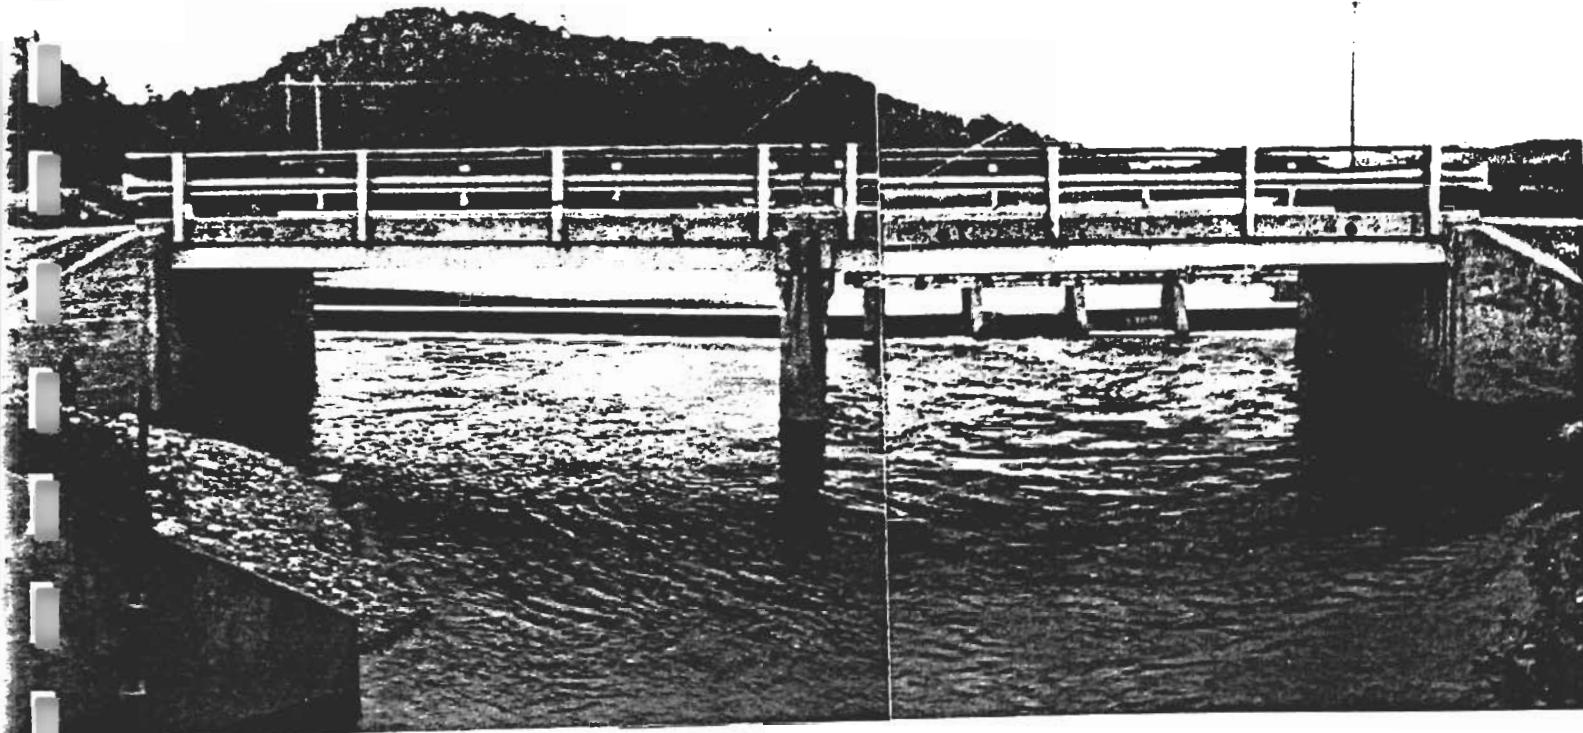
WARM CREEK AT CONNECTICUT DRIVE LOOKING UPSTREAM
STRUCTURE B7 STA. 29+11
PHOTOGRAPH 15

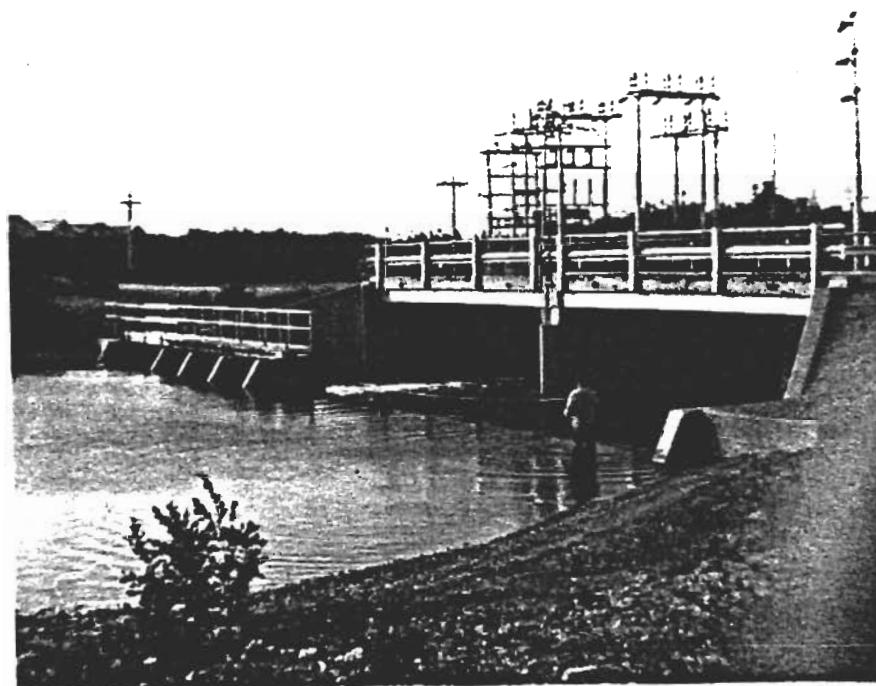
WEIR STRUCTURE ON WARM CREEK AT OUTLET END OF NOEL'S POND
LOOKING DOWNSTREAM TOWARDS BRIDGE ON CONNECTICUT DRIVE
STRUCTURE B7b STA. 29+60
PHOTOGRAPH 16

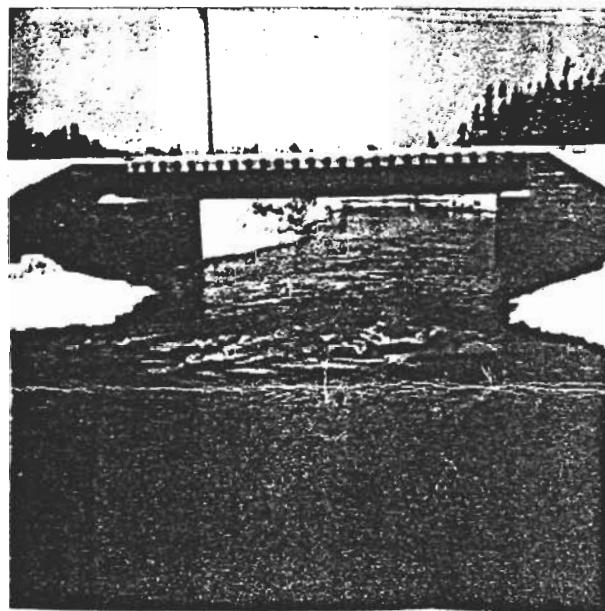
C.N.R. TRESTLE OVER WARM CREEK ON SPUR-LINE
TO LINERBOARD MILL LOOKING DOWNSTREAM
STRUCTURE B8a STA. 59+63
PHOTOGRAPH 18

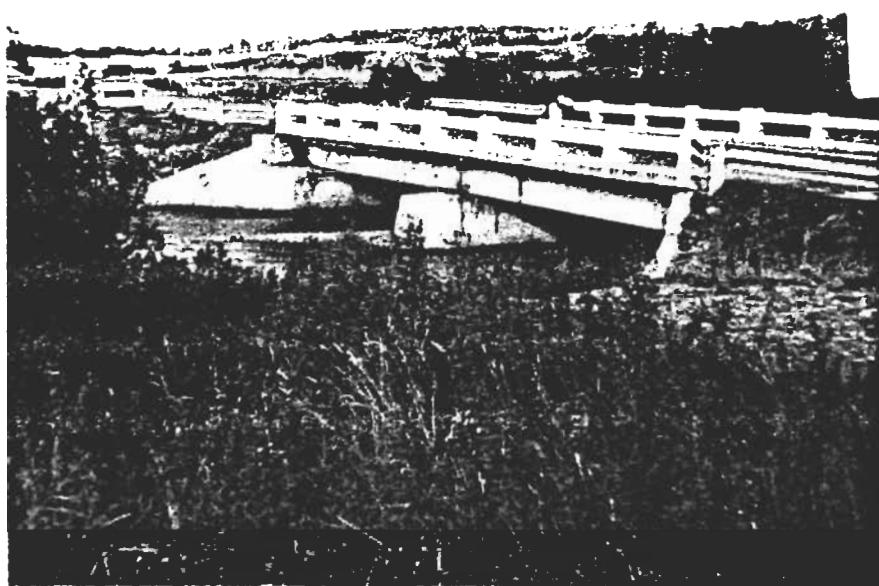
WARM CREEK AT HANSEN HIGHWAY (R. R. 460) LOOKING UPSTREAM
STRUCTURE B8 STA. 71+45
PHOTOGRAPH 19

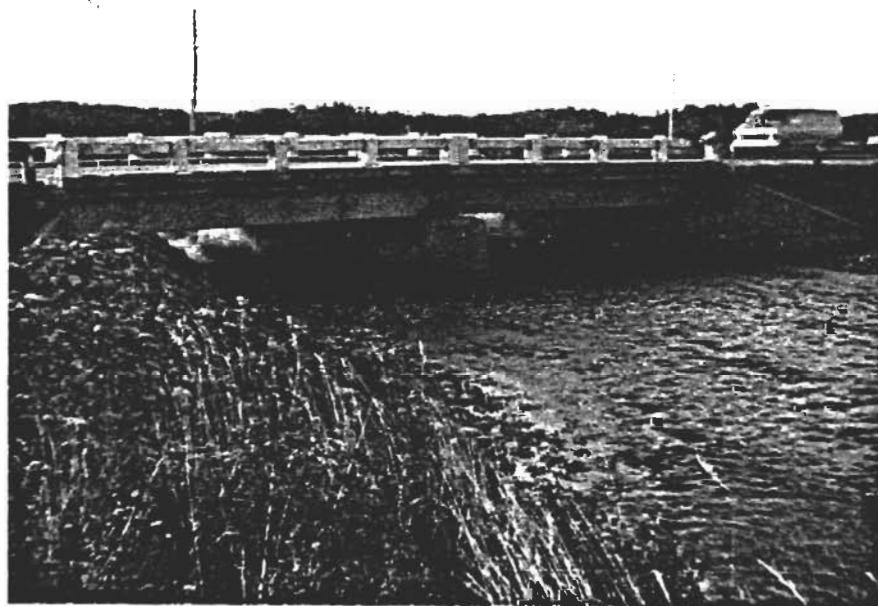
WARM CREEK AT HANSEN HIGHWAY (R. R. 460) LOOKING DOWNSTREAM
STRUCTURE B8 STA. 71+45
PHOTOGRAPH 20

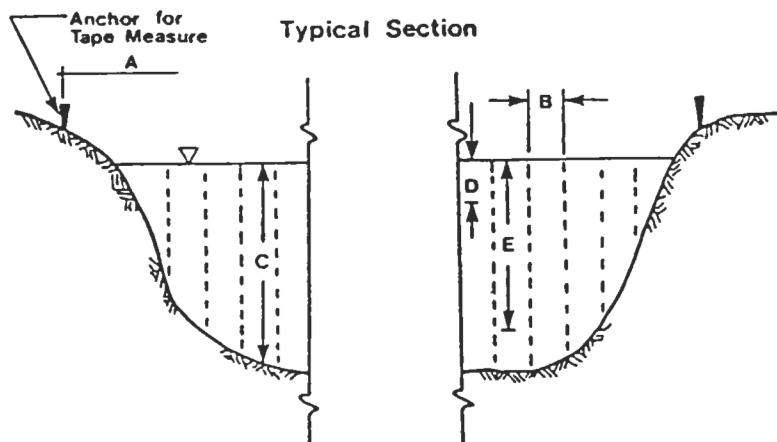
- A Distance to measuring point
- B Panel width ($d/20$)
- C Total depth at metering point
- D Metering Depth ($0.2 \times d$)
- E Metering Depth ($0.8 \times d$)

Flow measurements were taken by Mr. I. Wiseman of Stephenville using a Teledyne Gurley Type 622 current meter and wading rod. Measurements were taken in accordance with Water Survey of Canada guidelines. As the readings were taken using the standard meter head rather than a pigmy meter, some degree of error was experienced because of the shallow water and rough channel bed conditions prevalent at the time. However, based on a detailed review of computed discharge, it was found that this error was not significant.

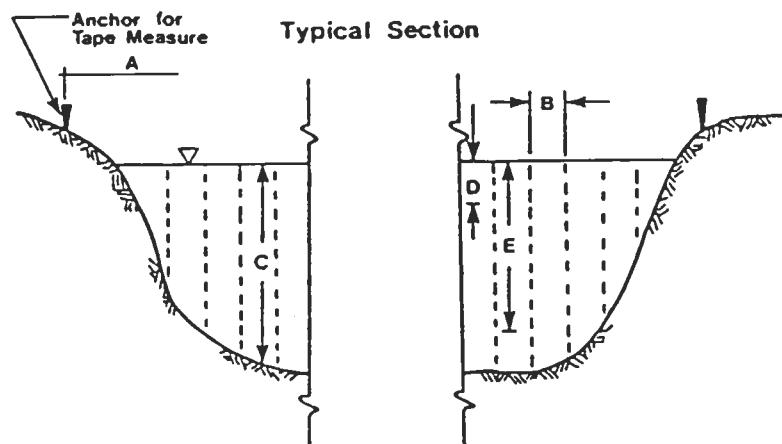
- A Distance to measuring point
- B Panel width ($d/20$)
- C Total depth at metering point
- D Metering Depth ($0.2 \times d$)
- E Metering Depth ($0.8 \times d$)

- start measurement at 11:24 am, stop at 11:52 am
- water temperature = 0°C at 11:30 am

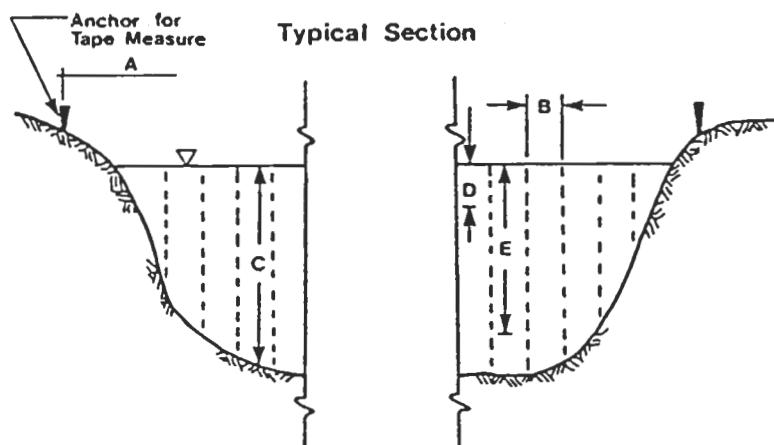
- A Distance to measuring point
- B Panel width ($d/20$)
- C Total depth at metering point
- D Metering Depth ($0.2 \times d$)
- E Metering Depth ($0.8 \times d$)

- measurements taken between 12:13 pm - 12:36 pm
- stage = 8.390 m
- water temperature = 3°C at 12:20 pm

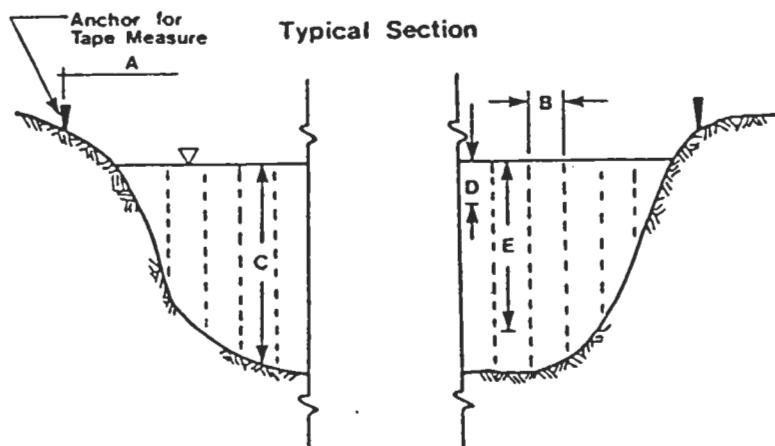
Panel No.	Depth "d" Dist.	Depth "d"	Meter "d"		Rev.	Time sec.	Velocity "v"	\bar{V}	Area	Discharge "Q"
			0.2	0.6						
1	0.5	.13 m		x	25		40	.421	.08 m ²	.03 m ³ /s
2	0.75	.13		x	25		40	.421	.03	.01
3	1.0	.18		x	33		40	.552	.05	.03
4	1.25	.16		x	20		40	.338	.04	.01
5	1.5	.20		x	45		40	.747	.07	.05
6	2.0	.24		x	25		40	.421	.09	.04
7	2.25	.25		x	35		40	.585	.06	.04
8	2.25	.16		x	50		40	.829	.06	.05
9	3.0	.25		x	60		40	1.00	.09	.09
10	3.25	.27		x	60		40	1.00	.07	.07
11	3.25	.29		x	40		40	.668	.07	.05
12	3.75	.30		x	45		40	.747	.08	.06
13	4.0	.28		x	25		40	.421	.10	.04
14	4.5	.20		x	45		40	.747	.07	.05
15	4.75	.22		x	45		40	.747	.06	.04
16	5.0	.21		x	20		40	.338	.12	.04
17	5.9	.12		x	40		40	.668	.09	.06
18	6.5	.10		x	15		40	.256	.06	.02
19	7.0	.11		x	13		40	.223	.14	.03
20	8.0	.00		x	-		-			
										Total Discharge .81 m ³ /s

- A Distance to measuring point
- B Panel width ($d/20$)
- C Total depth at metering point
- D Metering Depth ($0.2 \times d$)
- E Metering Depth ($0.8 \times d$)

- start measurement at 9:40 am, stop at 10:15 am
- stage elevation 9.116 m

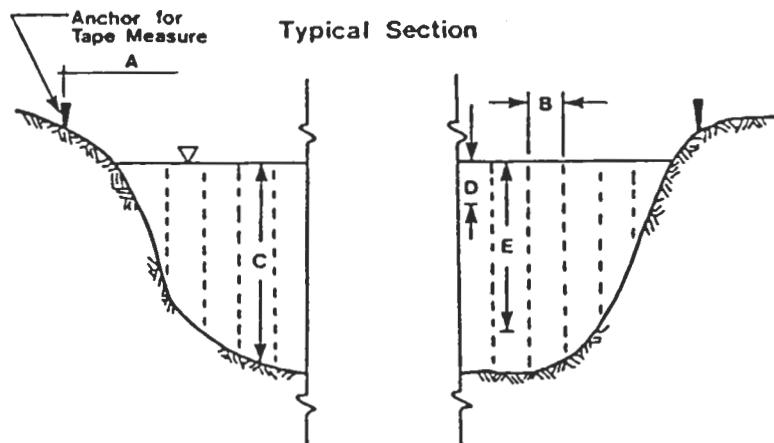
Panel No.	Depth "d" Dist.	Meter "d"		Rev.	Time Sec	Velocity "v"	\bar{V}	Area	Discharge "Q"
		0.2	0.6						
1	2.25	.09	m	x	19		40	.320	
2	2.50	.10		x	13		40	.226	
3	2.75	.10		x	14		40	.244	
4	3.0	.15		x	8		40	.146	
5	3.25	.14		x	23		40	.390	
6	3.50	.16		x	17		40	.300	
7	3.75	.17		x	40		40	.668	
8	4.00	.15		x	10		40	.174	
9	4.25	.09		x	15		40	.262	
10	4.75	.15		x	22		40	.375	
11	5.00	.15		x	7		40	.128	
12	5.25	.09		x	15		40	.262	
13	5.75	.08		x	22		40	.375	
14	6.00	.10		x	13		40	.226	
15	6.25	.10		x	14		40	.244	
16	6.50	.14		x	26		40	.445	
17	6.75	.14		x	8		40	.146	
18	7.0	.16		x	22		40	.375	
19	7.25	.16		x	19		40	.320	
20	7.75	.17		x	24		40	.408	
	8.5	.0						Total Discharge	.39 m ³ /s

- A Distance to measuring point
- B Panel width ($d=20$)
- C Total depth at metering point
- D Metering Depth ($0.2 \times d$)
- E Metering Depth ($0.8 \times d$)

- measurements taken from 1:11 pm to 1:35 pm
- water temperature 3°C at 1:15 pm

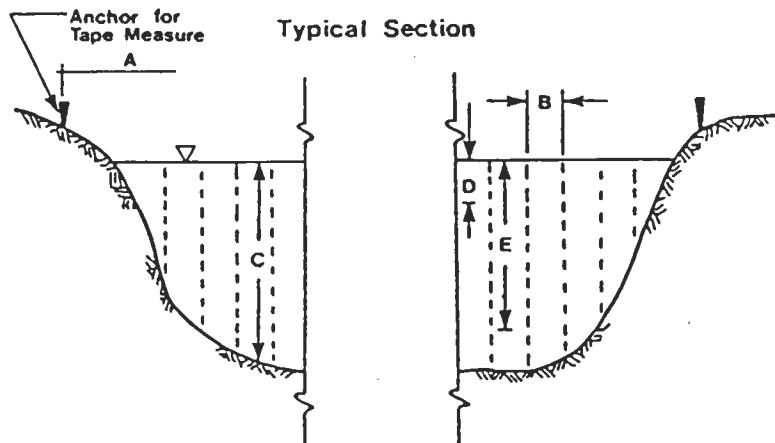
Structure B7
Location: Warm Creek
Date: June 3, 1983
Recorded by: I. Wiseman

Panel No.	Depth "d"	Meter "d"		Rev.		Time		Velocity "v"		\bar{V}	Area	Discharge "Q"
		0.5	0.6	40	40	40	41	.679	.665			
1	1.13	1.4	m	1.4	4.2	40	40	.679	.665	.67	1.58 m ³	1.06 m ³ /s
2	1.13	1.4		1.4	4.2	35	40	.594	.679	.63	1.58	0.99
3	1.13	1.3		1.4	4.1	30	10	.513	.176	.34	1.47	0.50
4	1.13	1.3		1.3	3.8	25	25	.381	.424	.40	1.41	0.56
5	1.13	1.2		1.3	3.7	30	15	.466	.259	.36	1.37	0.50
6	1.13	1.2		1.3	3.7	35	20	.591	.344	.47	1.37	0.64
7	1.13	1.3		1.3	3.8	30	35	.512	.591	.55	1.41	0.78
8	1.13	1.4		1.4	4.2	20	30	.344	.512	.42	1.58	0.66
9	1.13	1.4		1.4	4.2	30	15	.512	.259	.38	1.58	0.60
10	1.13	1.3		1.4	4.1	30	15	.512	.259	.38	1.47	0.56
11	1.13	1.3		1.3	3.9	55	40	.905	.649	.78	1.45	1.10
12	1.13	1.3		1.4	4.1	20	15	.344	.240	.29	1.47	0.43
13	1.13	1.3		1.4	4.1	25	25	.424	.424	.42	1.47	0.61
14	1.13	1.4		1.4	4.2	45	30	.743	.512	.62	1.58	0.98
15	1.13	1.6		1.5	4.7	25	35	.424	.591	.50	1.81	0.91
16	1.13	1.6		1.5	4.7	55	50	.886	.847	.87	1.81	1.60

17	1.13	1.6		1.5	4.7	50	50	.847	.807	.83	1.81	1.50
18	1.13	1.3		1.3	3.9	50	50	.847	.847	.85	1.45	1.23
19	1.13	1.3		1.4	4.1	30	55	.50	.908	.70	1.47	1.03
20	1.13	1.3		1.3	3.8	50	50	.847	.826	.84	1.41	1.18
Total Discharge											17.42 m³/s

- A Distance to measuring point
- B Panel width ($d/20$)
- C Total depth at metering point
- D Metering Depth ($0.2 \times d$)
- E Metering Depth ($0.8 \times d$)
