Canada - Newfoundland
Flood
Damage
Reduction
Program

Hydrotechnical Study of the Stephenville Area

Physical Surveys and Field Program

February , 1984

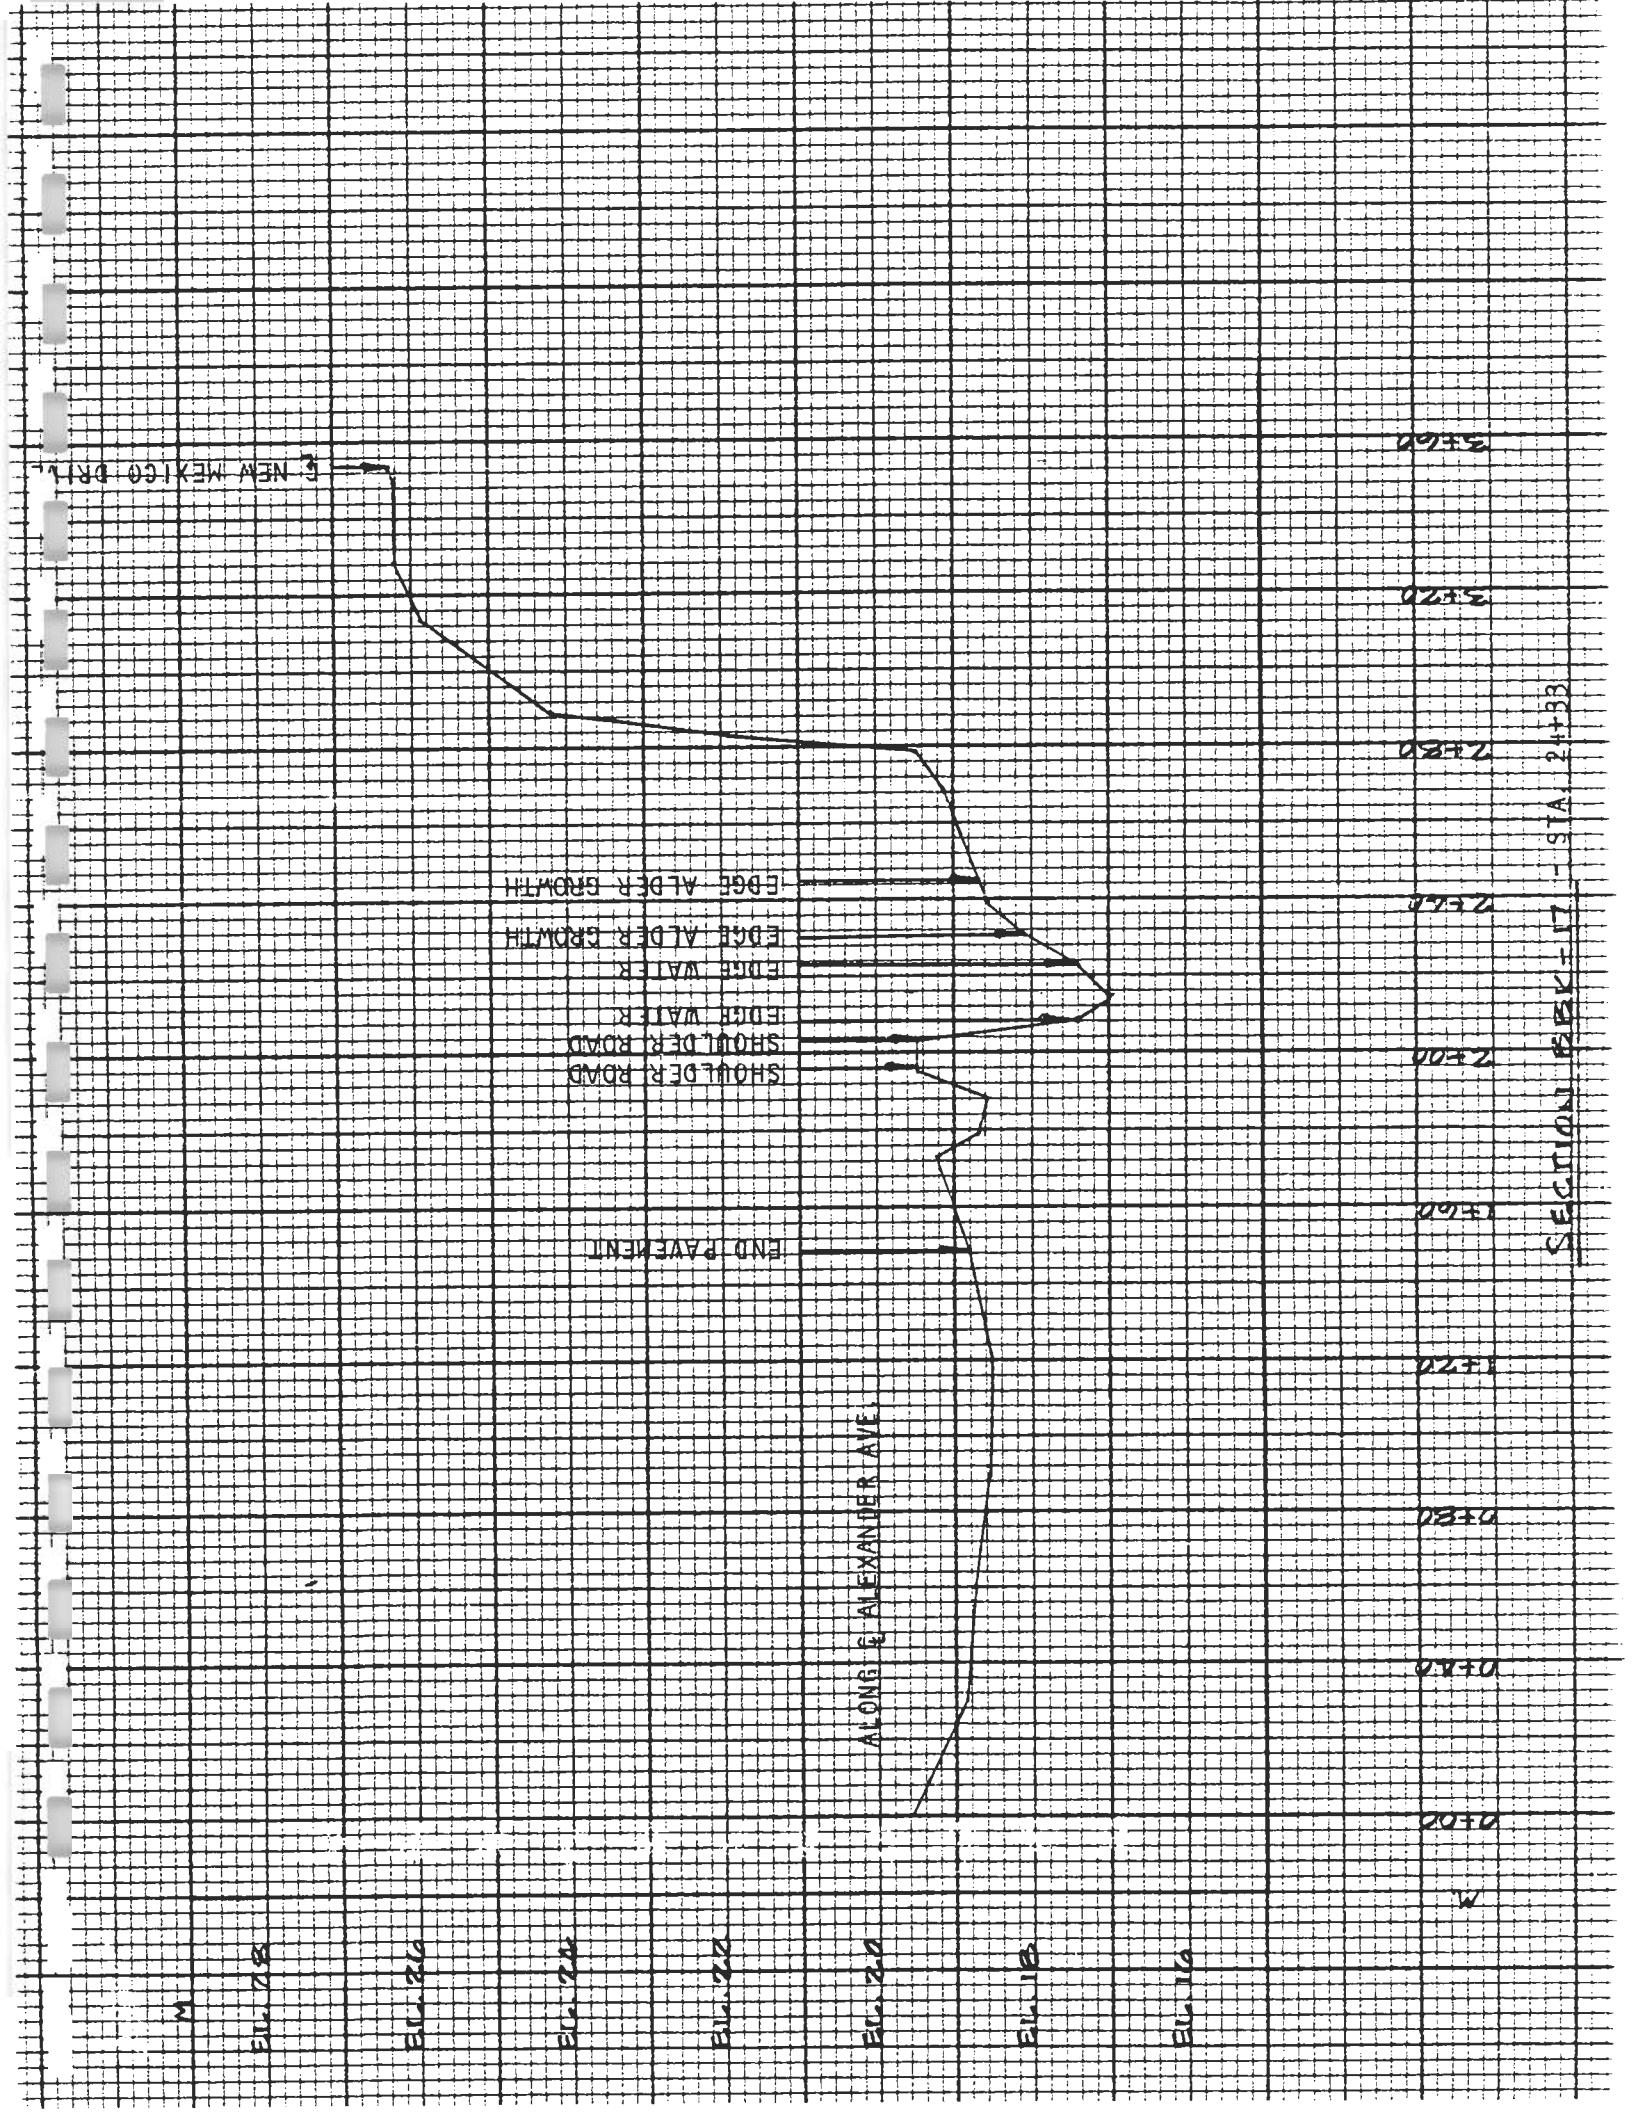
SECTION FIFTEEN - STA 2+33

E NEW MEXICO DRIVE
EDGE ALDER GROWTH
EDGE ALDER GROWTH
EDGE WATER
EDGE WATER
E BLANCHET STREET
END PAVEMENT

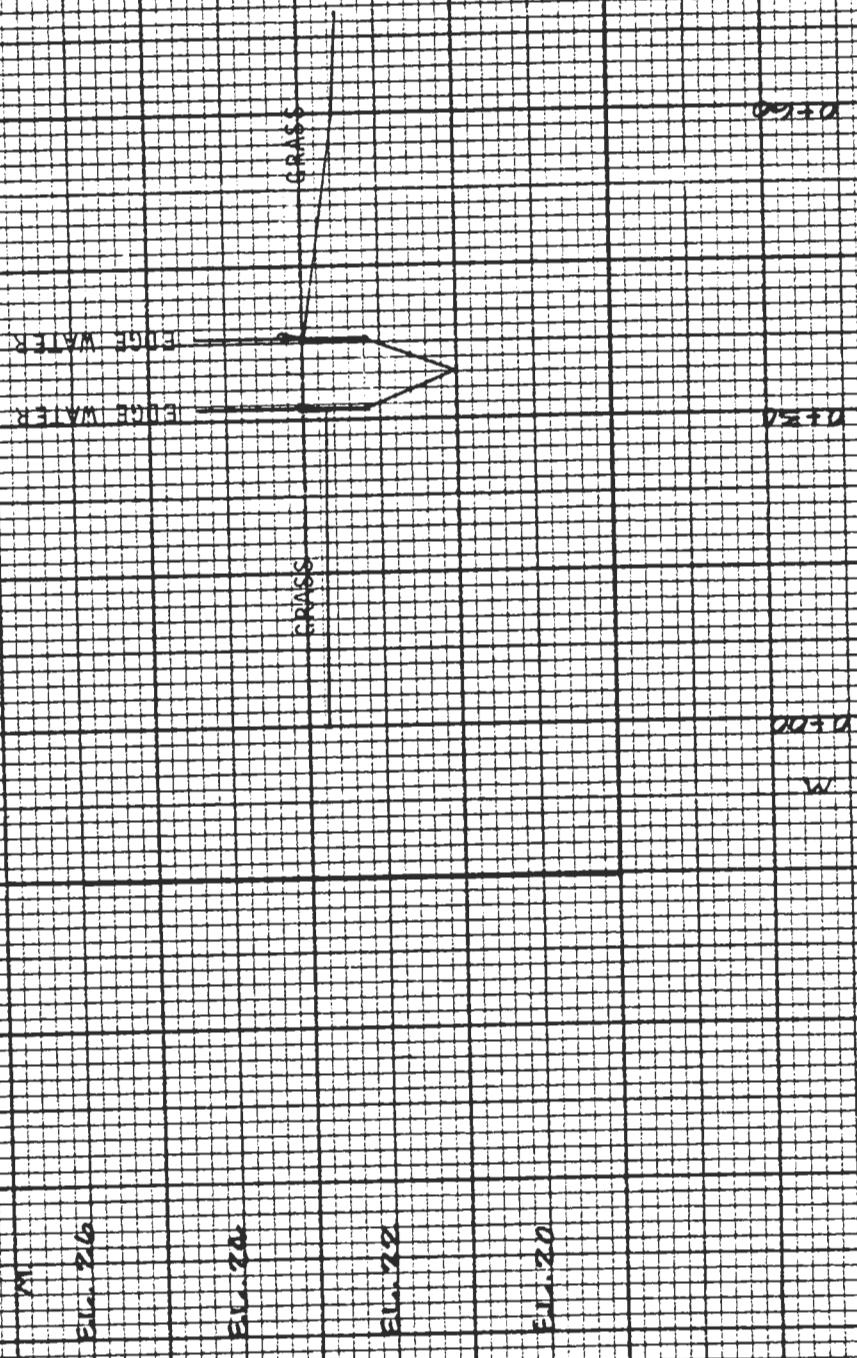
SECTION VC - 28

STA. 61+38

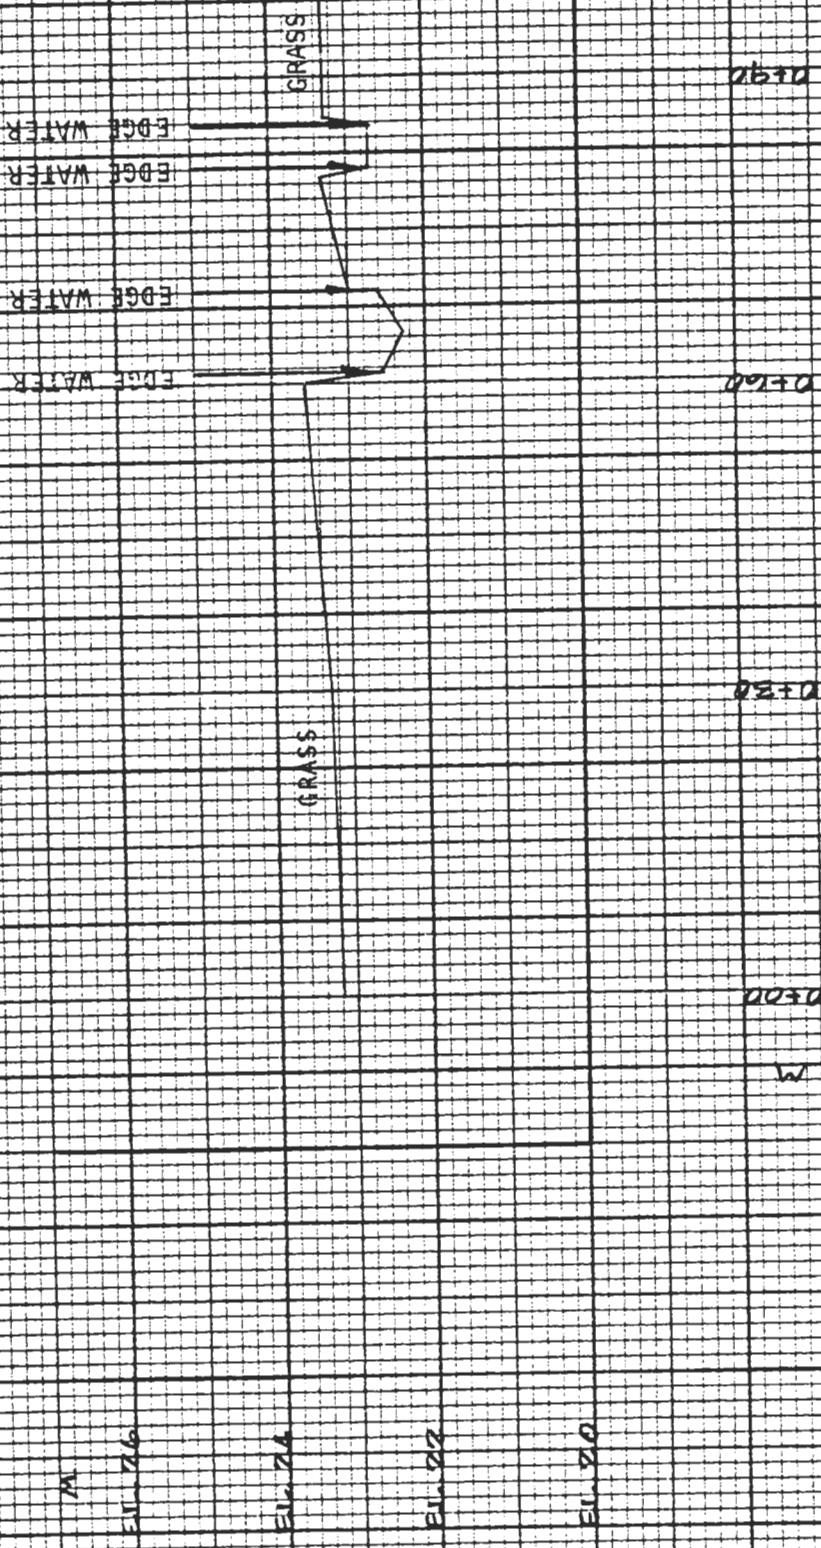
SECTION WC-29

STA. 6+08
