Canada-Newfoundland Flood Damage Reduction Program

Location of Potential Remedial Work Schemes

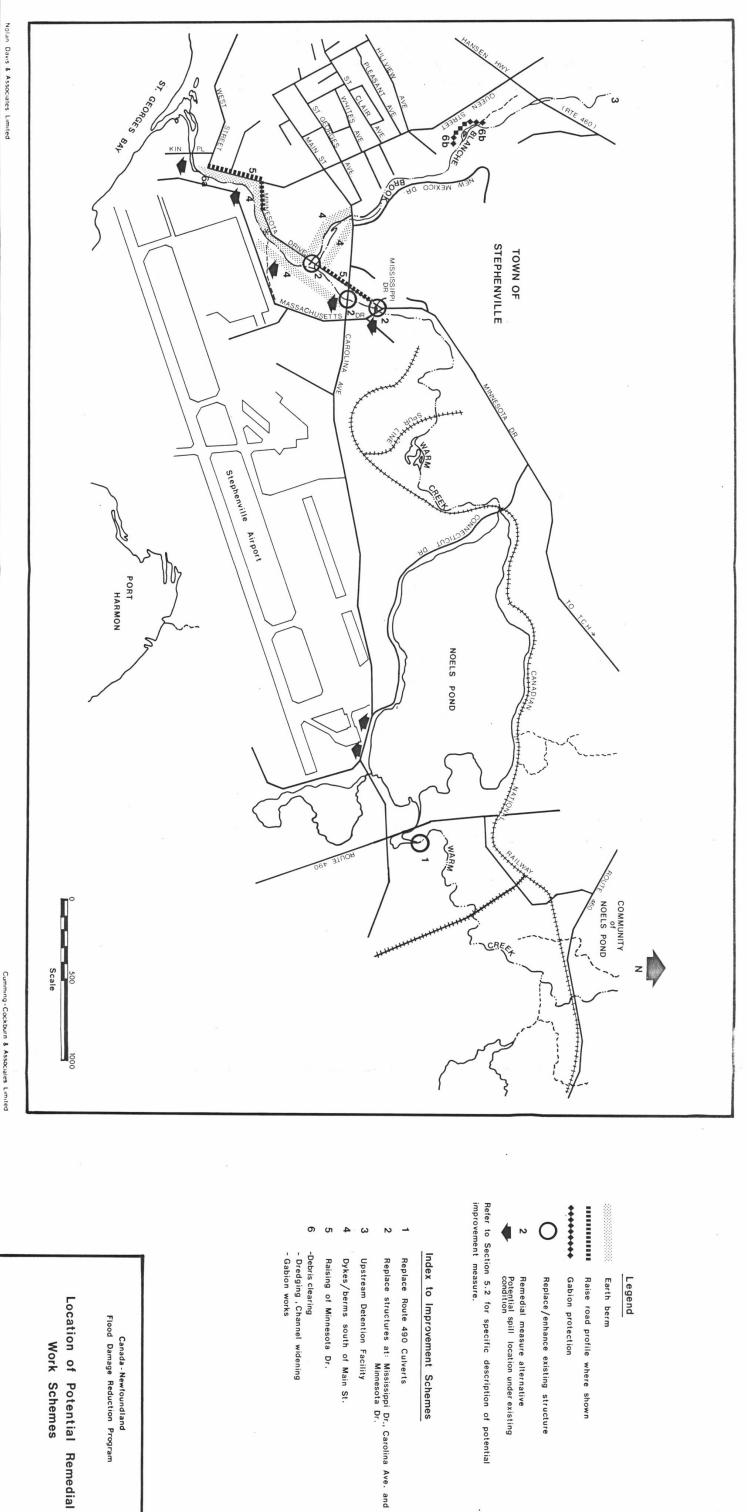
Raise road profile where shown

Remedial measure alternative Potential spill location under existing condition

## Index to Improvement Schemes

- Replace Route 490 Culverts
- Upstream Detention Facility
- Dykes/berms south of Main St.
- Raising of Minnesota Dr.

Refer to Section 5.2 for specific description of potential improvement measure.
